### HOME INSPECTION REPORT

8 Rusholme Park Cres

Feb 11th 2019

Pradeep Samaroo, RHI

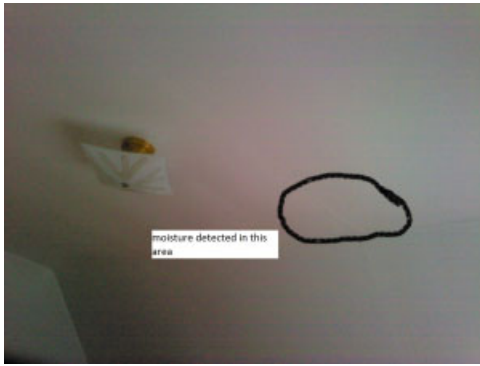
Moisture detected in the area where the flat ceiling meet the sloped surface

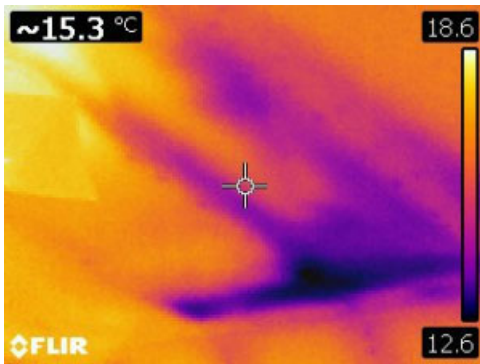
Thermal image showing location of moisture
