### HOME INSPECTION REPORT

56 Larstone Ave.

May 13th 2019

Pradeep Samaroo, RHI

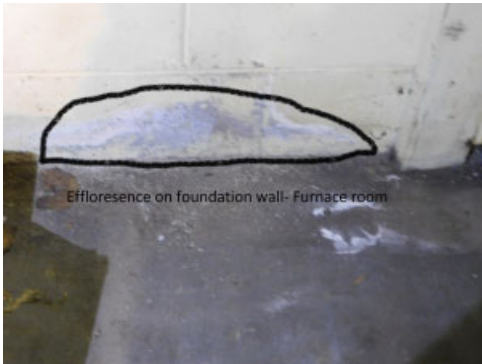
[Efflorescence observed on west wall of furnace room-](#)

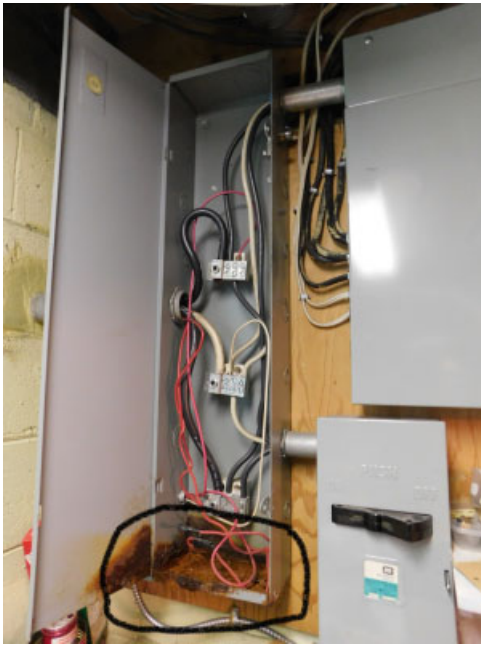
Electrical feed cabinet- Water infiltration

Standing water and rust at the base of the cabinet indicates an ongoing issue of water finding its into the conduit and into the cabinet. Potential shock hazard.

Water migrating into electrical cabinet through conduit-shock hazard- immediate attention is required

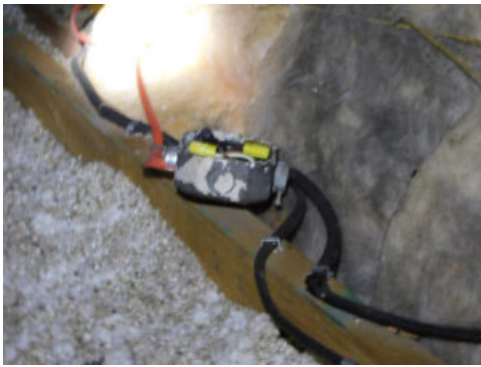
Missing coverplates/ loose outlets/ exposed cabling observed at: Attic space

Open junction box in attic

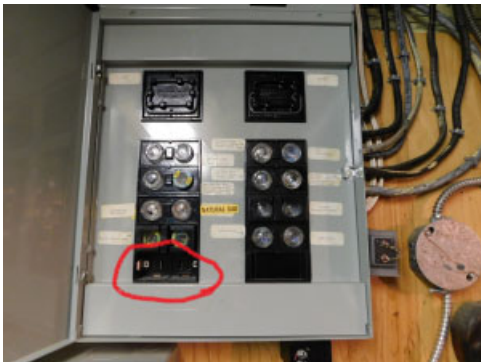
An open knock out on the electrical panel is a potential shack hazard

Opening in electrical panel - Potential shock hazard

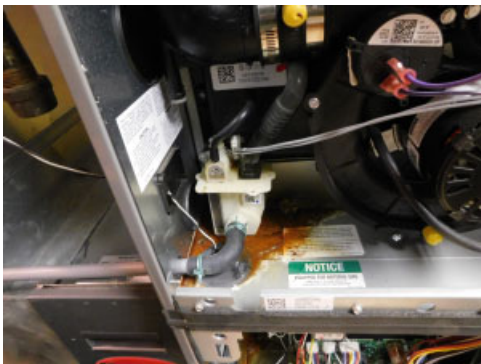
Condensate leak in furnace

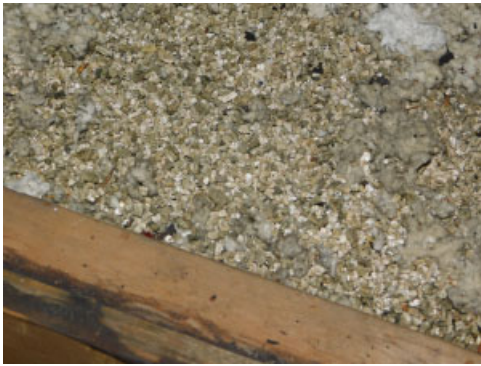
Vermiculite insulation in attic- may contain asbestos- Should be tested

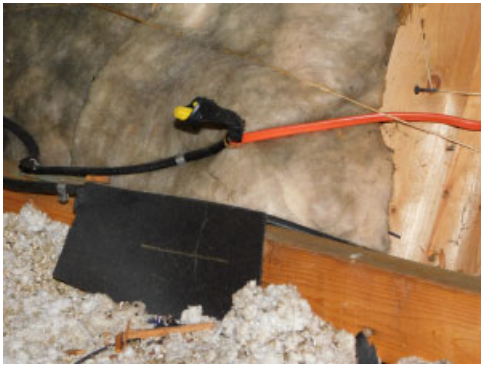
Improper connection in attic adjacent to skylight vault
