HOME INSPECTION REPORT

87 Muirhead Rd

October 29th 2019

Age of House 50 years. Construction Type: 2 storey semi-detached brick veneer & wood frame upper level

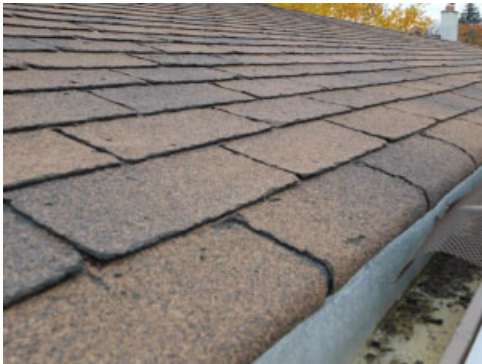
Upper roof- replace within the next year

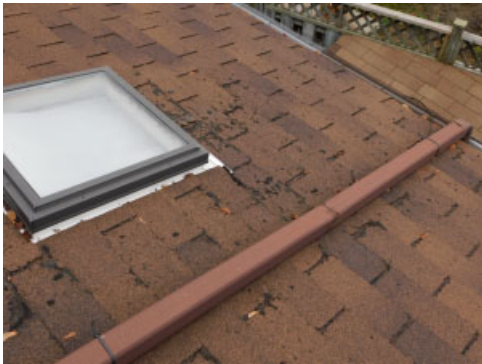
Garage roof- Replace immediately

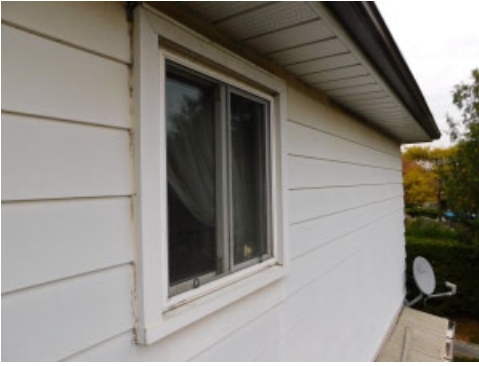
[Upgrade caulking around all windows](#)

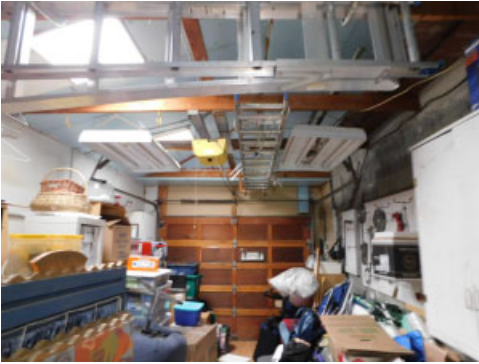
[GARage ceiling is insulated with foam board insulation- Encapsulate to protect from exposed flames](#)

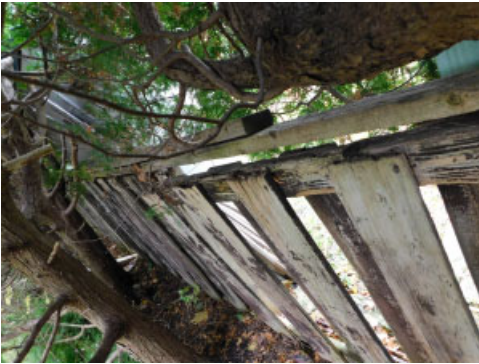
[Repair fence at rear.](#)

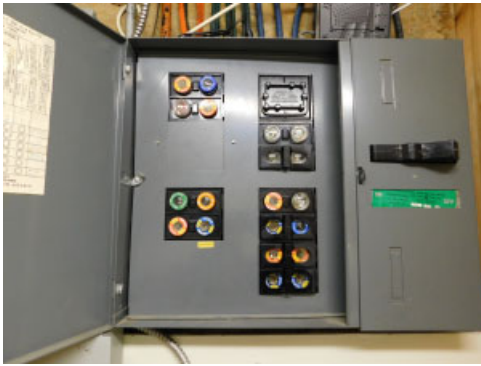
Most circuits are overfused

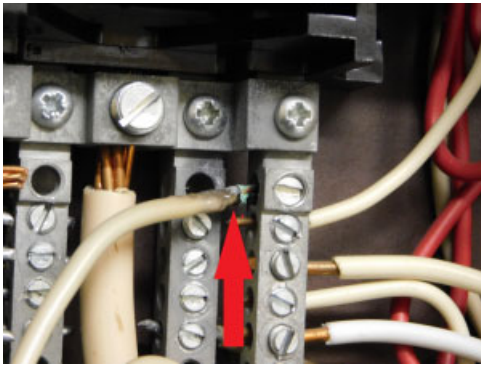
Overheated neutral conductor

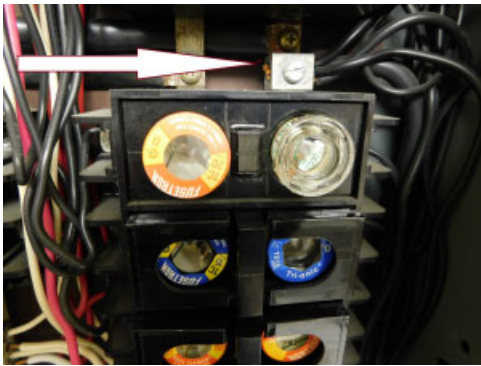
Conductors connected directly to bus- No overcurrent protection is provided to these circuits
