HOME INSPECTION REPORT

678 Willard Ave

11th March 2020

Pradeep Samaroo, RHI

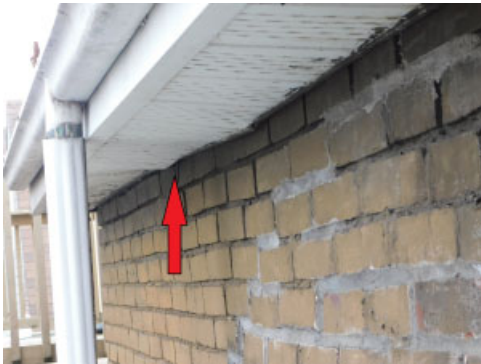
Repair soffit - possible point of vermin entrance into attic space

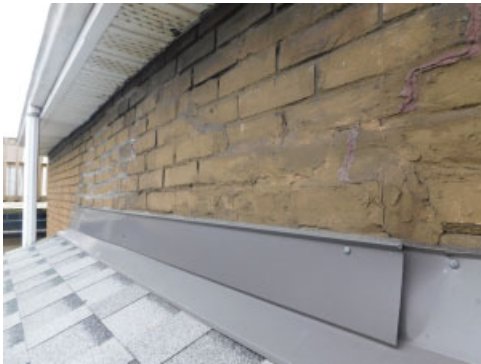
Upgrade caulking on flashing

All/most flashings are in Good condition Fair condition []
 Repair/replace/ install flashings at: []
 Repair/replace all flashings with next roof covering replacement. Caulking rec'd at: At rear enclosed porch
 Repairs/ maintenance required before next application of roof coverings: (ie) caulking or tarring

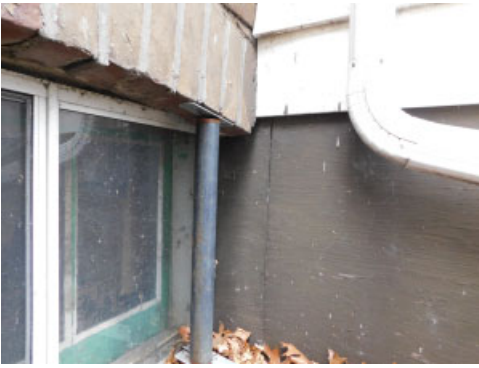
Steel post supporting the basement window arch coupled with the recent brick repair above the window and the tuck

compromised. Though recently repaired further evaluation may be required if new cracks appear,

Steel post supporting window arch of brick veneer- Monitor-Further evaluation may be required.

Further evaluation of structural support of brick veneer at rear may be required if new cracks appear.
Further investigation into the source of moisture at the base of the plumbing stack is recommended.

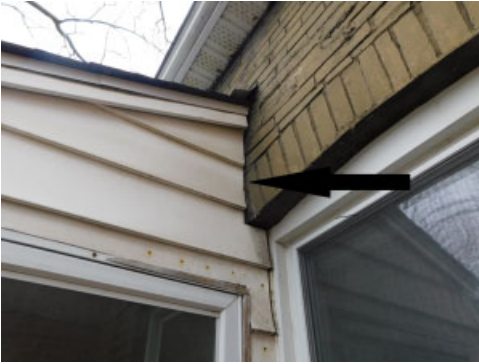
Upgrade caulking at transition between bricks and siding throughout

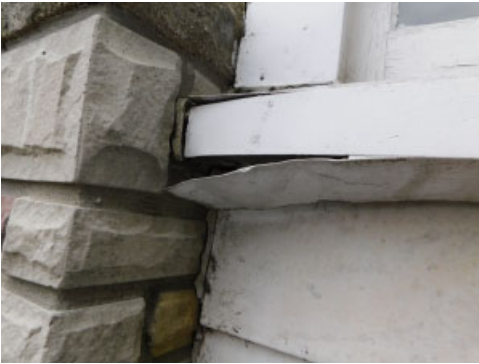
Upgrade caulking throughout - on front sunroom

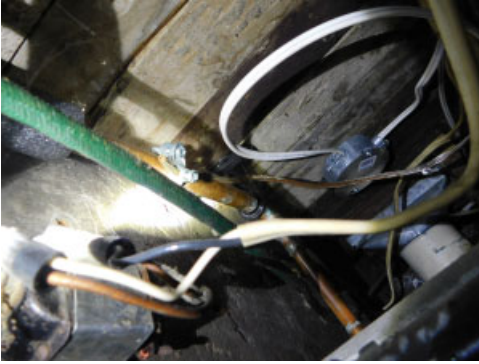
Grounding for the panel is incorrectly installed downstream of the water meter on the water service

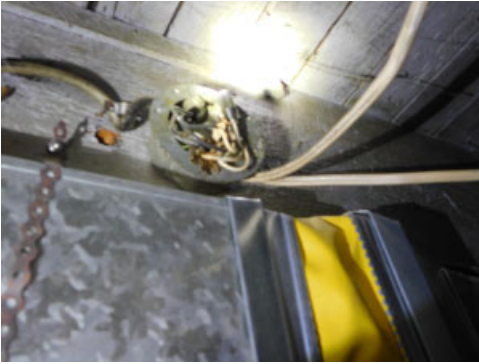
Missing **coverplates/** loose outlets/ exposed cabling observed at: Junction boxes on basement ceiling.

There are several open junction boxes on the basement ceiling.

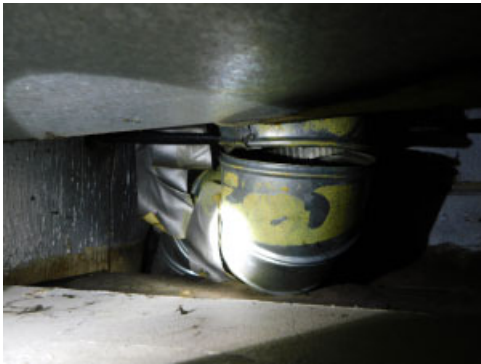
Disconnected duct- 1st take off on supply trunk

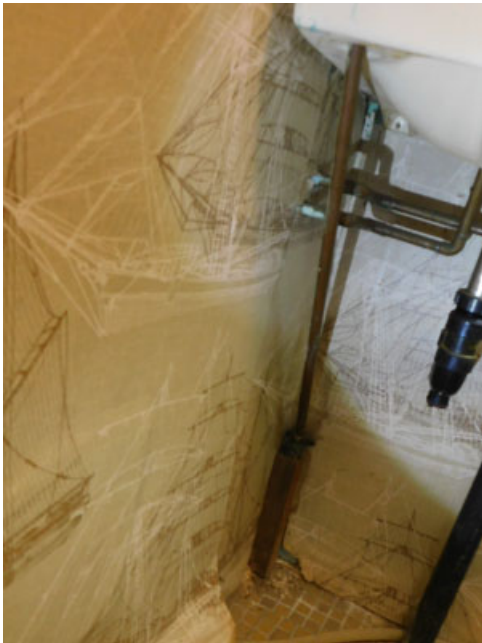
[Improperly installed vanity sink in the basement](#)

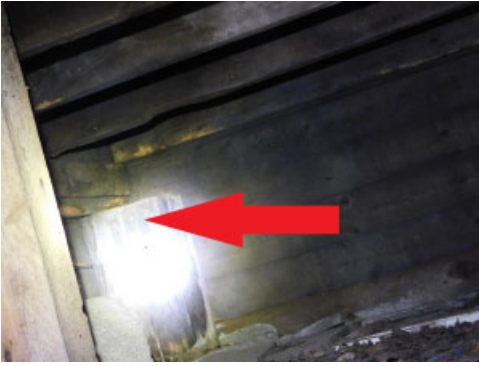
Header board of the rear mud room shows some signs of rot- further evaluation is recommended

- Continuous concrete Masonry/ wood piers Slab on grade Wood beam on grade
Crawlspace Full basement No visible accessibility Access to crawlspace is recommended.
Repairs/ improvements are required at: Some rot on header board observed (Mud Room)

Rear mud room- header board shows signs of rot- further investigation is recommended
