20/20 HOME INSPECTIONS

HOME INSPECTION REPORT

117 Glendale Ave

April 14th 2020

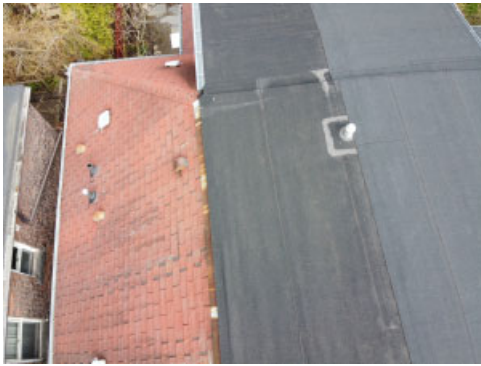
Shingles are approaching the end of useful life expectancy.

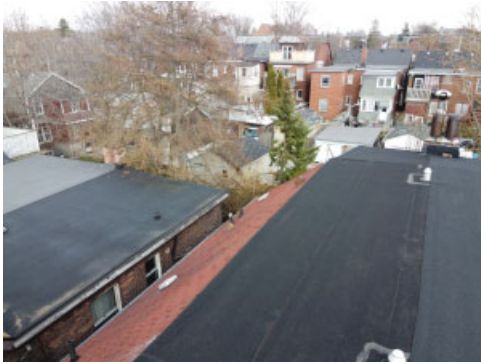
Flat roof membrane is in fair condition- anticipate reeplacement in 5 years
