20/20 HOME INSPECTIONS

HOME INSPECTION REPORT

38 Station Rd

June 23rd, 2020

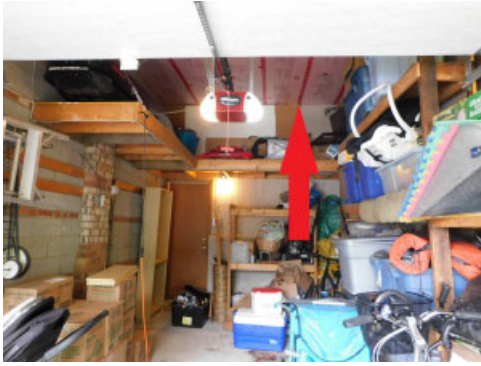
Foam board insulation on garage ceiling- should be encapsulated or removed

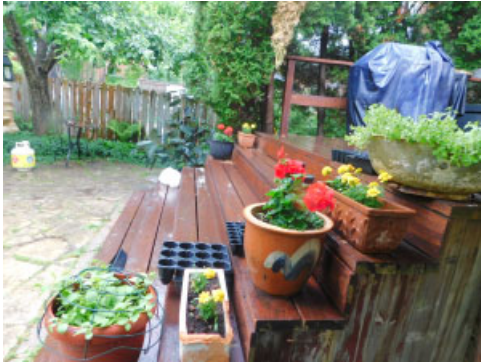
Handrail are required along the steps as well as properly spaced guardrails on side of deck

Handrail/ guardrail recommended alongside steps at: **rear deck**

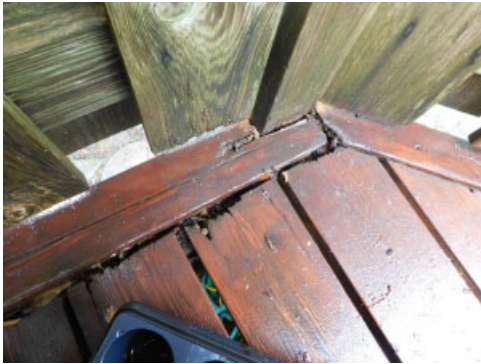
Decking: Good condition Fair condition **some rotted boards**

Some boards onthe rear deck show signs of rot

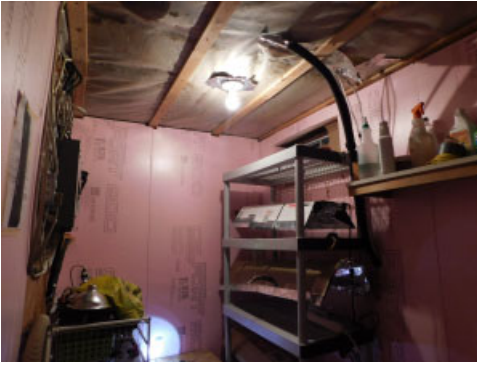
Foam insulation should be removed or covered with a fire rated material (drywall, plywood)

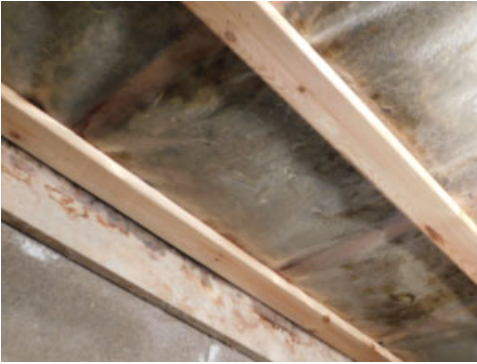
Water has accumulated on the vapor barrier on the cold room ceilings

Remove insulation vapour barrier from ceilings of coldroom and provide better ventilation to the spaces. If left in their present condition there is the possibility that mold will propogate.
