20/20 HOME INSPECTIONS

HOME INSPECTION REPORT

128 Watson Ave

June 27th 2020

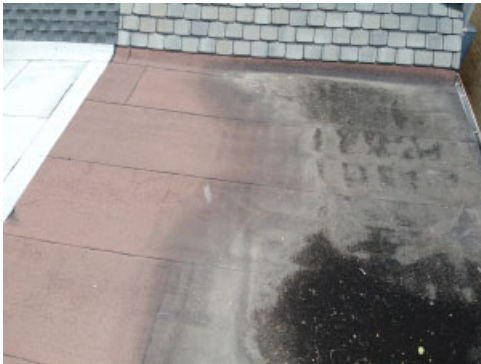
The flat roof is approaching the end of its life expectancy

Replace all flat roof coverings Time frame 0-3 years Budget \$ 4000

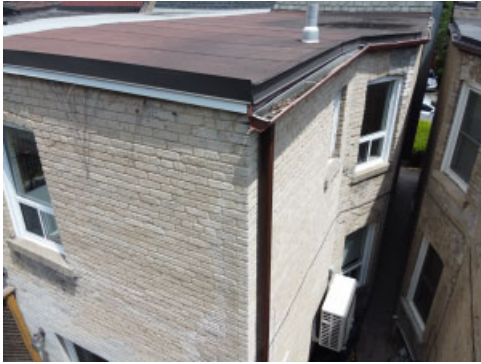
The eavestrough is not secured to the building. Loose nails

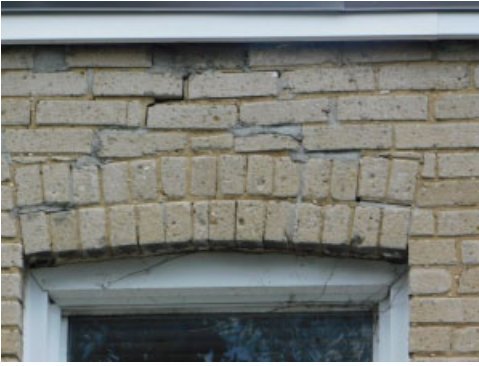
Tuck point is required is several locations on the building

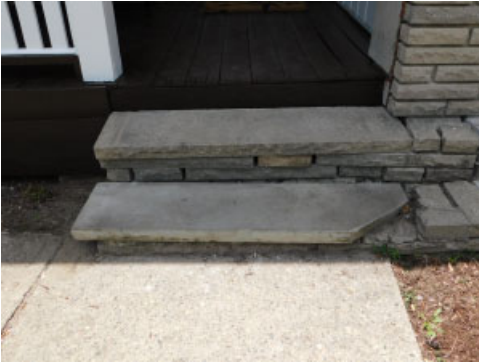
Steps/stairs: Good condition Fair condition Stones on steps are loose

The front steps are unstable due to loose stones that make it up - Safety issue

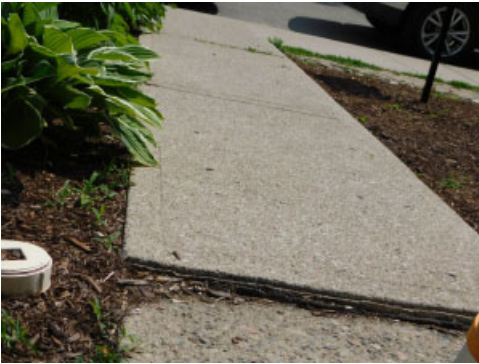
Repair work required/ recommended at: Walkway- Raised section with a lip- potential trip hazard

Raised slab on walkway presents a trip hazard.

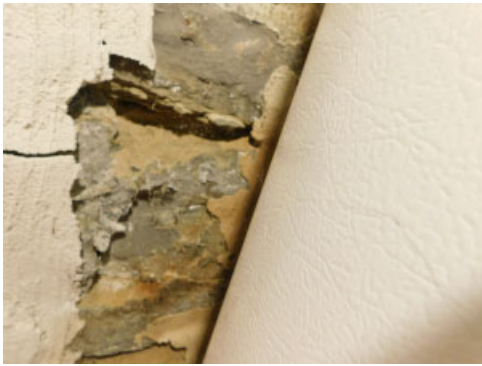
- Brick Stone Concrete block Poured concrete Preserved wood foundation
Foundation wall interiors not accessible for visual inspection. Load-bearing components not visually accessible.
Non-structural cracks were observed which could be a source of future water penetration.
Some tuck pointing required between stones on accessible walls in utility room

Some tuckpointing is required between the stones of the foundation walls where accessible

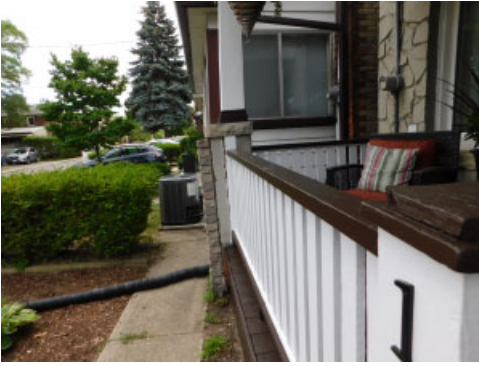
Column supporting the roof and the porch on the south side of house the has shifted

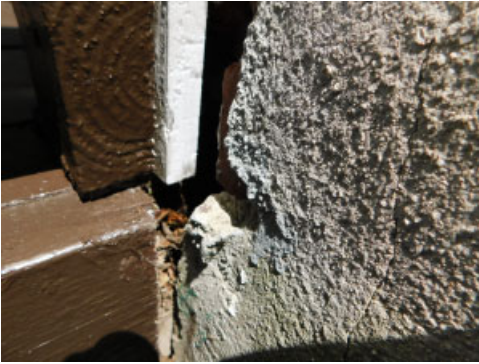
Structural supports: Good condition Fair condition Structural support into column is rotted

Structural support of the porch framed into the column has rotted

Deck/porch repairs/replacement- Front Time frame 0-5 years Budget \$ 5000

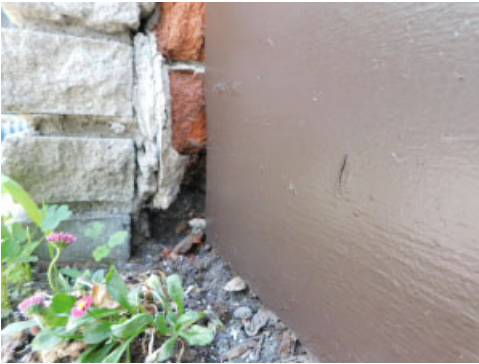
Bricks at the base of the column has deteriorated
