HOME INSPECTION REPORT

111 Leigh St

September 4th 2020

Pradeep Samaroo, RHI

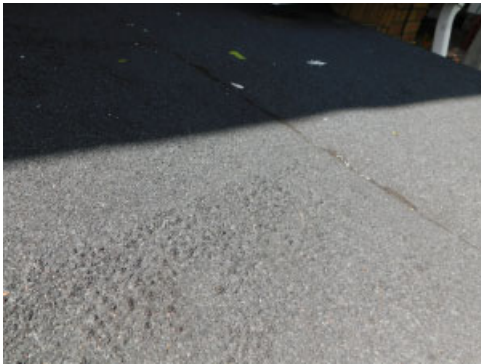
- Current repair is required at:
- Roof covering replacement is required at:
- High probability of replacement of roof coverings within years.
- Repairs/ roofing tune-up is required soon/ before next application of roof coverings Annual visual inspection required.
- Trim tree branches/ vines away from roof edge. Tree removal recommended at:
- Centre strip of membrane is beginning to blister- Expect to repair within the next 2 years

[Flat roof membrane is beginning to blister](#)

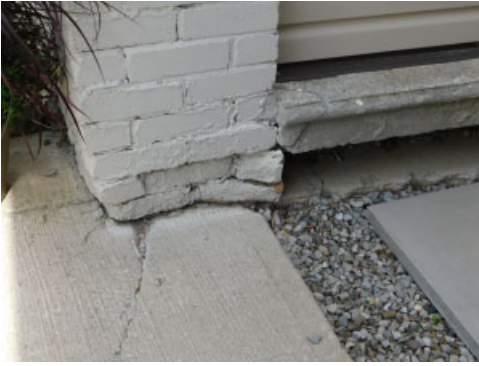
Base of column on south side of front porch requires repair. Bricks are loose

Repair base of column at front porch Time frame 0-3 years Budget \$ 500

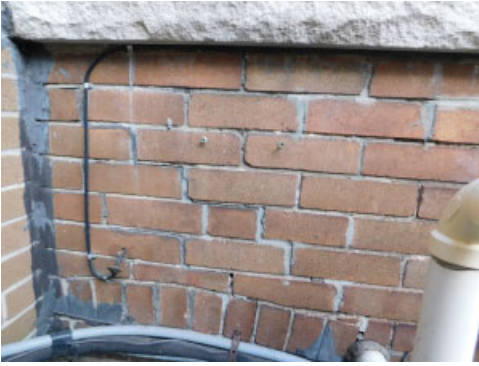
Tuck pointing is required in cracks of rear wall above and below window.
