HOME INSPECTION REPORT

1836 Bickford Dr

February 10th 2021

Pradeep Samaroo, RHI

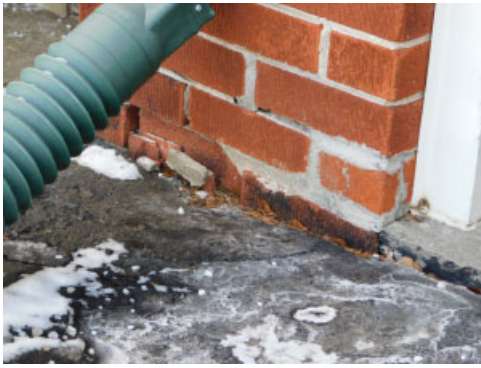
Tuck pointing and brick is required on the bottom courses of bricks adjacent to the garage door

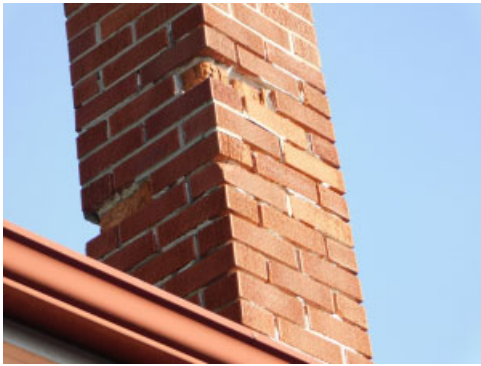
Chimney requires brick repairs. As it is obsolete it can also be removed

Repair chimney Time frame 0-2 years Budget \$ 500

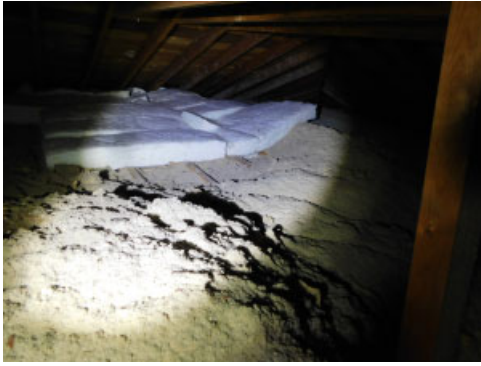
Unevenly installed insulation in the attic

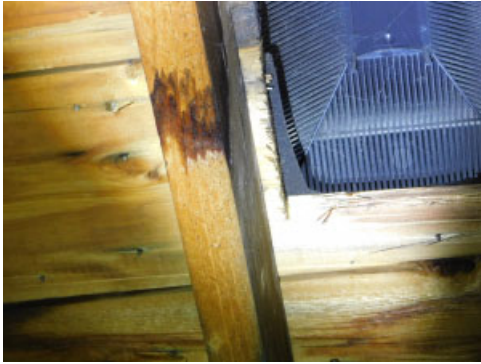
Wet rafter beside roof vent

Repair moisture issue at roof vent Time frame 0-1 years Budget \$ 200

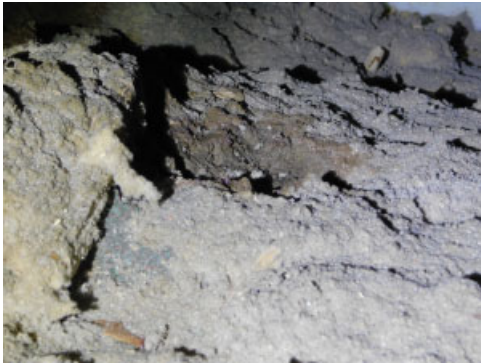
Wet insulation below roof vent. Have a roofing contractor inspect to determine cause
