20/20 HOME INSPECTIONS

HOME INSPECTION REPORT

412 Perth Ave

March 15th 2021

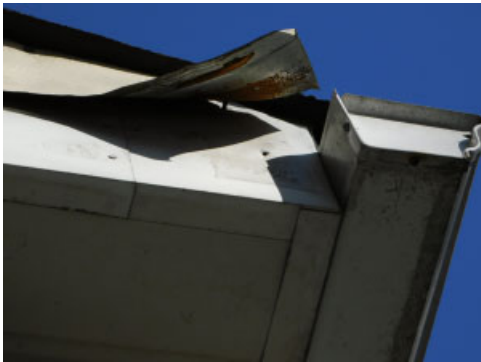
[Repair aluminum cladding at front porch](#)

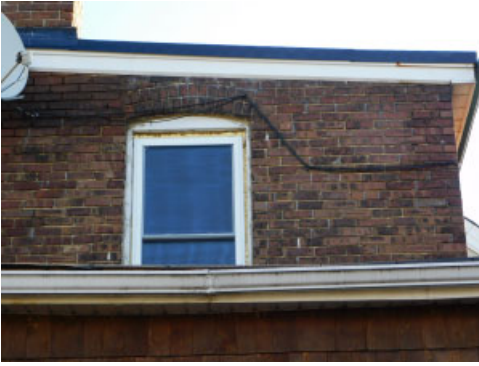
No flashing around windows. Foam is exposed

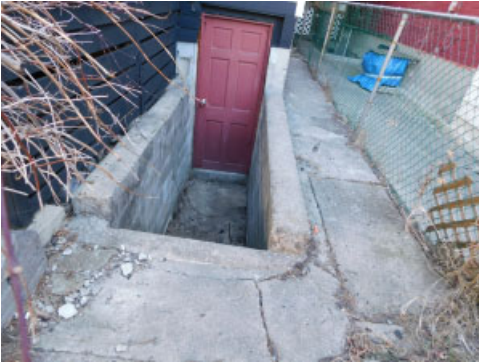
Door is not for exterior use, not adequately flashed to prevent air and water infiltration. No handrails

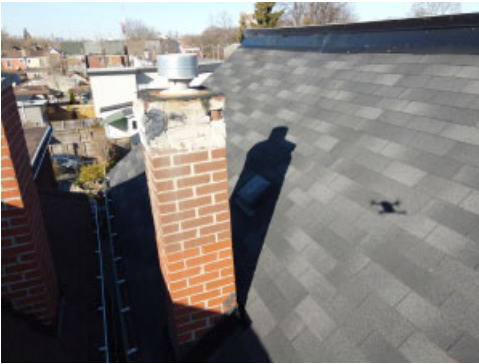
Some minor tuck pointing required on chimney

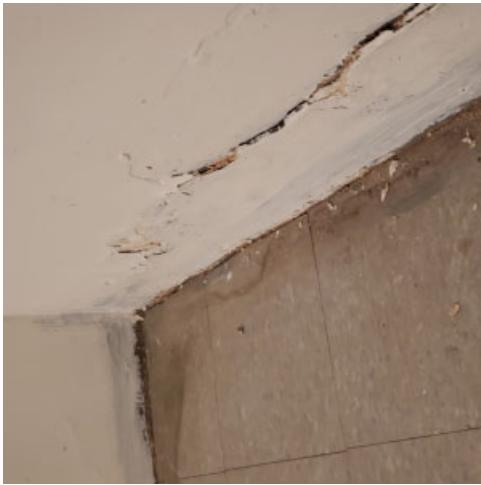
Rear wall of addition Previous water damage - dry when measured

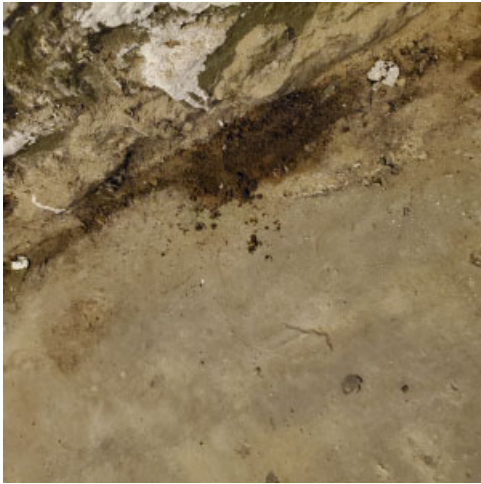
Dampness at bottom of foundation wall beside furnace

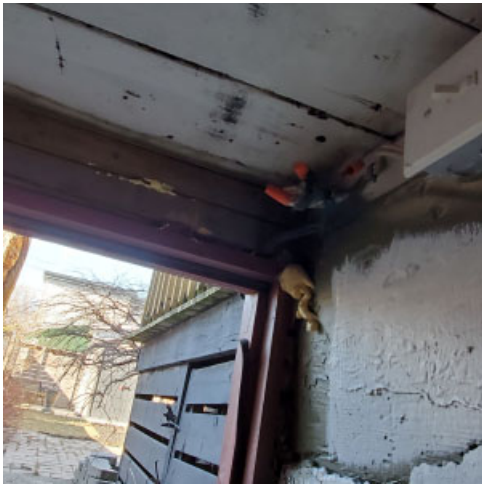
Connection not in junction box

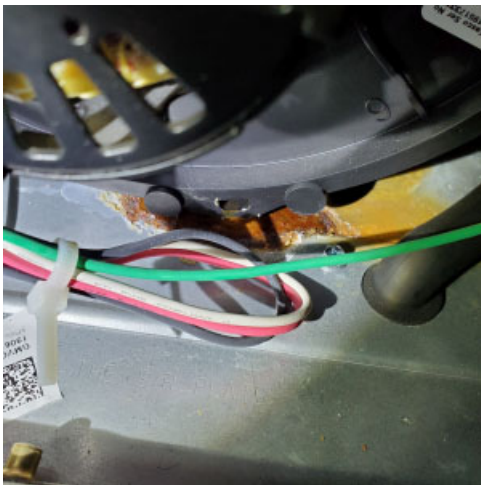
Condensate leak below vent motor
