### HOME INSPECTION REPORT

983 St Clarens Ave

March 16th 2021

Pradeep Samaroo, RHI

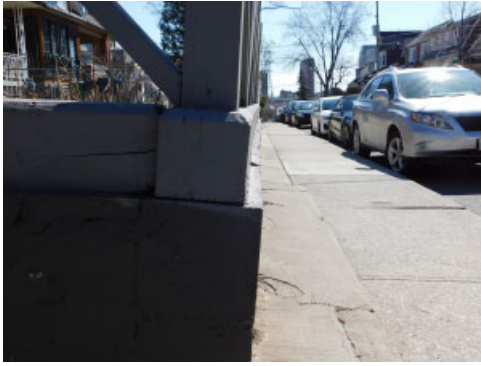
Block retaining at front is shifting

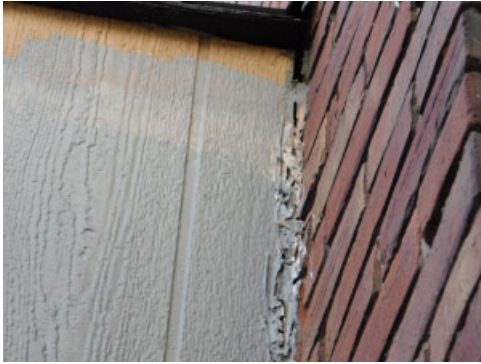
Upgrade caulking at front and rear sunrooms, between cladding and bricks.

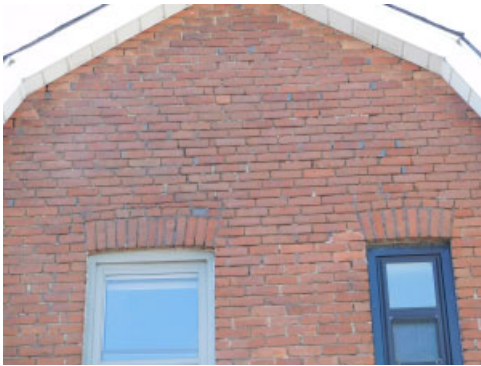
Tuck pointing required on rear wall and side walls at rear portions.
