# A Buyer's Choice Home Inspections

## PROPERTY INSPECTION REPORT

208 Northcliffe Blvd, Toronto, ON, M6E 3K7

Date of Inspection: 3/6/2021 Time: 12:00 PM Size: 0  
Order ID: 840

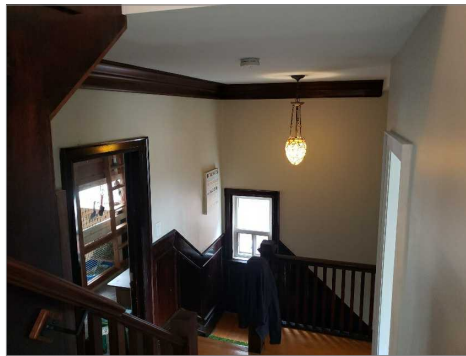
Page 9 Item: 2	CO Alarms	<ul style="list-style-type: none"> <li>• <b>Repair/Safety</b> - There is no Carbon Monoxide detector outside the bedrooms. By law, every house with an attached garage, fireplace and fuel burning appliances is required to have a CO alarm outside the sleeping areas of the home. It is required that a CO alarm is installed. It is also recommended that a CO alarm is installed on every floor with a fuel burning appliance.</li> </ul>
----------------	-----------	--

**CORRECTIVE MEASURE TAKEN:**  
Recommended CO2/smoke alarm has been installed.

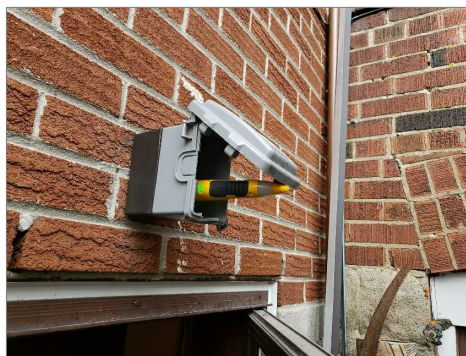
Page 12 Item: 4	Exterior Outlets	<ul style="list-style-type: none"> <li>• <b>Improve</b> - Non-GFCI outlet noted. Recommend replacement with A GFCI type as per current electrical standards.</li> </ul>
-----------------	------------------	---

**CORRECTIVE MEASURE TAKEN:**  
GFCI outlet installed

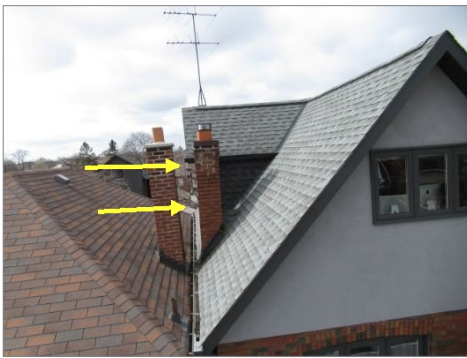
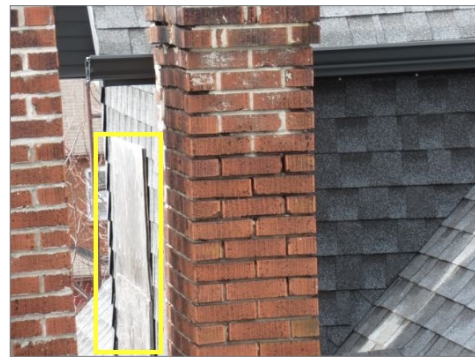
Page 13 Item: 6	Siding	<ul style="list-style-type: none"> <li>• <b>Repair</b> - Plywood area noted on the side dormer of the upper level. This area should be finished with proper siding material to prevent water infiltration. Recommend evaluation by a qualified professional.</li> </ul>
-----------------	--------	---

**CORRECTIVE MEASURE TAKEN:**  
South facing dormer shingled.

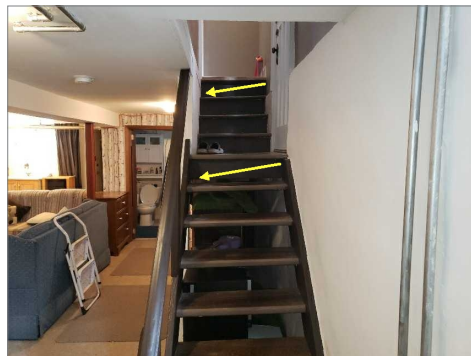
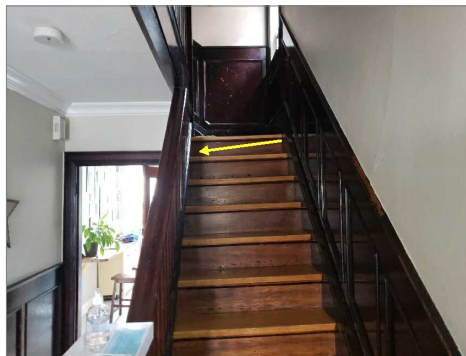
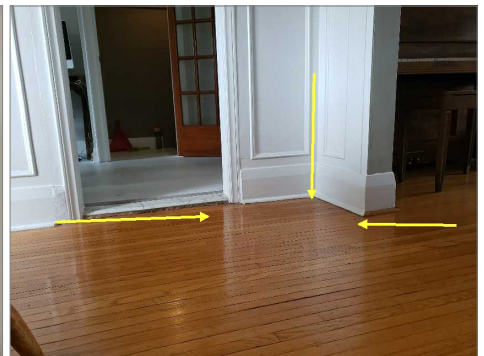
• Further evaluation required - The floors in the home are noted as not level. Sloping floors are noted on all levels of the home. While this is typical in older homes, it should be reviewed to ensure that structural movement is not ongoing, and remedial actions are taken if the movement continues. Recommend evaluation by a qualified professional.

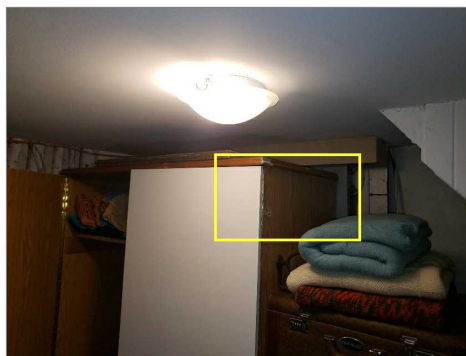
• Repair/Safety - Insufficient clearance noted around panel area. Minimum unobstructed area must be maintained as a minimum of 1 meter in front of the panelboard, 2 meters in height and at least the width of the panelboard or 1 meter, whichever is greater. Recommend removal or rearrangement of the obstructions for safe access to the panel area.

Panel blocked by wardrobe

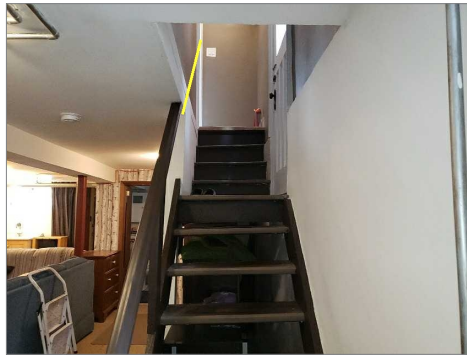
• Repair - Partial handrail observed, recommend installing handrail as necessary for safety. Recommend evaluation by a qualified professional.

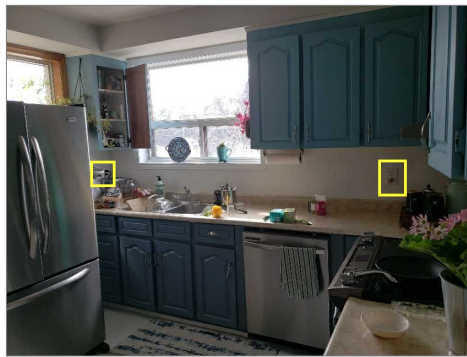
• Improve - No **GFCI** protection present. At the time that the house was built, **GFCI** outlets were not a requirement. It is recommended that **GFCI** protected receptacles are installed, as per current electrical standards. Recommend improvement by a qualified professional.

**CORRECTIVE MEASURE TAKEN:**

GFCI outlet installed.

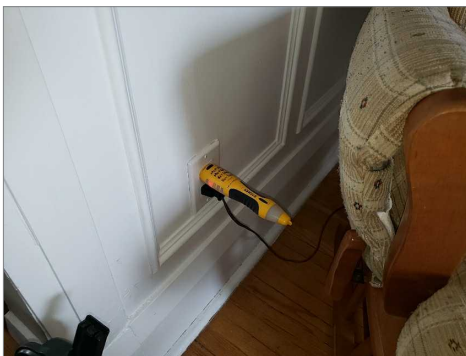
• Repair - Two outlets noted on the main floor with open or missing ground. Recommend evaluation by a qualified professional.

**CORRECTIVE MEASURE TAKEN:**

GFCI outlet installed and cover plate labelled.

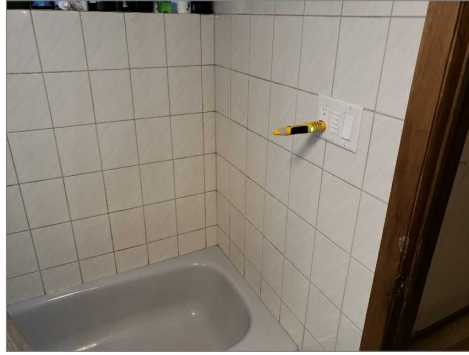
• Improve - No **GFCI** protection present. At the time that the house was built, **GFCI** outlets were not a requirement. It is recommended that **GFCI** protected receptacles are installed, as per current electrical standards. Recommend evaluation by a qualified professional.

**CORRECTIVE MEASURE  
TAKEN:**

GFCI outlet installed.

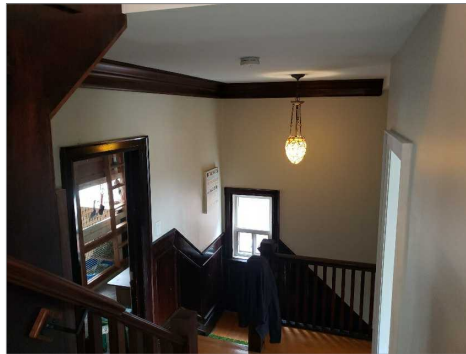
- Information - Smoke and CO detectors should be tested as soon as possible upon taking possession of the home, and ongoing on a regular basis to ensure that are functional and providing protection for occupants.
- Basement detector expiry date: 2028
- Main floor detector expiry date: not present
- Upper floor detector expiry date: not present
- Third floor detector expiry date: 2031
- Repair/Safety - There is no Carbon Monoxide detector outside the bedrooms. By law, every house with an attached garage, fireplace and fuel burning appliances is required to have a CO alarm outside the sleeping areas of the home. It is required that a CO alarm is installed. It is also recommended that a CO alarm is installed on every floor with a fuel burning appliance.

**CORRECTIVE/  
PREVENTATIVE MEASURES  
TAKEN:**

CO2/smoke alarms installed

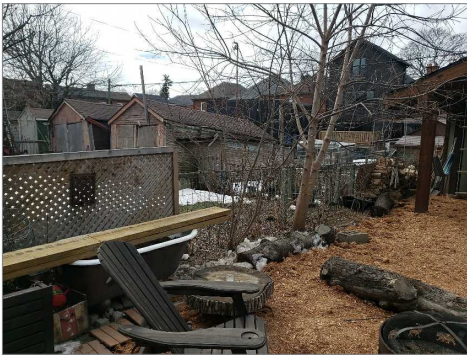
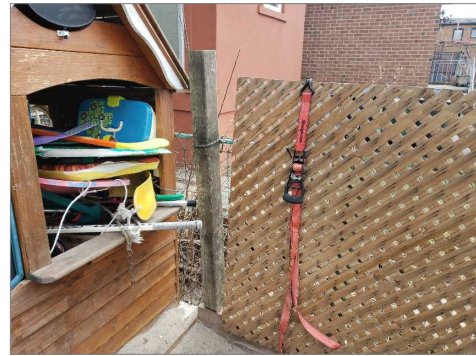
- [Repair - Fence is damaged and leaning in some areas. This does not affect the house but the client is advised to consider repair. Recommend evaluation by a qualified professional.](#)

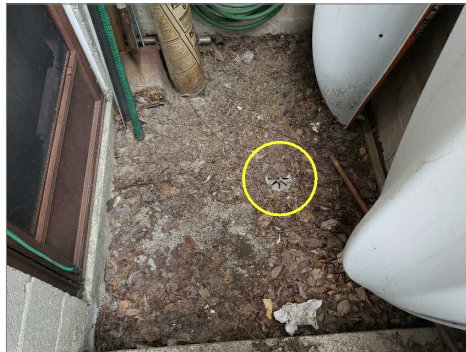
- No material deficiencies noted.
- Maintenance tip - Ensure that the drain is clear of debris at all times, to ensure proper drainage of stairwell area.

**CORRECTIVE MEASURE  
TAKEN:**

Drain has been cleared of  
debris to ensure proper  
drainage.

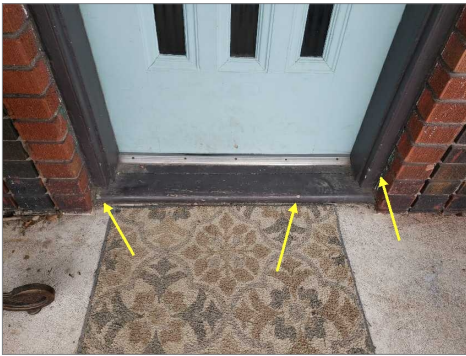
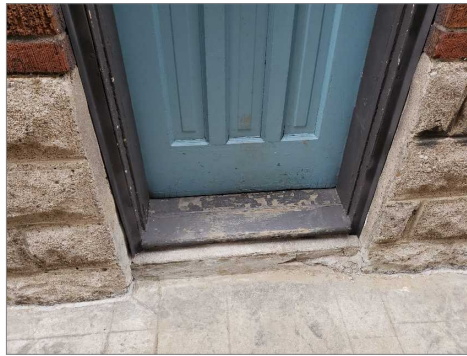
- Wood door with glass
- Maintenance - Painting needed on door and around door jamb area to ensure weathertight seal. Recommend painting as necessary.
- Improve - The basement walk out door is noted with moisture damage and upgrading to a newer entry door is recommended. Recommend evaluation by a qualified professional.

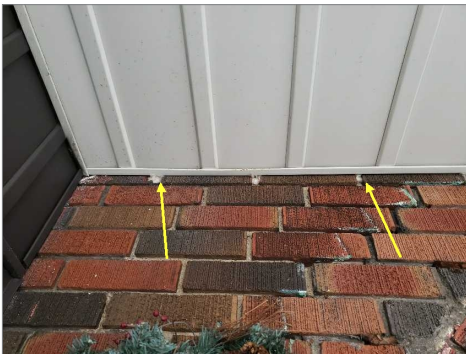
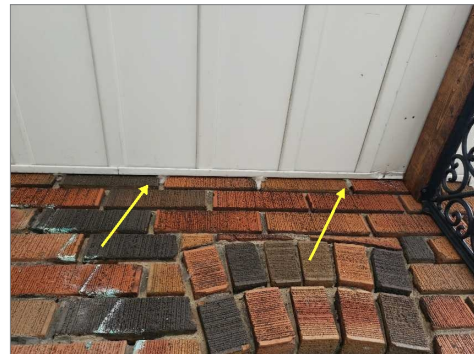
- Repair - Open spaces noted at the joint between the **soffit** and the brick siding, this is a potential pest infiltration point. Recommend evaluation by a qualified professional.

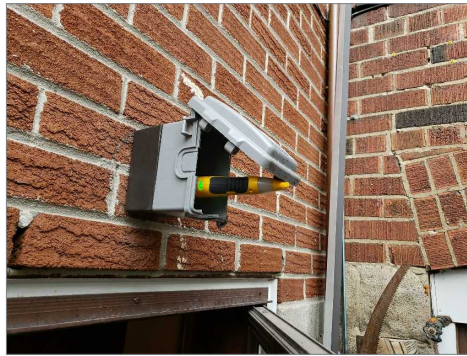
- Improve - Non-**GFCI** outlet noted. Recommend replacement with A **GFCI** type as per current electrical standards.

**CORRECTIVE/  
PREVENTATIVE MEASURE  
TAKEN:**

GFCI outlet installed.

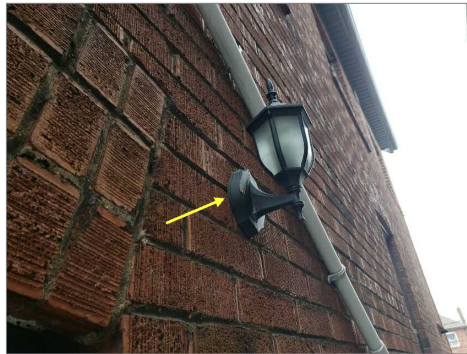
- Maintenance - Deteriorated or missing caulking or sealant noted on siding. Suggest sealing/caulking around all electrical fixtures, penetrations in siding, and joints between different siding materials, as part of routine maintenance to ensure watertightness and prevent further deterioration. Recommend evaluation by a qualified professional.

**CORRECTIVE/  
PREVENTATIVE MEASURE  
TAKEN:**

Electrical fixtures  
sealed/caulked.

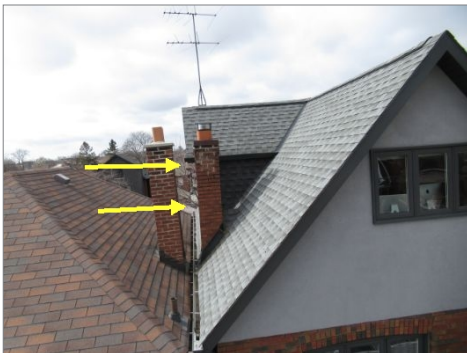
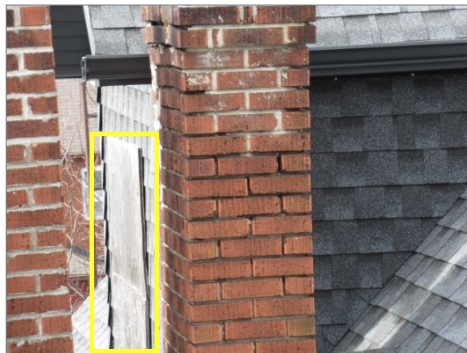
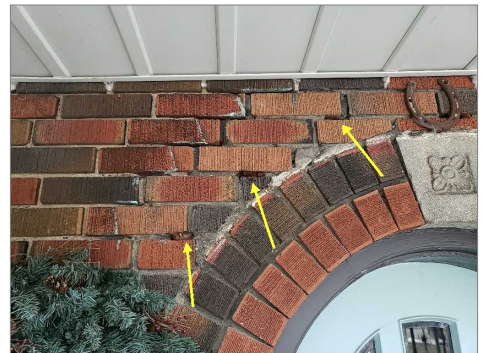
- Repair - Cracks noted on the brick veneer. It is recommended that the mortar joints that have cracked, are sealed to prevent any moisture penetration. Recommend evaluation by a qualified professional.

- Repair - Deteriorated mortar noted, recommend re-pointing of some mortar areas, to prevent moisture penetration. Recommend evaluation by a qualified professional.

- Maintenance - Deteriorated caulking or sealant noted on siding. Suggest sealing/caulking around all electrical fixtures, penetrations in siding, and joints between different siding materials, as part of routine maintenance to ensure watertightness and prevent further deterioration. Recommend evaluation by a qualified professional.

- Repair - Plywood area noted on the side dormer of the upper level. This area should be finished with proper siding material to prevent water infiltration. Recommend evaluation by a qualified professional.

**CORRECTIVE/ PREVENTATIVE MEASURE TAKEN:**  
South facing dormer shingled.

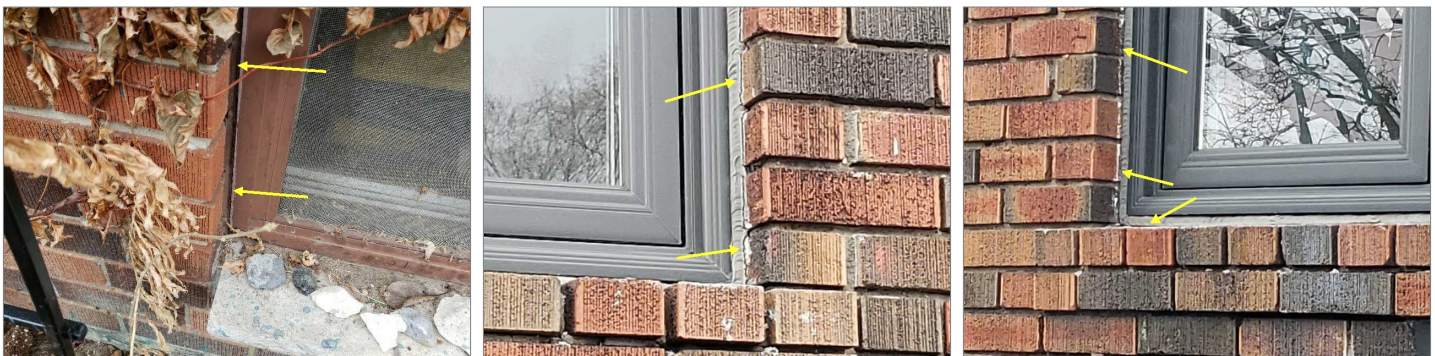
• Maintenance - Caulking around windows is noted as deteriorated or missing. This is a potential water infiltration point. Recommend evaluation by a qualified professional.

**CORRECTIVE/ PREVENTATIVE MEASURE TAKEN:  
Caulking applied to seal around windows.**

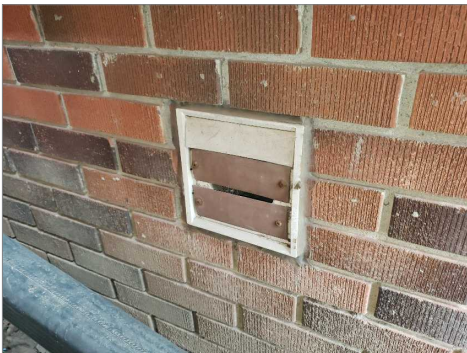
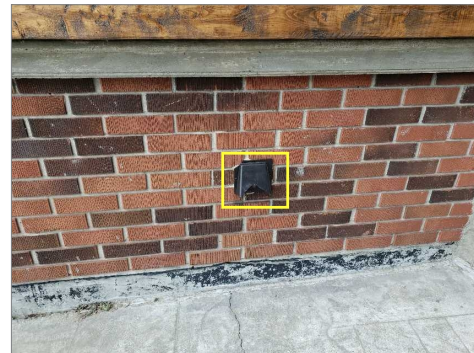
- **Repair - Damaged vent covers noted.** This is a potential pest infiltration point and will reduce the energy efficiency of the home through air leakage. Recommend evaluation by a qualified professional.
- **Maintenance - Recommend caulking around the vent covers to prevent water penetration.**

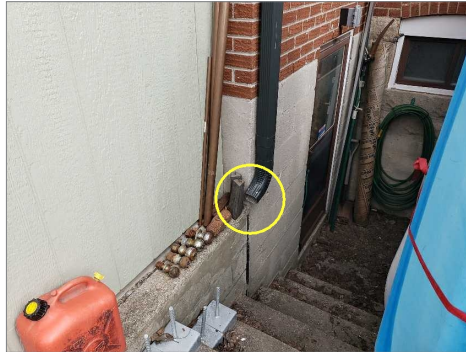
- Improve - Downspout leaders should be extended at least 6 feet beyond the foundation perimeter to move water away from foundation. This will dramatically reduce the amount of water that is present to be absorbed into the foundation walls.

**CORRECTIVE/ PREVENTATIVE MEASURE TAKEN:  
Downspouts extended**

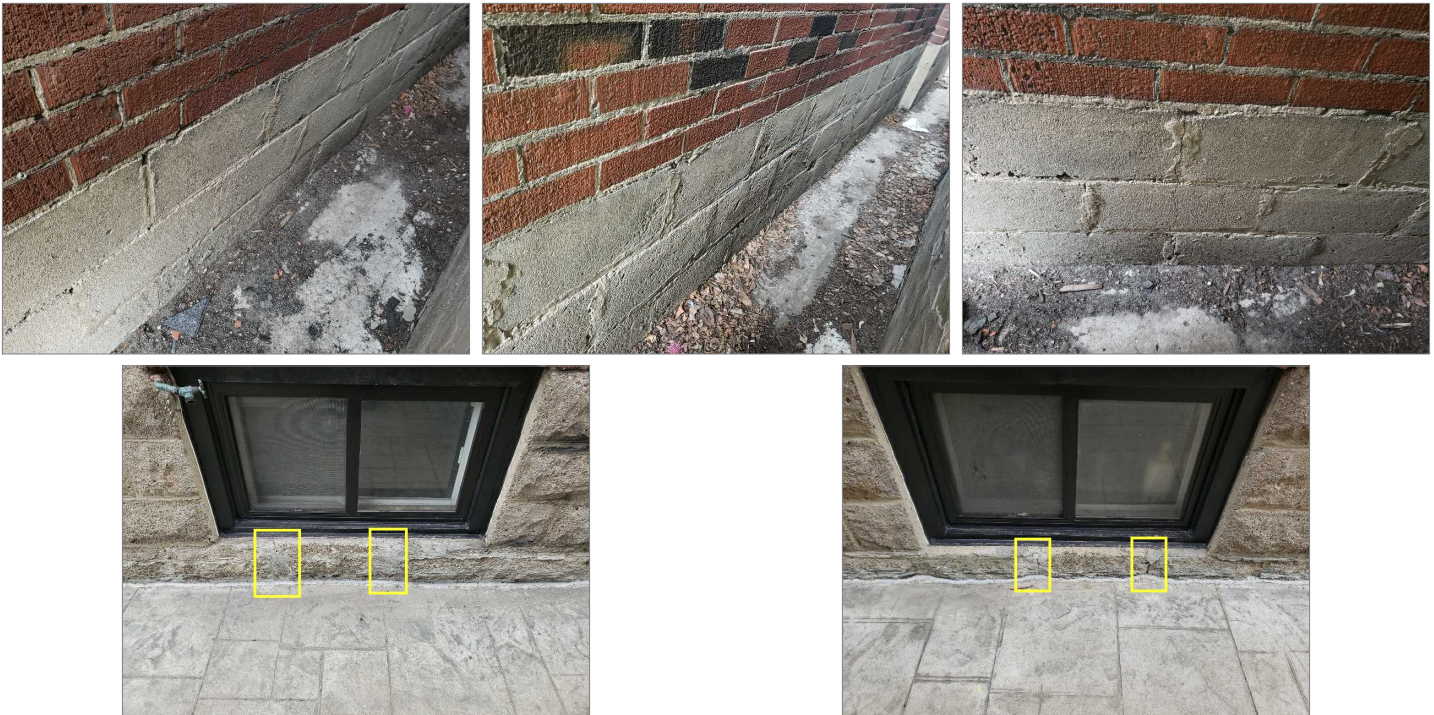
- Block Foundation
- Repair - **Parging** deterioration noted, this will increase the possibility of moisture intrusion into the foundation and structure. Recommend evaluation by a qualified professional.
- Further evaluation recommended - Cracking noted on the exterior of the structure at the base of the windows. It is recommended that the cracks are evaluated and sealed to prevent moisture penetration. Recommend evaluation by a qualified professional.

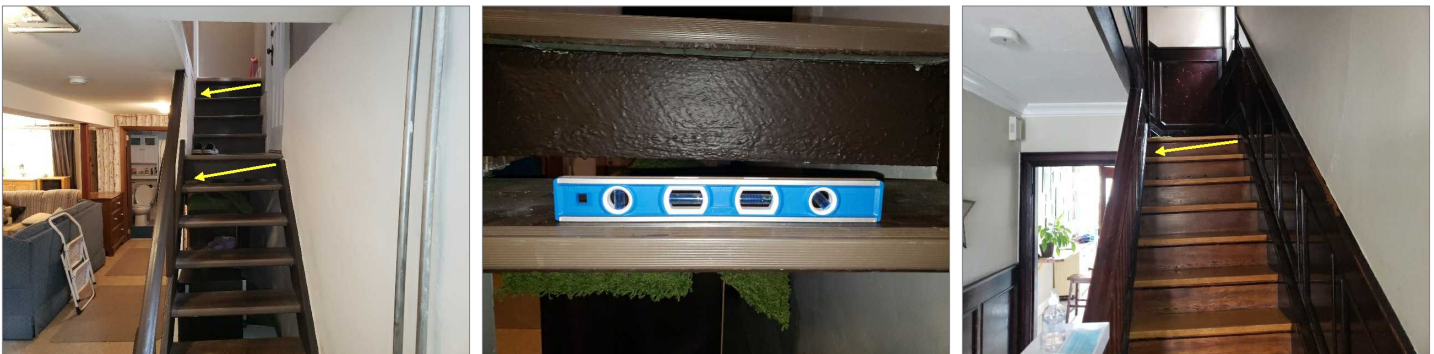
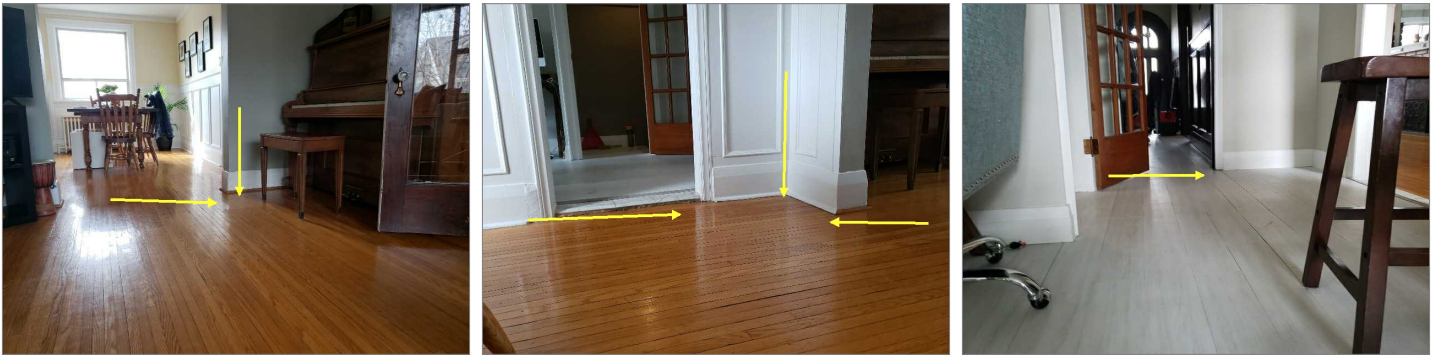
- Further evaluation required - The floors in the home are noted as not level. Sloping floors are noted on all levels of the home. While this is typical in older homes, it should be reviewed to ensure that structural movement is not ongoing, and remedial actions are taken if the movement continues. Recommend evaluation by a qualified professional.

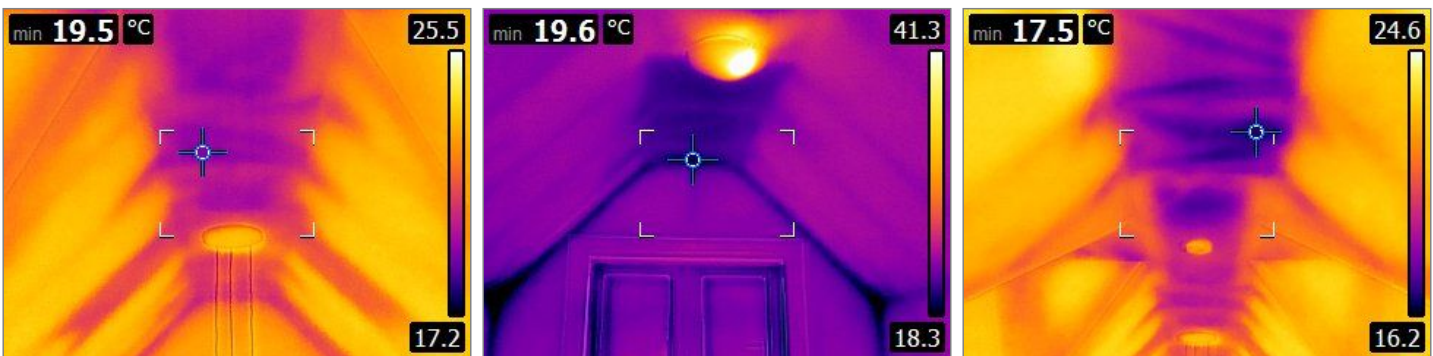
- Improve - Areas of low insulation or possible air infiltration noted on the upper floor as slightly colder zones are noted at the top ceiling space on the upper floor. Recommend evaluation by a qualified professional.

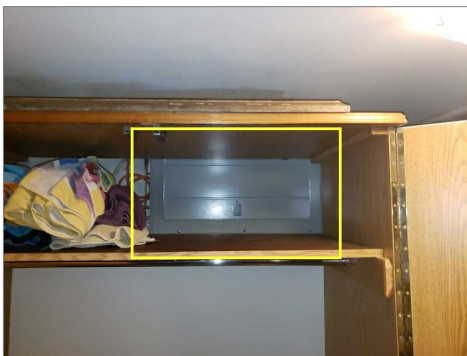
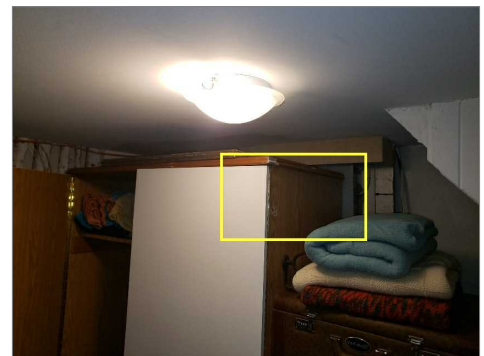
• Repair/Safety - Insufficient clearance noted around panel area. Minimum unobstructed area must be maintained as a minimum of 1 meter in front of the panelboard, 2 meters in height and at least the width of the panelboard or 1 meter, whichever is greater. Recommend removal or rearrangement of the obstructions for safe access to the panel area.

Panel cover not removed due to lack of access

Panel blocked by wardrobe

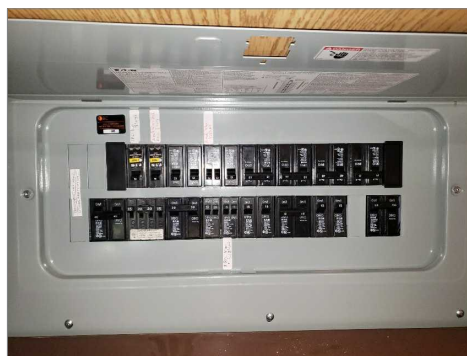
Incomplete labelling noted

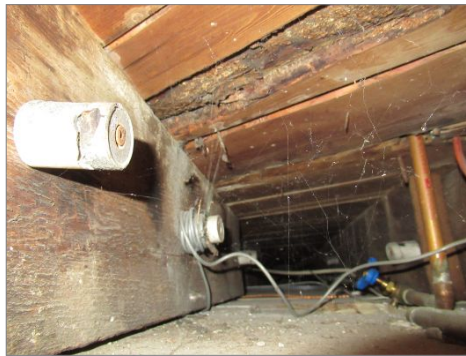
- All of the circuit breakers appeared serviceable.
- **Information - Remnants of knob and tube wiring noted in the basement area. This wiring tested as not live at the time of inspection. It is not known whether all the knob and tube wiring has been removed from service. Recommend evaluation by a qualified professional.**

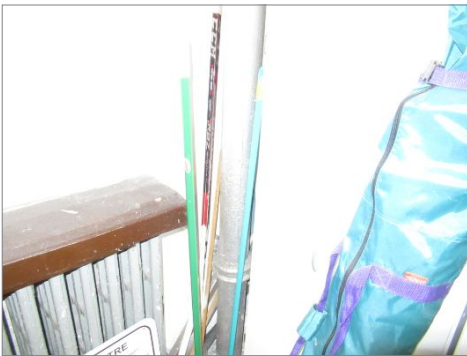
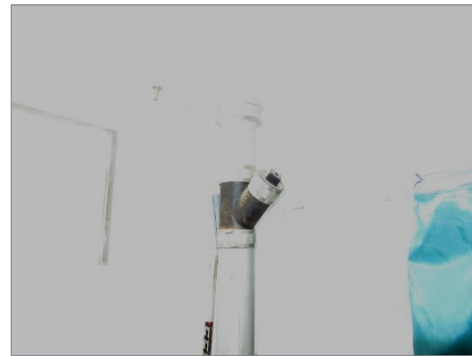
- Monitor - There are cast iron drain pipes in the basement. These pipes may have surpassed their expected lifespan and should be monitored for signs of leaking and replacement need. Recommend evaluation by a qualified professional.

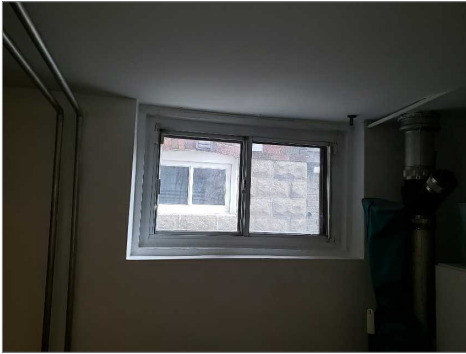
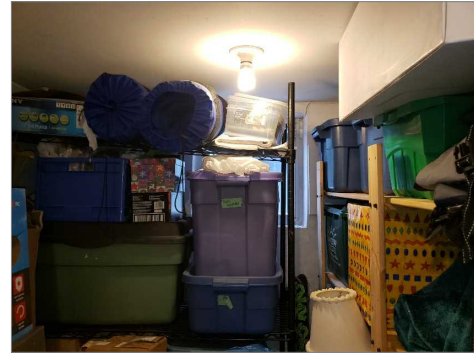
- **Improve - Single glazed windows noted. Recommend upgrading to thermal insulated windows for additional security and energy efficiency.**

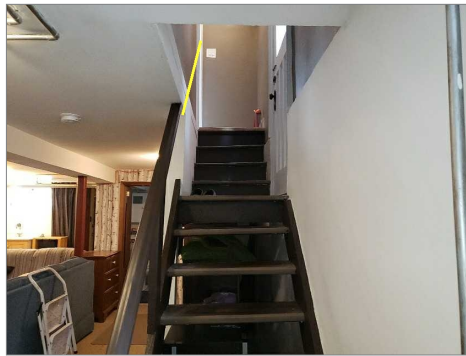
- **Repair - Partial handrail observed, recommend installing handrail as necessary for safety. Recommend evaluation by a qualified professional.**

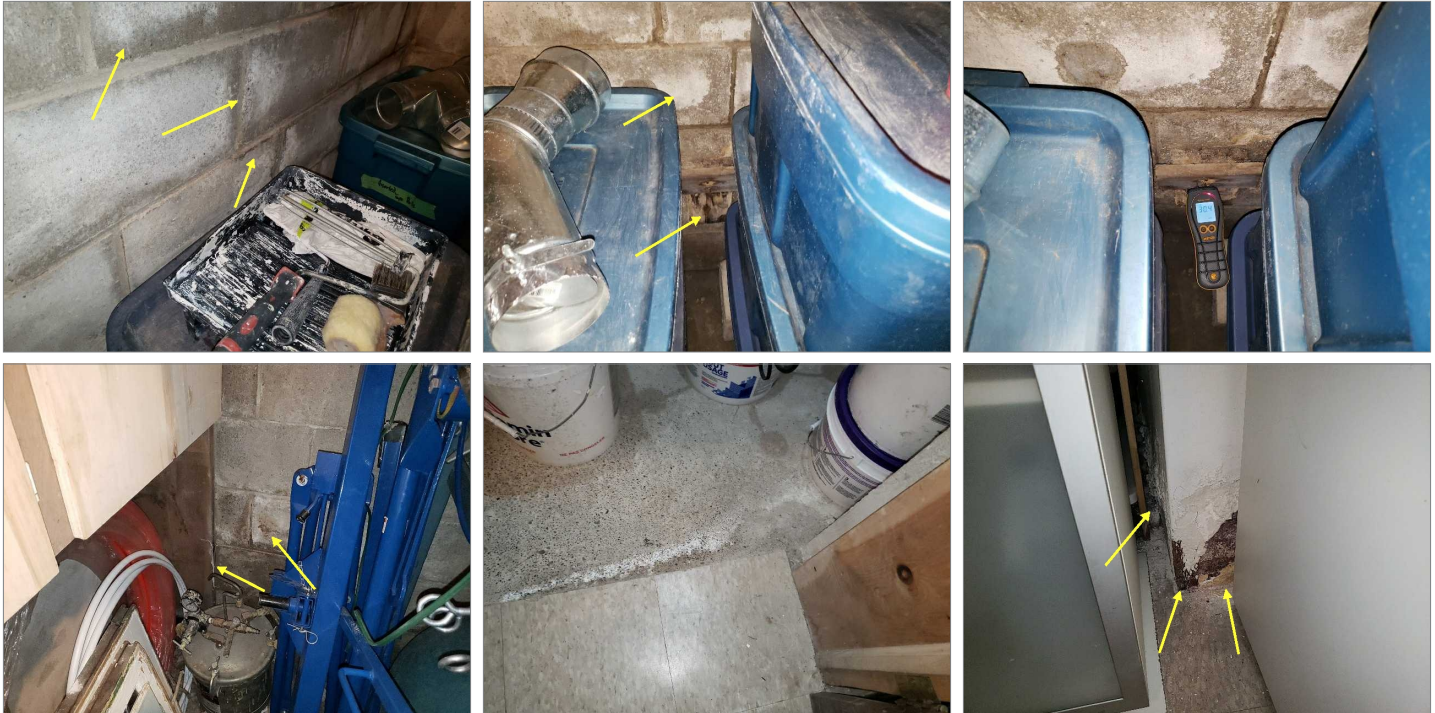
- Monitor - Evidence of past leaking or moisture penetration noted on the walls and floors in the basement area. No evidence of current leaking noted at the time of inspection. Recommend monitoring and evaluation by a qualified professional as necessary.
- Monitor - Minor moisture and efflorescence is present in the cold room. Recommend monitoring and repairs as necessary.

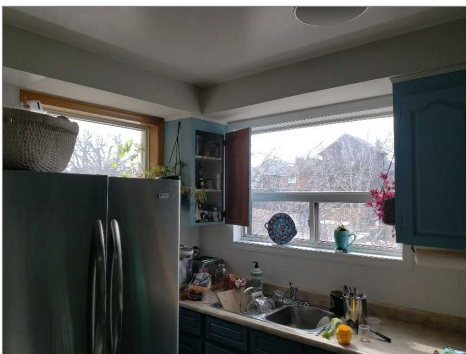
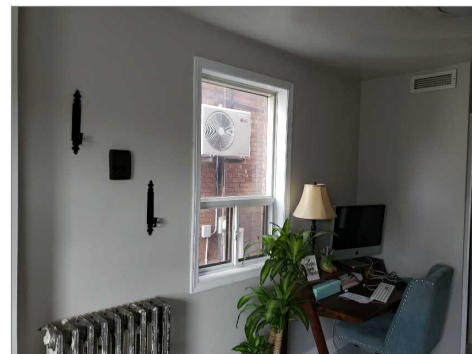
- **Improve - Single glazed windows noted. Recommend upgrading to thermal insulated windows for additional security and energy efficiency.**

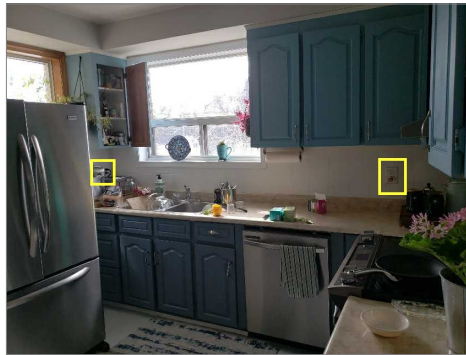
- Improve - No GFCI protection present. At the time that the house was built, GFCI outlets were not a requirement. It is recommended that GFCI protected receptacles are installed, as per current electrical standards. Recommend improvement by a qualified professional.

**CORRECTIVE/  
PREVENTATIVE MEASURE  
TAKEN:**

GFCI outlets installed.

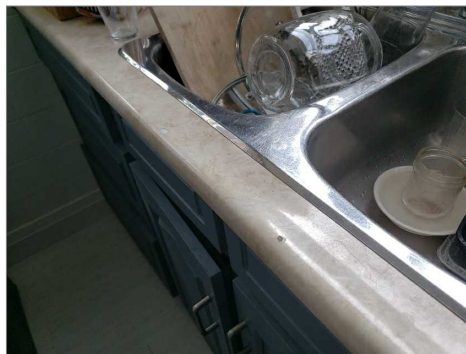
- Composite and laminate countertop
- Repair - The counter tops are noted as cracked or damaged, and will not stop water or moisture from entering countertop or cabinets. Recommend evaluation by a qualified professional.

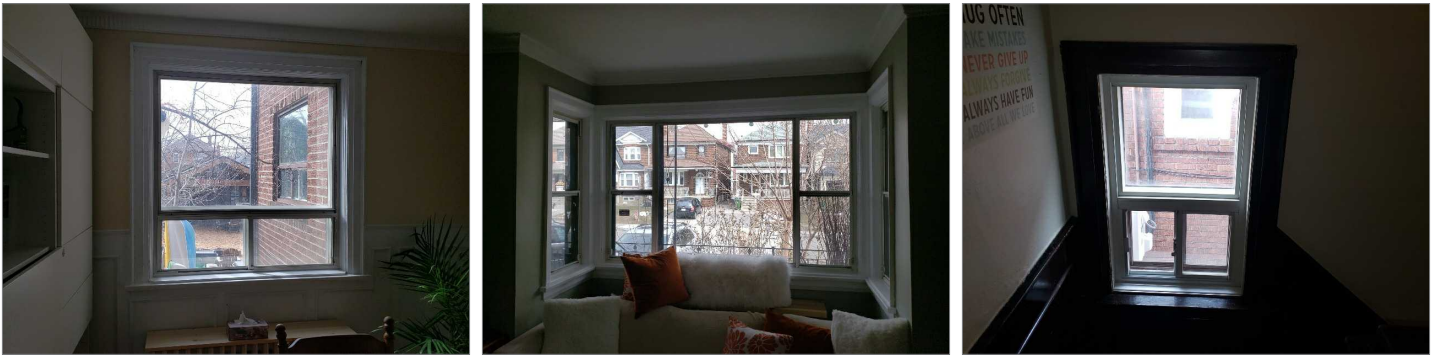
- **Improve - Single glazed windows noted. Recommend upgrading to thermal insulated windows for additional security and energy efficiency. Recommend evaluation by a qualified professional.**

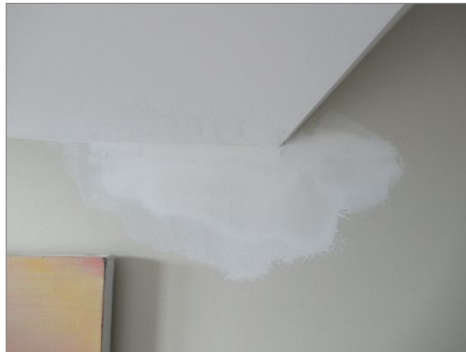
- **Monitor** - Drywall patch noted on the upper floor that was wet at the time of inspection. Recommend monitoring and repairs as necessary.

Wall was being repaired at time of inspection.

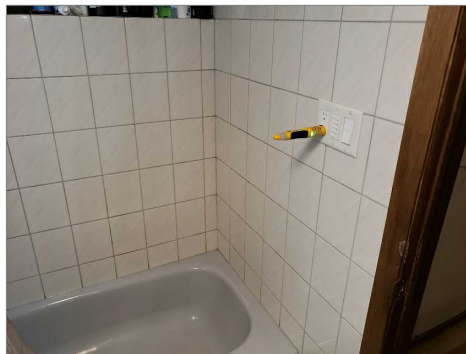
• Improve - No GFCI protection present. At the time that the house was built, GFCI outlets were not a requirement. It is recommended that GFCI protected receptacles are installed, as per current electrical standards. Recommend evaluation by a qualified professional.

**CORRECTIVE  
MEASURE  
TAKEN:**

GFCI outlet  
installed.

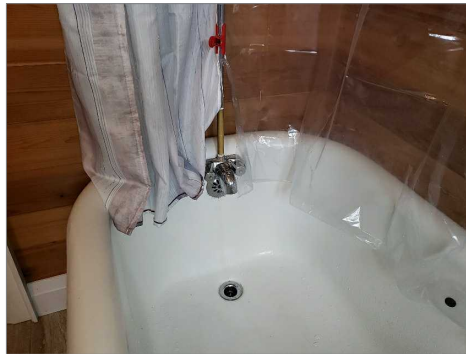
- **Repair - The hot & cold water supplies are reversed. This is not a functional problem but to someone who is not familiar with this condition unexpected hot water could scald them. Recommend evaluation by a qualified professional.**

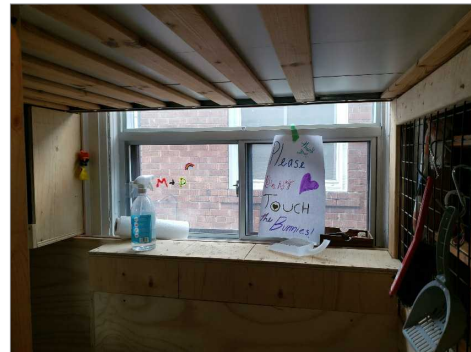
- Improve - Single glazed windows noted. Recommend upgrading to thermal insulated windows for additional security and energy efficiency.
