HOME INSPECTION REPORT

1210 College St

May 25th 2021

Pradeep Samaroo, RHI

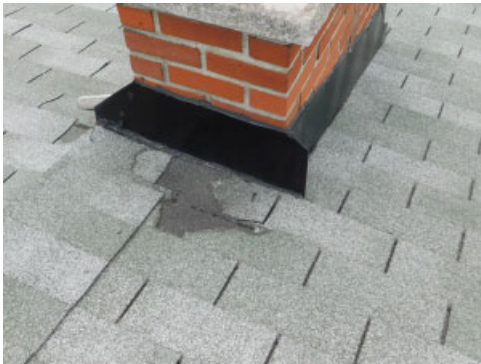
[Repair torn shingles beside chimney](#)

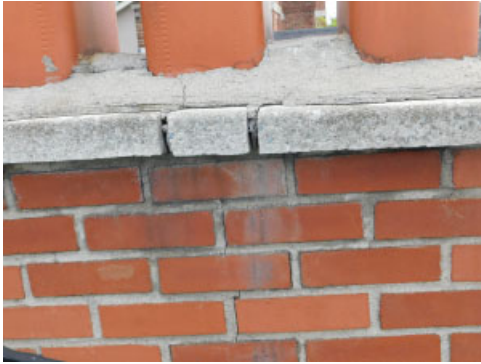
[Tuck point chimney](#)
