20/20 HOME INSPECTIONS

HOME INSPECTION REPORT

1099 St Clarens Ave

June 16th 2021

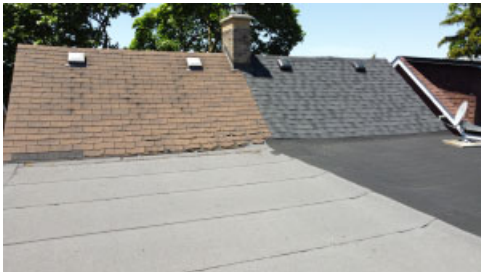
Roofing Image

[Shingles near the end of their life expectancy](#)

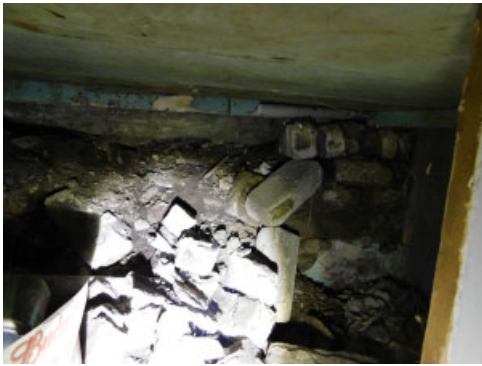
Structure Image

- Continuous concrete Masonry/ wood piers Slab on grade Wood beam on grade
Crawlspace Full basement No visible accessibility Access to crawlspace is recommended.
Repairs/improvements are required at: under steps of basement walkup at rear-repair foundation wall require

Foundation wall of rear walk up - under steps has collapsed- repair is recommended

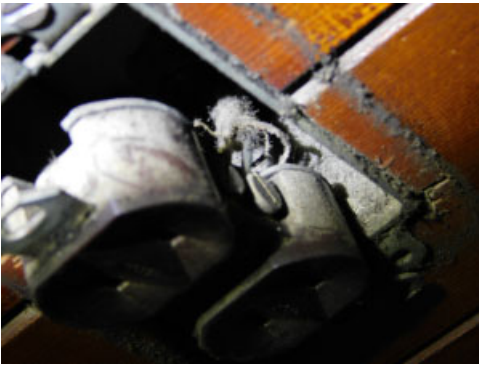
Electrical Image

[Receptacle on Knob & tube wiring on 3rd floor](#)

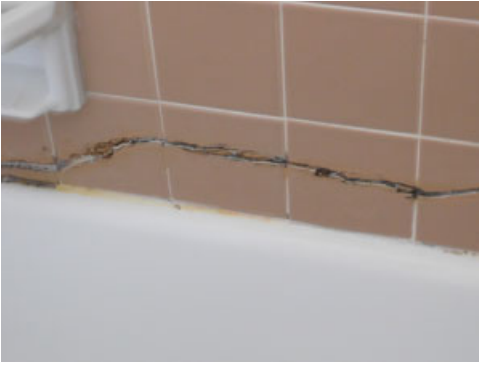
Interior Image

Cracked tiles on wall of shower- Will need repair to prevent water infiltraion into wall
