20/20 HOME INSPECTIONS

HOME INSPECTION REPORT

38 Jackson Place

August 30th 2021

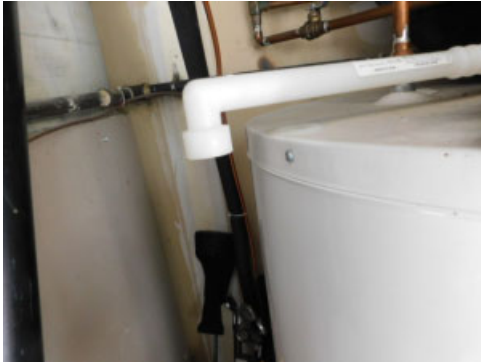
Plumbing Image

Water heater- Discharge tube is to extend to 1 inch above to floor level- extension is required

Venting condition (gas/oil only): ☐ Good/ fair condition ☐ Metal lining recommended ☒ Extend discharge tube to the floor
