HOME INSPECTION REPORT

630 Glebeholme Blvd

March 30th 2022

PRE-LIST SUMMARY

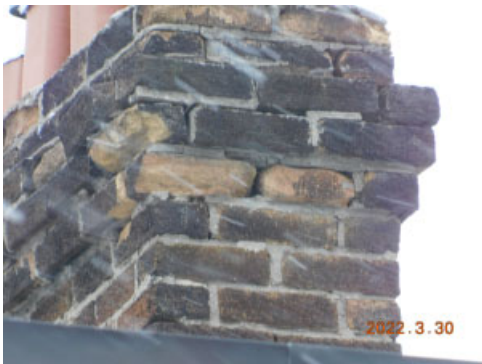
Exterior Image

[Chimney requires tuck pointing](#)

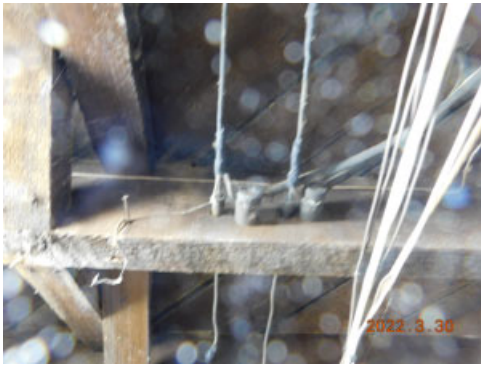
Electrical Image

Knob and Tube is the predominant branch wiring in this house
