20/20 HOME INSPECTIONS

HOME INSPECTION REPORT

7 Rushbrooke Ave

May 27th 2022

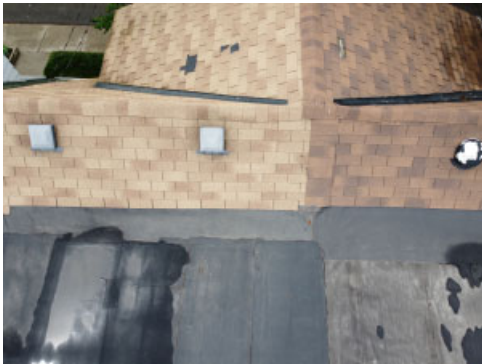
Roofing Image

A few blown off shingles- Should be repaired ASAP

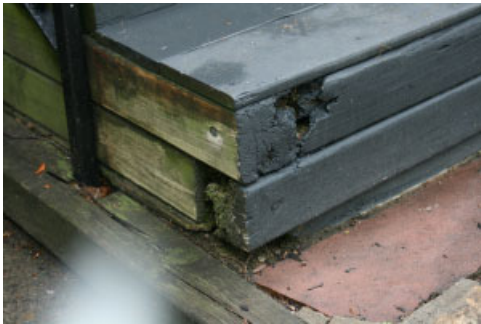
Exterior Image

[Some rot on bottom step of front porch](#)
