### HOME INSPECTION REPORT

36 Humber Trail

May 31st 2022

Pradeep Samaroo, RHI

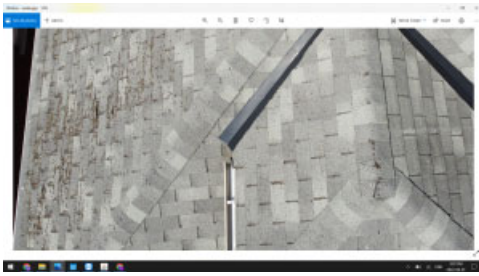
## Exterior Image

shingles on south side of roof is worn - expect to replace within 2 years
