### HOME INSPECTION REPORT

117 Dorset Rd

sept 12th 2022

Pradeep Samaroo, RHI

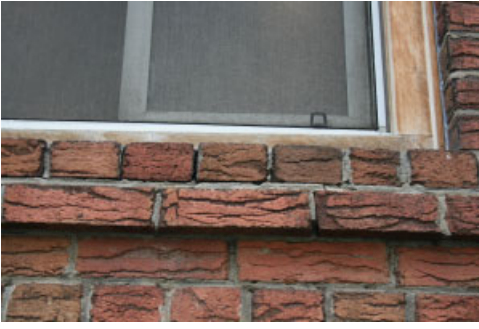
[some window sills require tuck pointing](#)

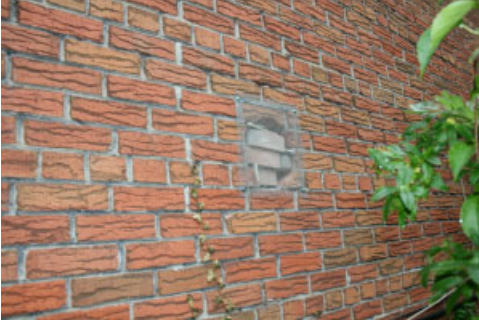
[Repair hole for old exhaust vent on north wall](#)

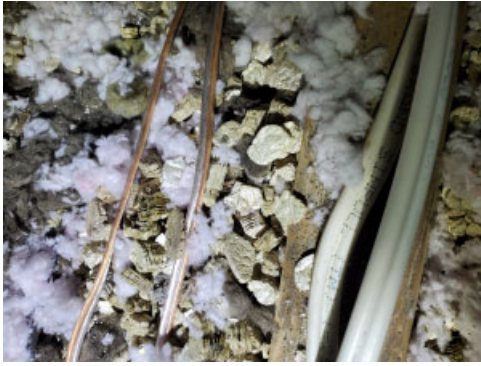
vermiculite insulation in the attic was tested and came back negative for asbestos
