HOME INSPECTION REPORT

1939 Davenport rd

September 12th 2022

Age of House approx 90 years. Construction Type: 2 storey semi-detached solid masonry/double brick

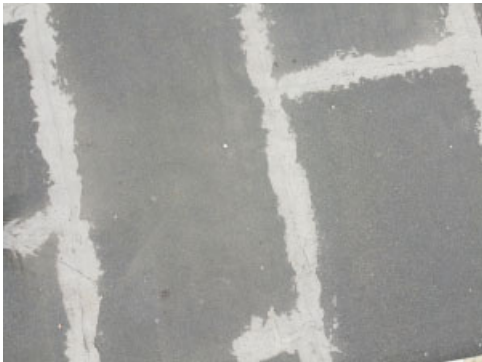
Roofing Image

- Current repair is required at: seams on flat roof are beginning to crack
- Roof covering replacement is required at:
- High probability of replacement of roof coverings within years.
- Repairs/ roofing tune-up is required soon/ before next application of roof coverings
- Annual visual inspection required.
- Trim tree branches/ vines away from roof edge.
- Tree removal recommended at:

Seams between strips of roofing membrane are beginning to crack

Replace flat roof coverings (annual visual inspection to determine timing) Time frame 0-5 years Budget \$ 5000

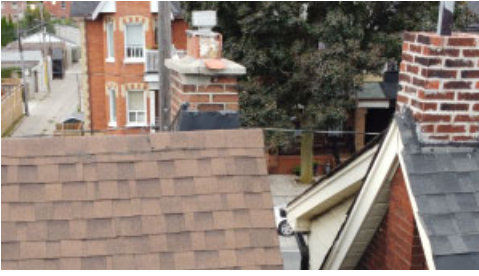
Exterior Image

Flue on chimney is broken and cap is cracked

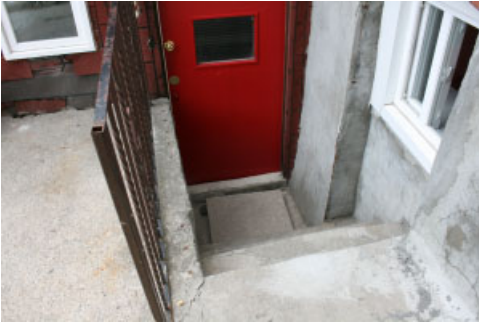
Handrail is required in staricase

repair handrails and guardrails where noted in report Time frame 0-1 years Budget \$ 1000

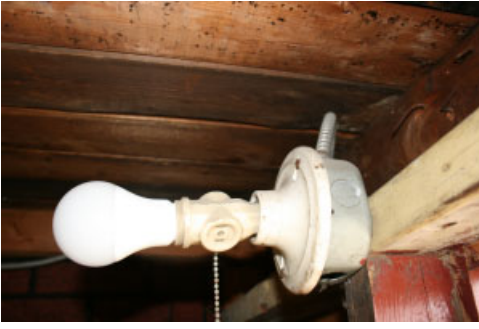
Electrical Image

[Shed- plug in light fixture is GFCI protected.](#)

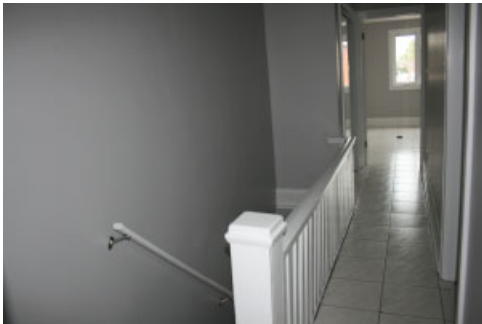
Interior Image

Guardrails are too low
