20/20 HOME INSPECTIONS

HOME INSPECTION REPORT

111 Brookside Dr

Sept 11th 2023

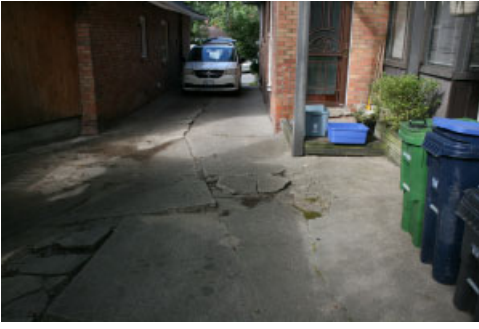
Concrete driveway has cracked and heaved.

Open discussion with neighbour to repair mutual drive- needs attention and repairs

Repair work required/ recommended at: Shared Concrete drive is in need of repairs/loose flagstone on steps

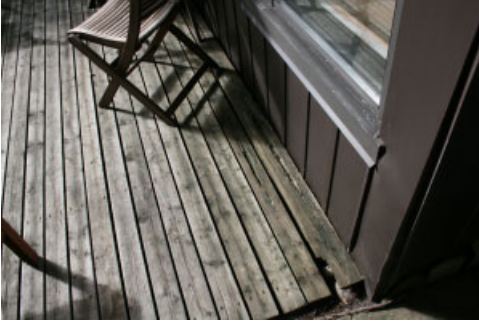
Boards on rear deck are beginning to rot

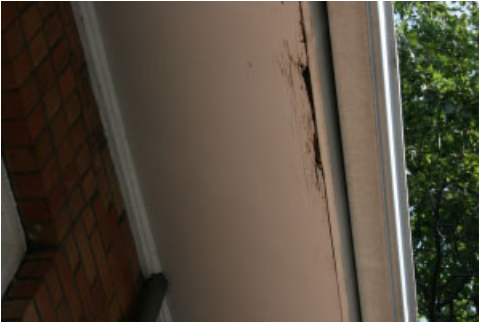
Soffit on south side of house show signs of rot

- Type: Aluminum Plywood Wood Vinyl []
- Soffit & fascia are in: Good condition Fair condition Painting of soffit/ fascia required
- Repairs are required/ recommended at: south side of roof- some rot on wood
 - Replacement/ new aluminum cladding of soffit/ fascia is recommended in future. []

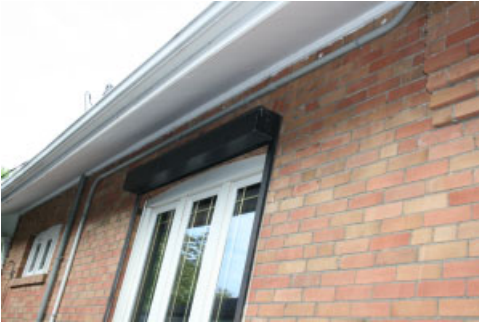
Unable to determine functionality of fire shutters above windows
