20/20 HOME INSPECTIONS

HOME INSPECTION REPORT

60 Indian Grove Rd

Dec 2nd 2024

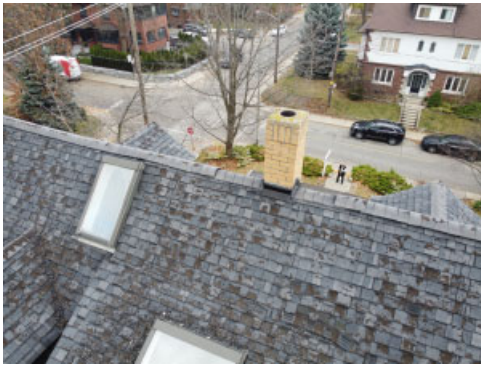
Worn shingles

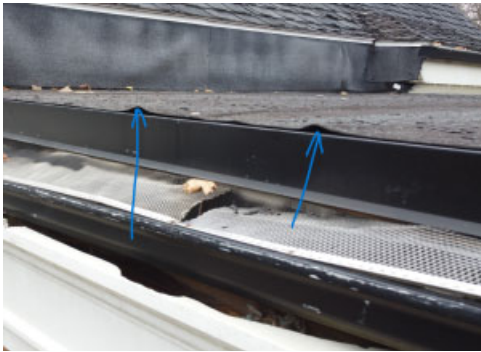
Flat roof- front porch- Membrane has delaminated from roof sheathing

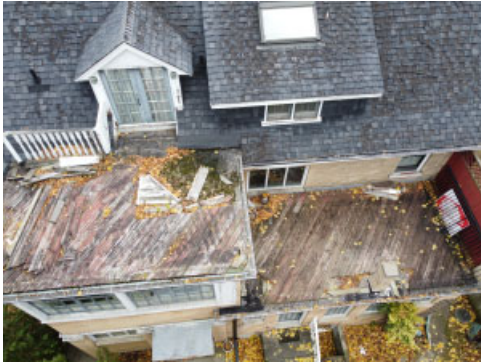
Tar and gravel roof under decking has to be replaced

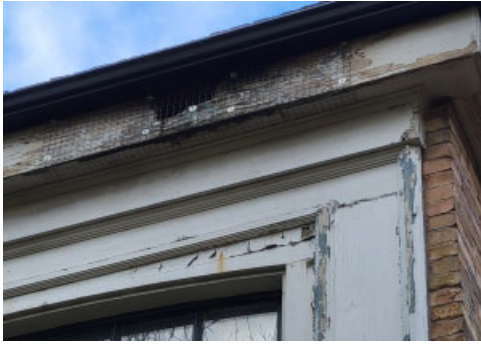
Fascia and overhangs are in need of repairs and repainting

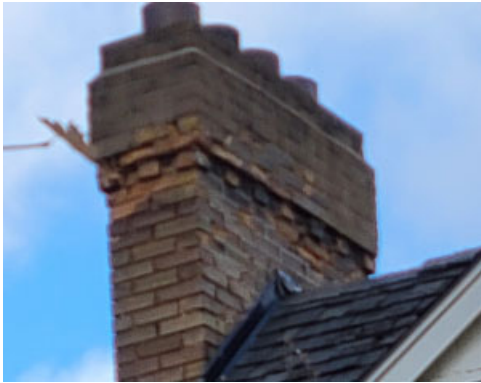
Repairs of bricks is required

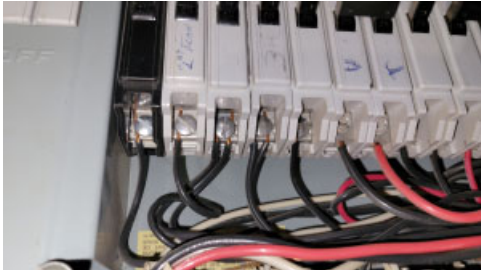
Double tapping of circuits on main panel
