### HOME INSPECTION REPORT

17 Waterbridge Way

February 17 2025

Pradeep Samaroo, RHI

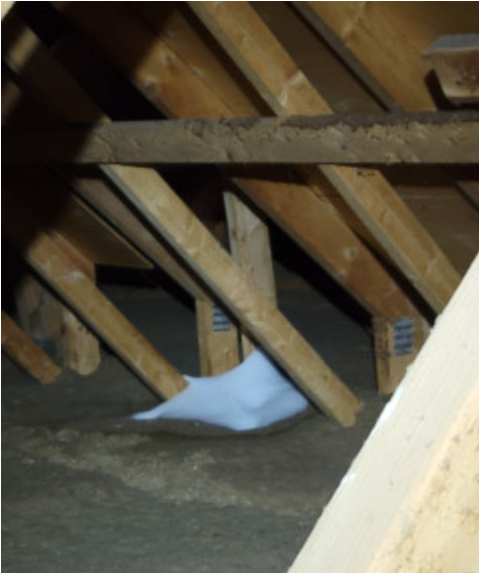
Accumulation of Snow in the attic

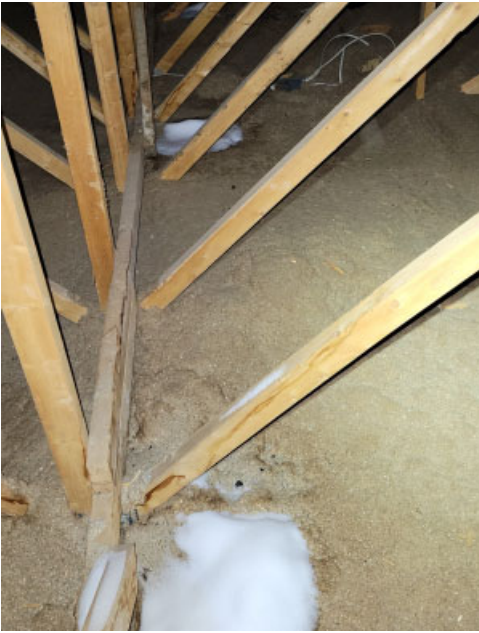
Accumulation of snow in attic under each roof vent -
