20/20 HOME INSPECTIONS

HOME INSPECTION REPORT

416 Clendenan Ave

February 18th 2025

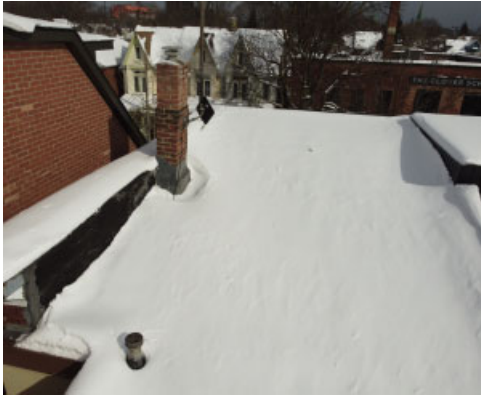
Roof is completely snow covered- unable to view roofing mambrane

Roofing inspection is recommended once snow has melted and roof is visible

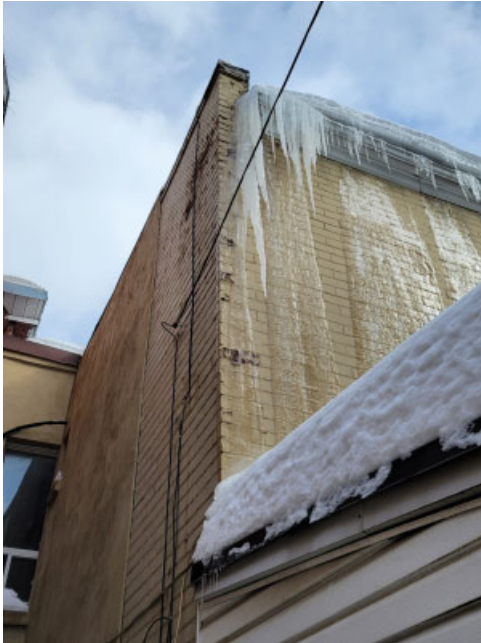
Excessive ice build up on getters and wall - Indicates insufficient insulation in the flat roof cavity

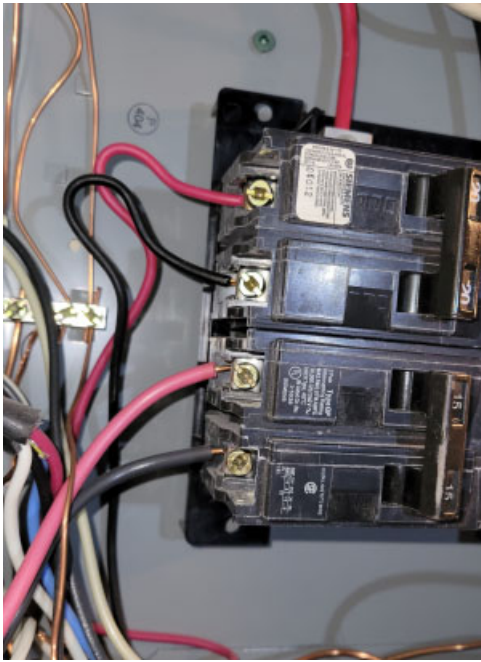
- ☒ Circuits at the auxillary panel are incorrectly fused
- Adequate sized main distribution panel is installed. ☐ Labelling of branch circuit panels is recommended.
- Adequate number of circuits are available to properly distribute intended load. ☐
- distribution panel(s) are recommended(for future use). ☐
- ☒ Spare circuits available at distribution panel: Yes ☐ No spare circuits are available. Auxiliary panel is recommended.
- ☐ Double tapping noted at some circuits Possible overloaded circuit situation. Monitor.

Auxillary panel- conductors are not connected to the correctly sized breakers

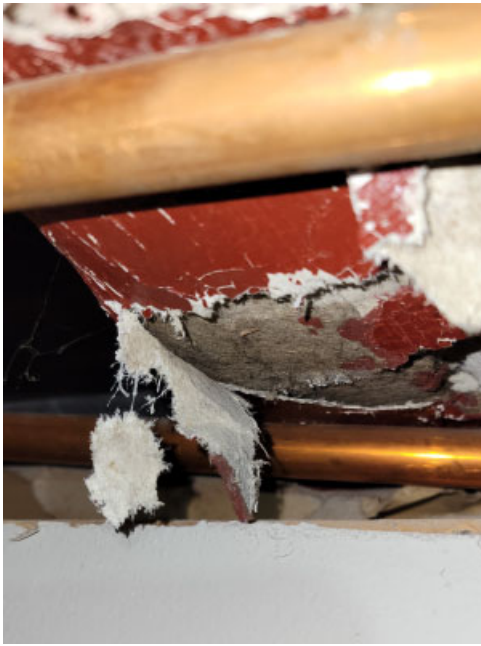
Asbestos wrap on heating pipes above the boiler

☒ Encapsulation or removal of asbestos wrap on pipes in the boiler room and crawlspace is recommended

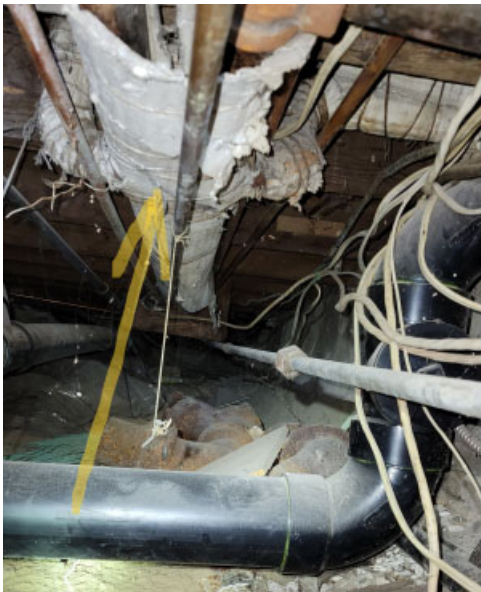
Asbestos wrap on heating pipes in crawlspace

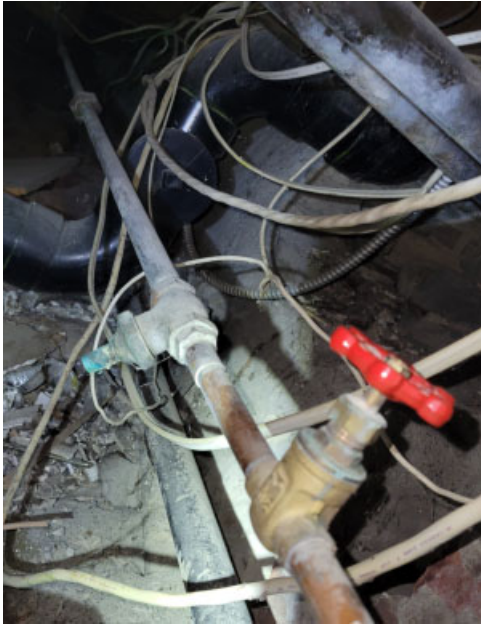
Galvanized steel water supply line in the crawlspace

A/C is approaching end of expected lifespan-budget for replacement	Time frame	0-1 years	Budget \$	1500
One galvanized steel water supply is in the crawlspace may require replacement for insurance purposes	Time frame	0-1 years	Budget \$	500
Encapsulate or remove asbestos on heating pipes above boiler and in crawlspace	Time frame	0-1 years	Budget \$	1000
Install hand rails on basement staircase	Time frame	0-1 years	Budget \$	300
<input checked="" type="checkbox"/> Add heating source to main floor washroom	Time frame	? years	Budget \$	500
<input type="checkbox"/>	Time frame	years	Budget \$
