20/20 HOME INSPECTIONS

HOME INSPECTION REPORT

33 Pickering Street

March 15 2025

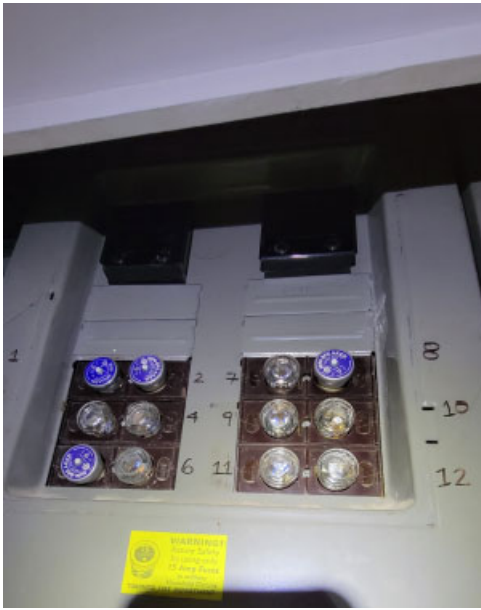
Electrical Image

Fuse panel should be upgraded to a breaker panel

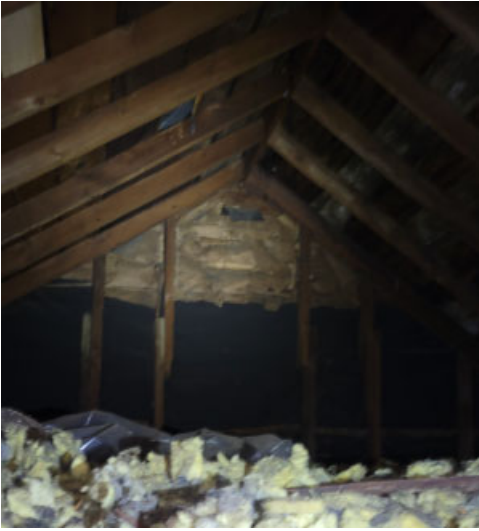
Interior Image

The attic space is interconnected with the adjacent dwelling. Fire separation is recommended
