HOME INSPECTION REPORT

223 Wallace Ave

April 4th 2025

Pradeep Samaroo, RHI

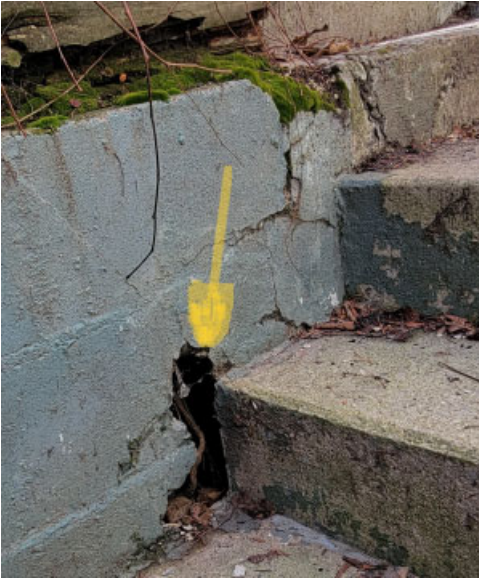
There is a deflection on the wall and several blocks have deteriorated-

Repair retaining wall at basement entrance Time frame 0-3 years Budget \$ \$5000

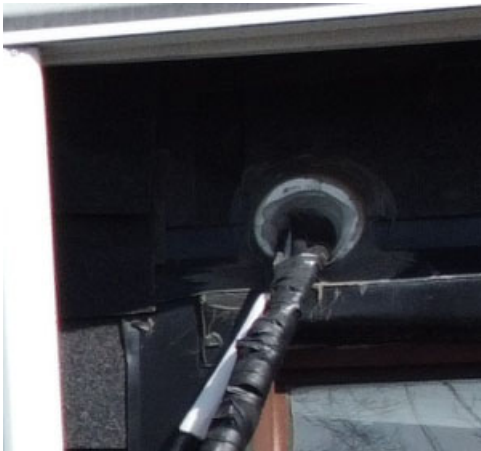
Heat Pump on roof refrigerant line penetration into house is not sealed/caulked

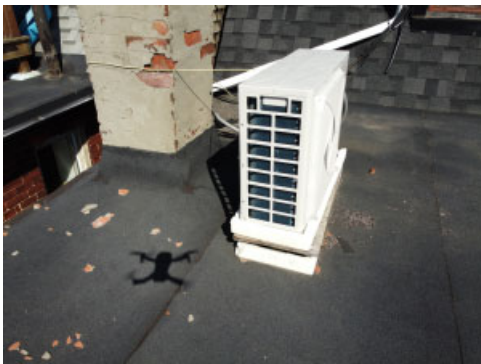
Heat Pump unit sits on an unstable base and has no lateral support

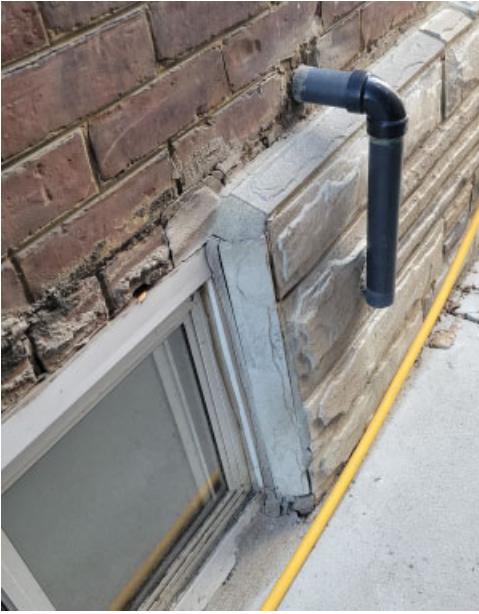
Sumo pump discharge is too close to the window
