20/20 HOME INSPECTIONS

HOME INSPECTION REPORT

50 Sellers Ave

June 10th 2025

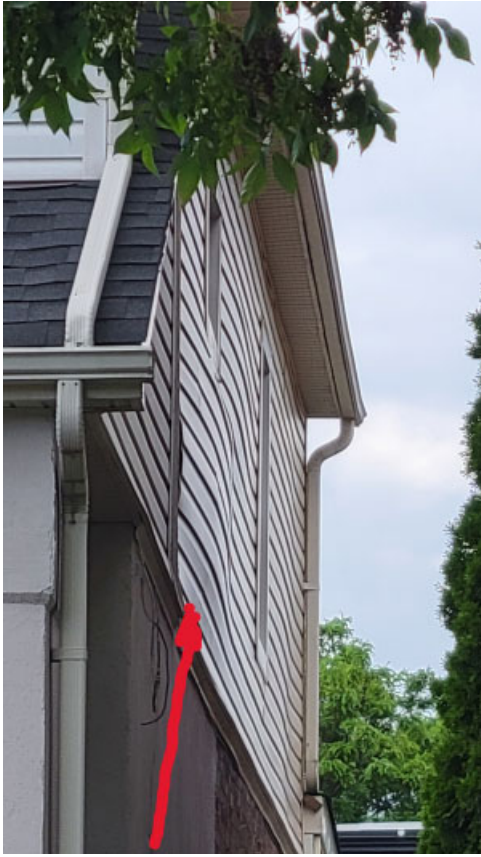
Siding is detached on the north side of the house.

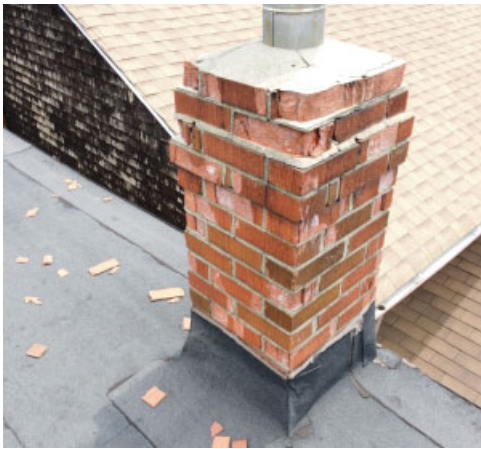
- Type:** ☒ Masonry ☐ Metal ☐ Side wall venting ☐ None required ☐
☐ Good condition ☐ Fair condition ☐ Requires repair/ tuck pointing ☐ Flue cap recommended
☐ Requires new chimney cap/ drip edge ☒ Requires **rebuilding**/extending ☒ Remove obsolete chimney

Obsolete chimney- bricks are spalling. repair or remove

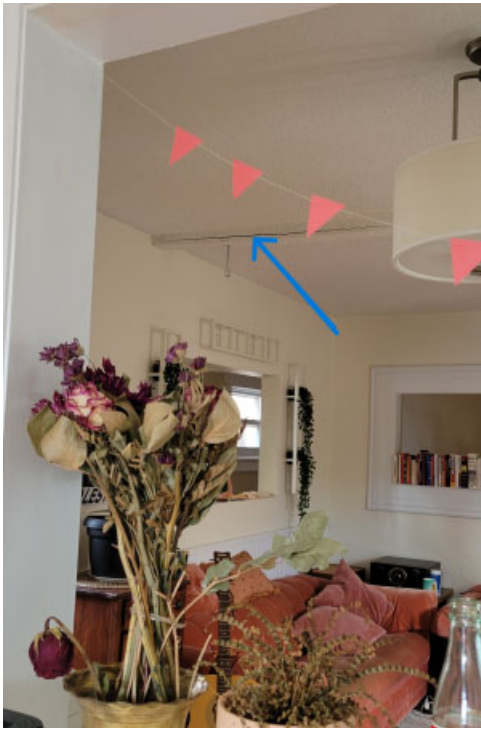
☒ Repair required at: 2nd floor living room - ceiling- beam cracked- have a professional determine if it is structural ?

Crack or separation of built up decorative beam/joist? have a professional determine if structural
