## HOME INSPECTION REPORT

646 Beresford Ave

October 6th 2025

Pradeep Samaroo, RHI

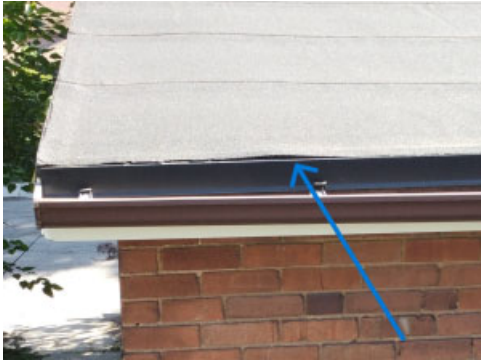
☒ Current repair is required at: Falt roof- Rear- Edge of membrane is lifting from the sheathing  
☐ Roof covering replacement is required at:  
☐ High probability of replacement of roof coverings within years.  
☐ Repairs/ roofing tune-up is required soon/ before next application of roof coverings ☒ Annual visual inspection required.  
☐ Trim tree branches/ vines away from roof edge. ☐ Tree removal recommended at:  
☐

Membrane is lifting - susceptible to water ingress under membrane

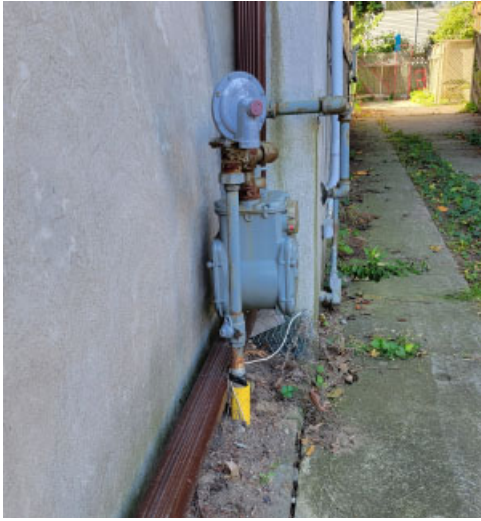
[Install protection for gas meter and gas lines from mechanical damage \( car hitting it\)](#)

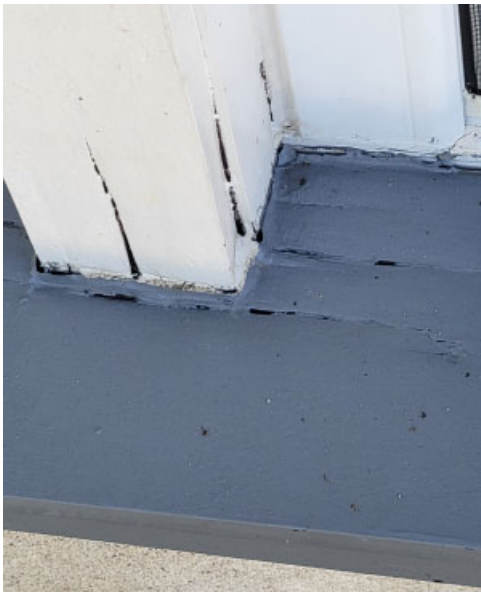
[Front porch window. Rot on sill and wood trim](#)

- ☐ Storm/ screen systems are recommended to be upgraded at:
- ☒ Repair/ replace window frame/ sills at
- ☐ Window refurbishing/ replacement recommended:

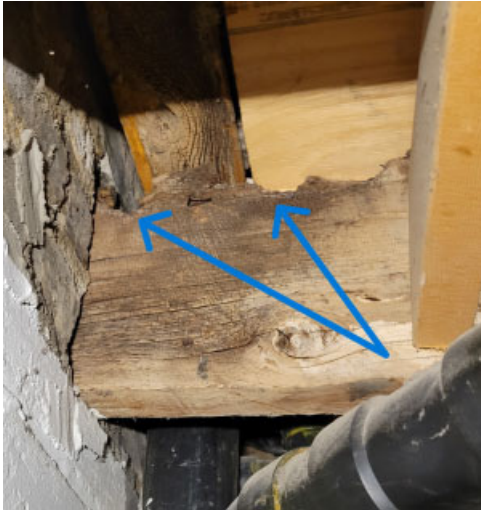
- ☐ Some localized repairs/ defects ☒ **Repair** replace floor joists at: **Furnace room- joist closest to rear wall-some dry rot**

Some dry rot on joist S/W corner furnace room.

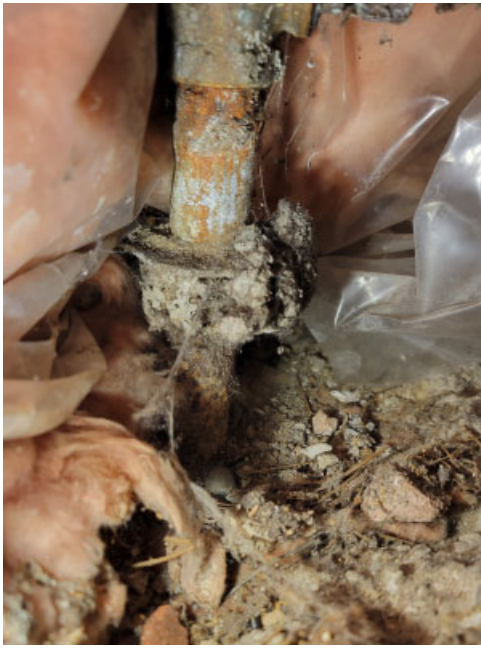
- ☐ Good functional flow to 2 fixtures when used simultaneously. Basement fixtures excluded.
- ☐ Fair functional flow is evident ☒ Poor functional flow is evident ☒ Upgrade of main water service is recommended.

Water service is galvanized steel- replacement recommended to improve water pressure
