### HOME INSPECTION REPORT

263 Humbercrest Blvd

April 18th 2026

Pradeep Samaroo, RHI

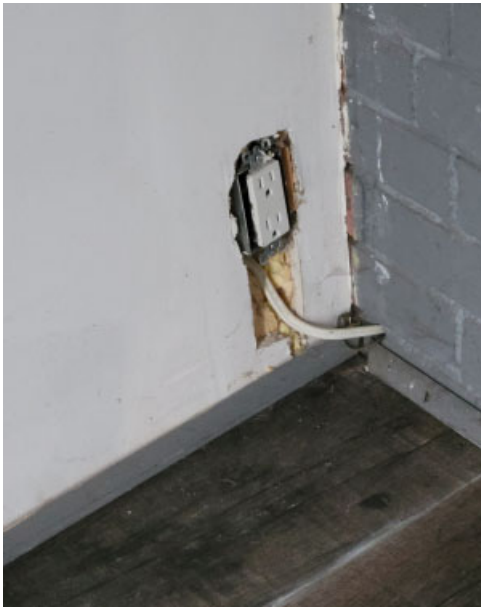
## Electrical Image

Missing coverplates/ loose outlets/ exposed cabling observed at: Front entrance enclosure - lower north wall

Rework wiring so that it is in a conduit and install a coverplate

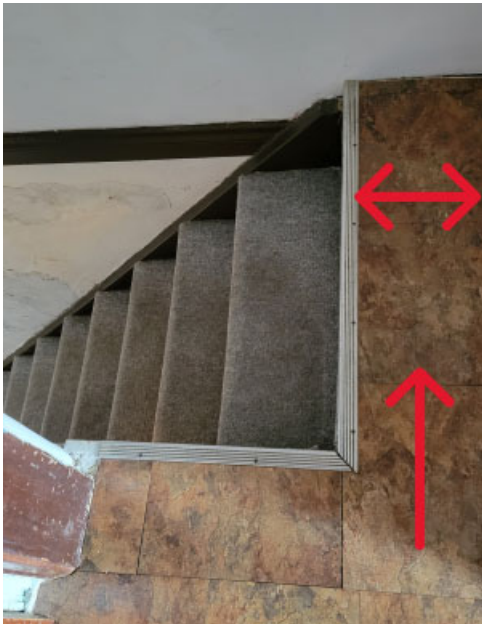
Interior Image

Insufficient width landing at the top of stairs- potential fall hazard

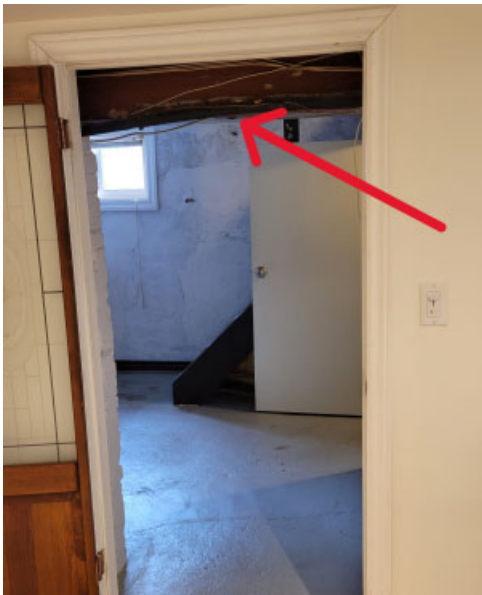
Low beam at doorway- head strike hazard
