HOME INSPECTION REPORT

37 Lewin Crescent

April 19th 2026

Age of House 55 years. Construction Type: 1 storey detached brick veneer

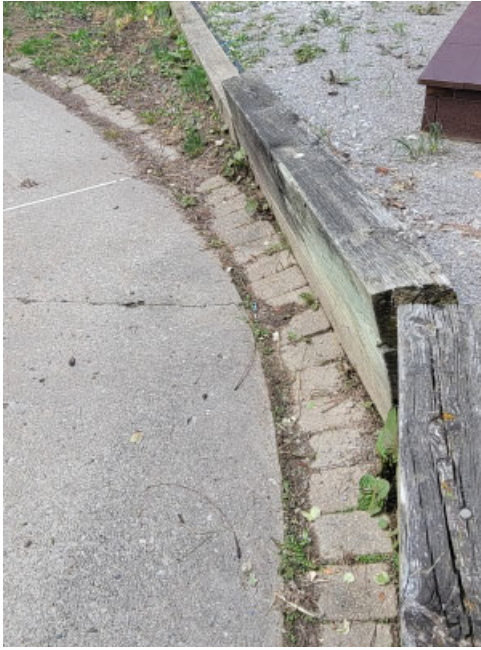
Exterior Image

Retaining wall shows signs of movement and wood decay. Repair or replacement is recommended

Repair/replace retaining wall in front of pool Time frame 0-3 years Budget \$ 4000

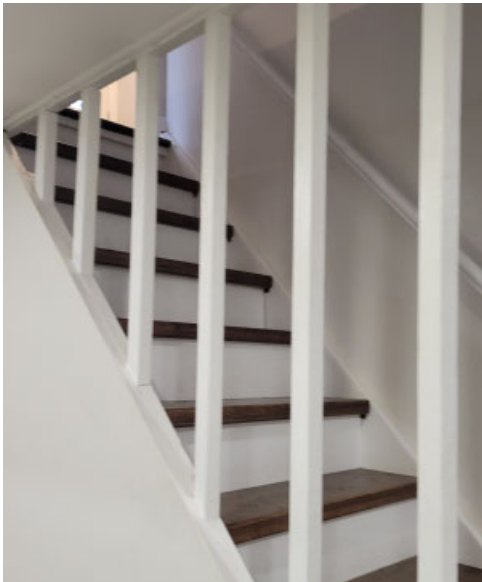
Interior Image

Unsafe spacing between spindles in the guardrail of basement staircase
