## Home Inspection Report

PROPERTY INSPECTED:  
**81 Armadale Avenue**  
**Toronto, ON M6S 3W9**

**Date of Inspection: 02/24/2026**

Inspection No. 141168-1803

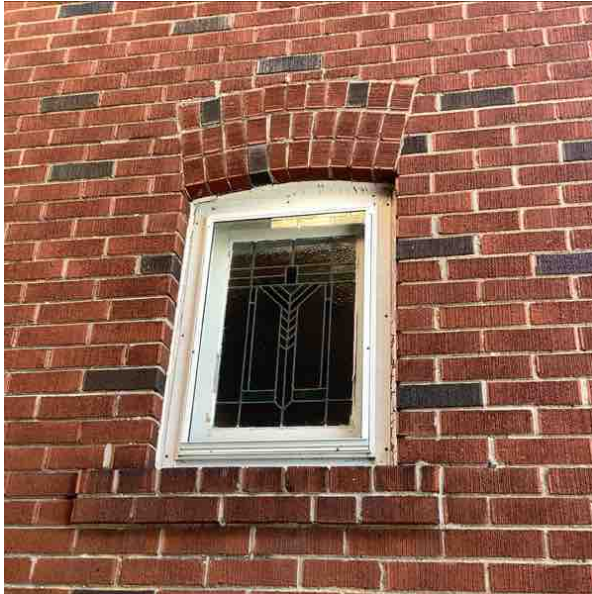
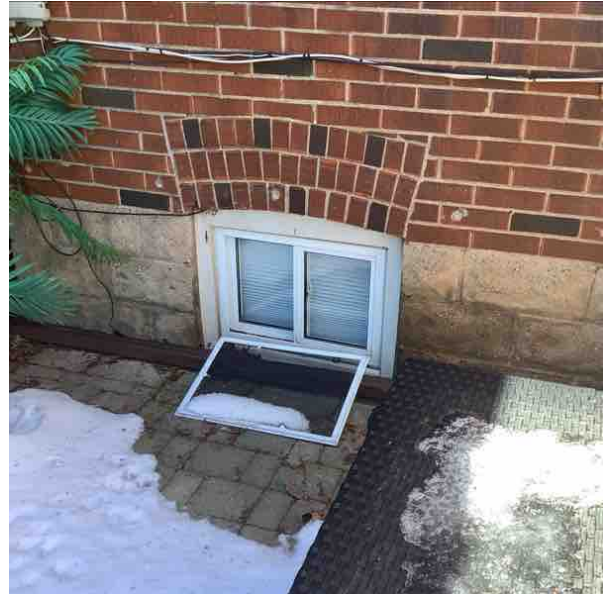
3.6.2 While most are updated a couple of concerns were noted with the older ones, an abbreviated list would be;

- Some of the windows have caulking that is cracked, deteriorated or missing.
- Wood frames show peeling / deteriorated paint
- Screen fall off (at rear)
- Aged windows offer low thermal values, single pane, wood / aluminum frame and while serviceable, recommend to consider budgeting for replacement.

Recommend a handyman or qualified contractor update / repair.

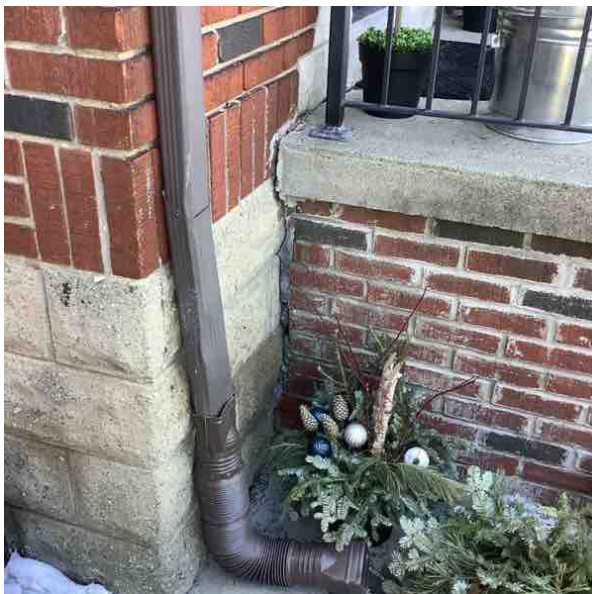
3.8.2 Small gap noted between the foundation wall and the front porch. While no immediate improvement is required, recommend a qualified contractor fill-in.

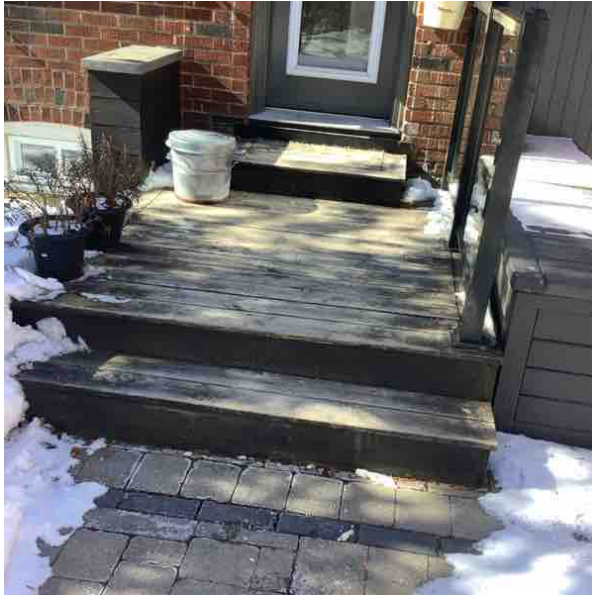
3.9.2 Wood walkout to the deck is showing age, minor deterioration, has exposed wood and in need of some maintenance. Recommend a handyman or qualified contractor update / repair.

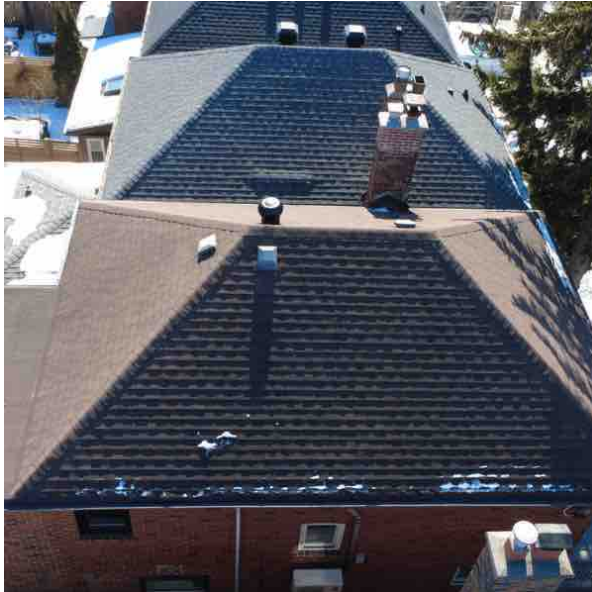
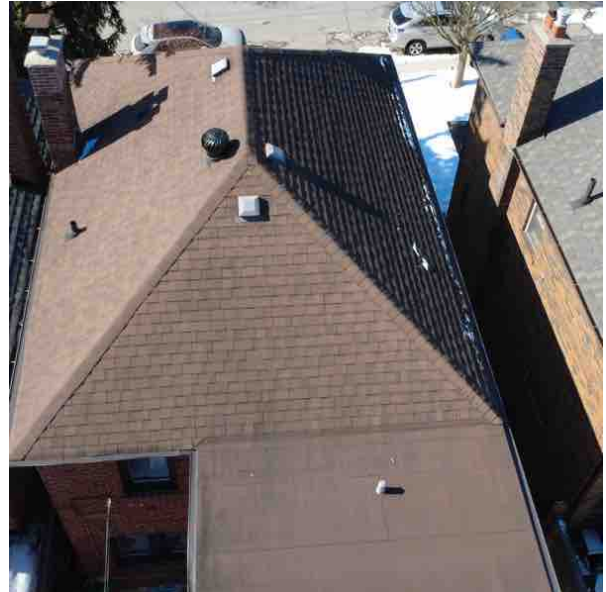
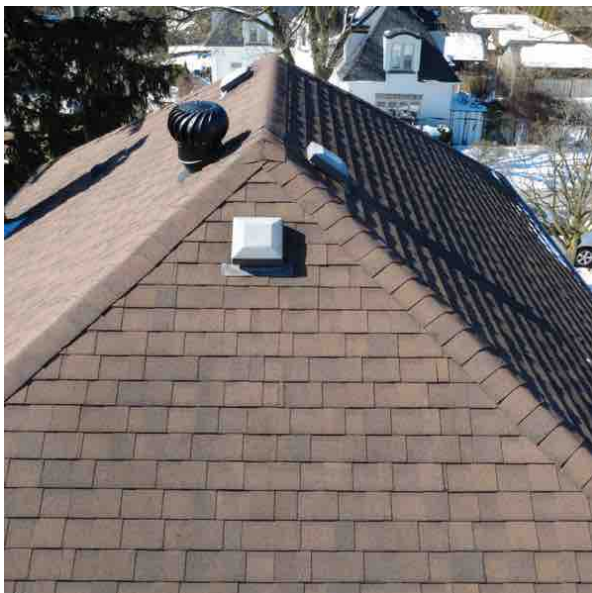
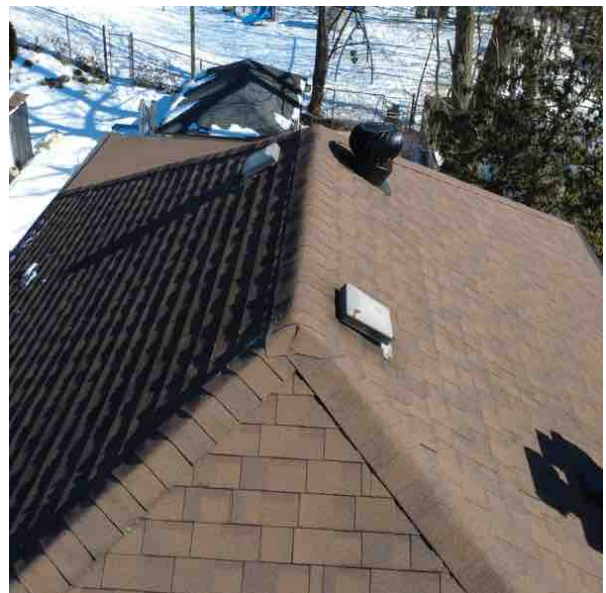
4.2.4 **Asphalt shingles are premium quality, estimated to be around 15 - 20 years old, middle of life cycle and in good condition.**

**Typical life expectancy is 25+ years.**

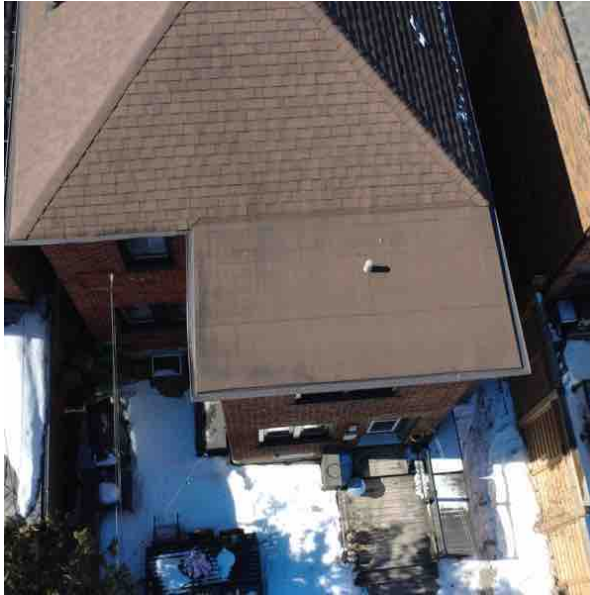
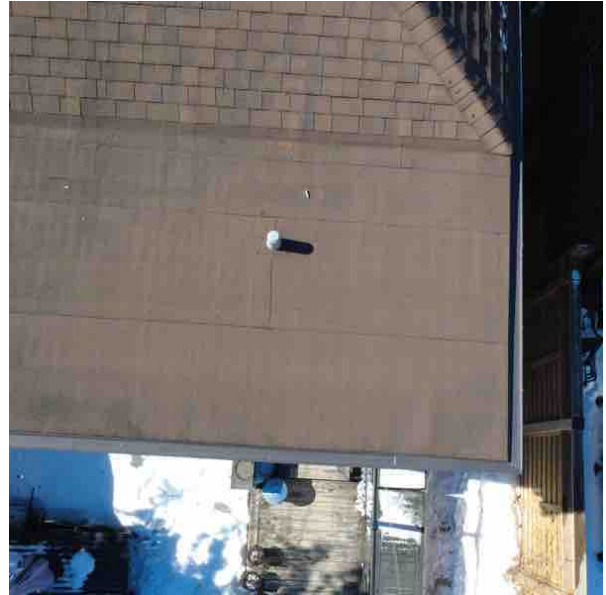
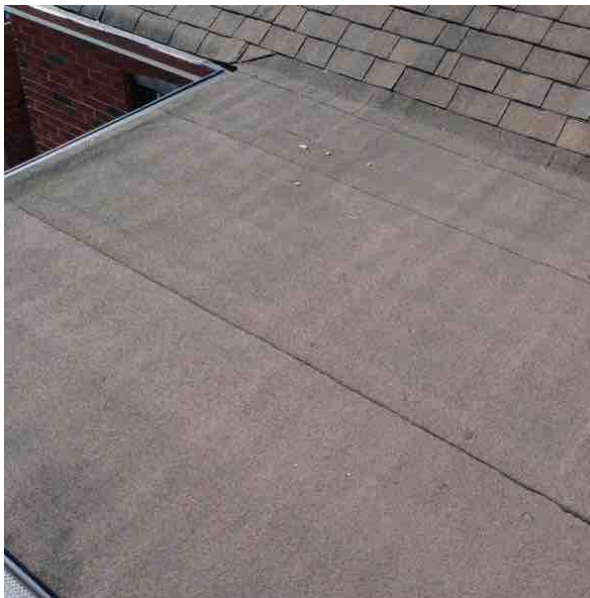
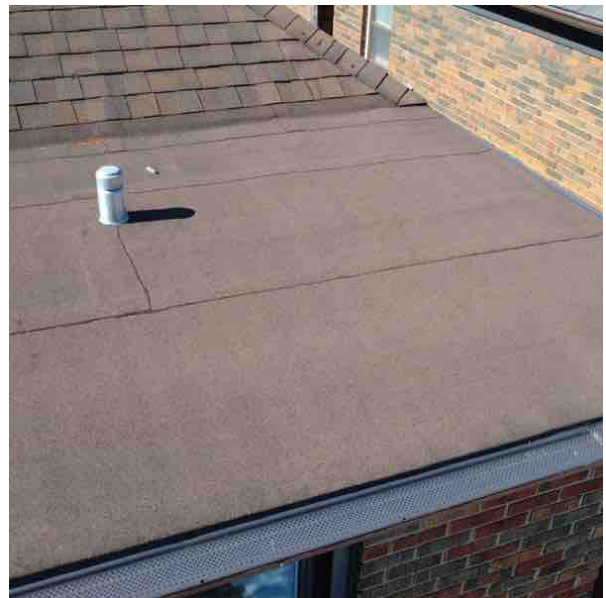
4.3.2 The flat roof membrane is estimated to be 5 years or less, beginning of life cycle and in satisfactory condition.

Typical life expectancy is 15 - 20 years.

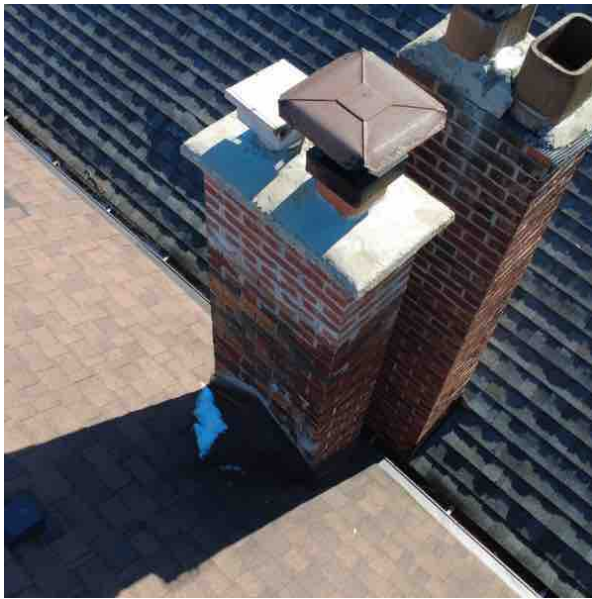
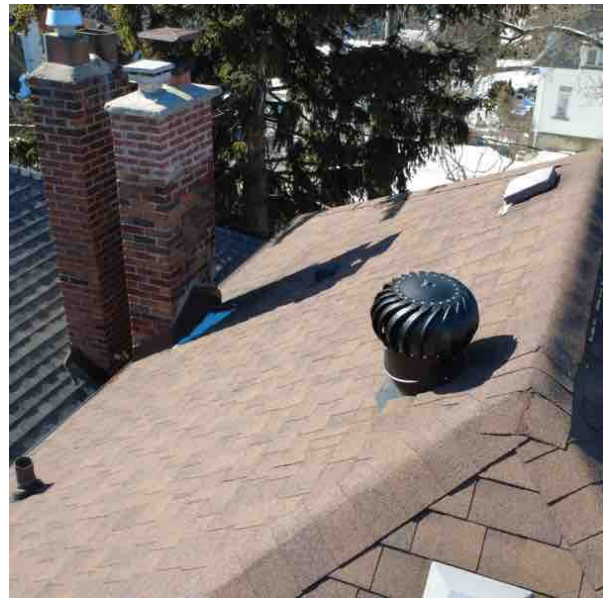
4.6.2 The chimney appears to have some recent work (rebuilt) and is in satisfactory condition.

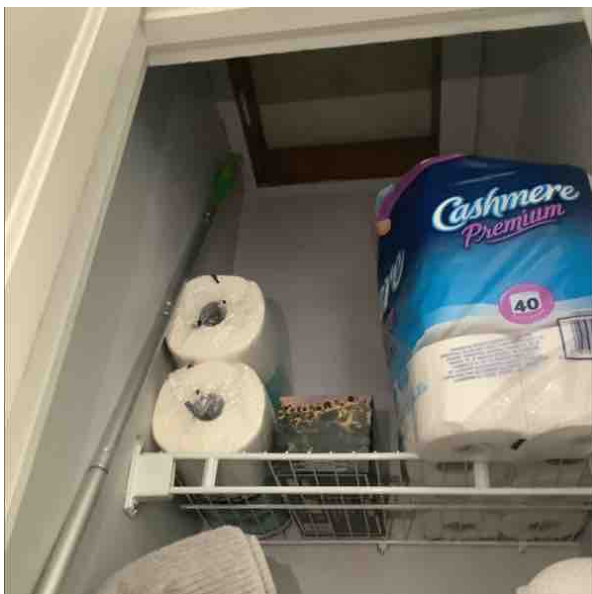
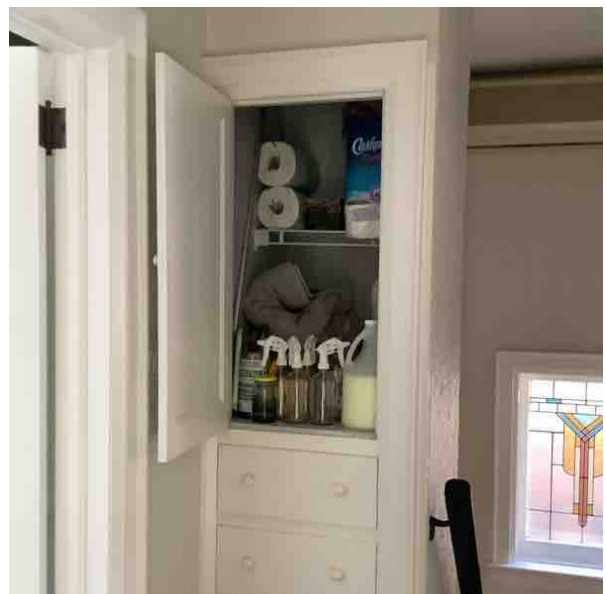
5.3.1 Attic access is via the hallway closet. Unable to access it as it is very narrow and difficult to get to the hatch.

Recommend improving accessibility to allow access.

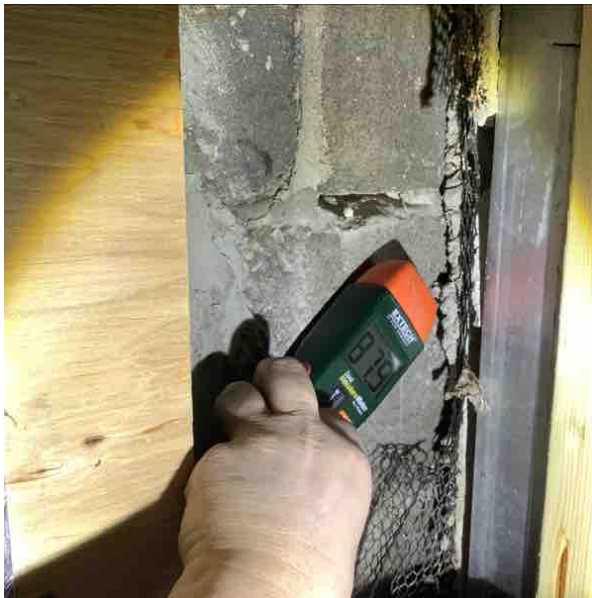
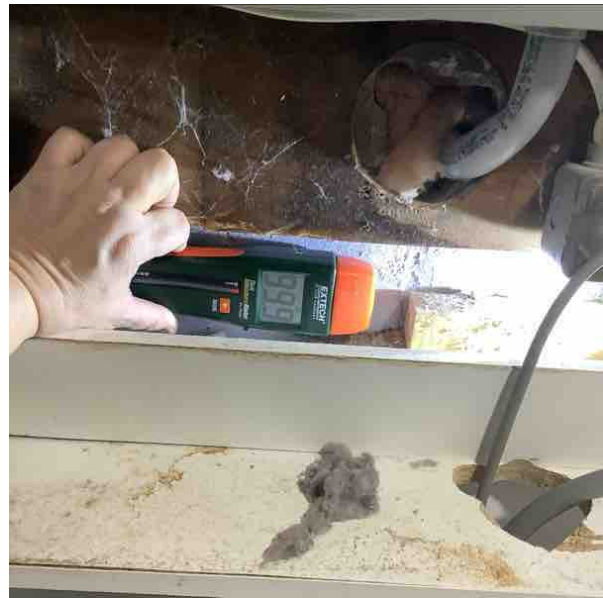
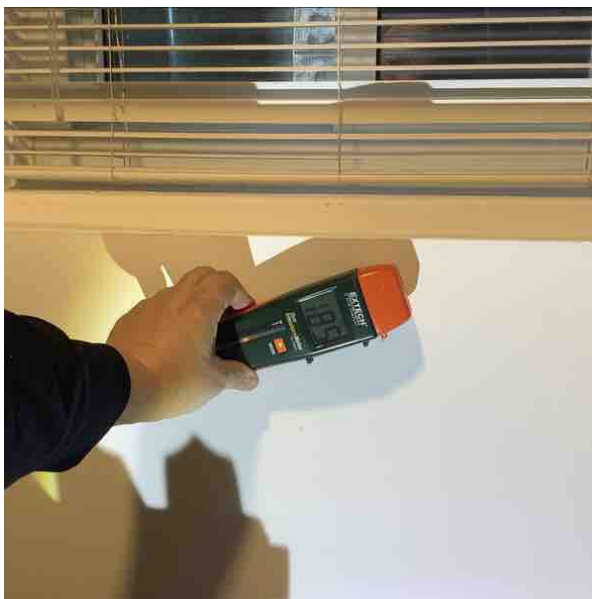
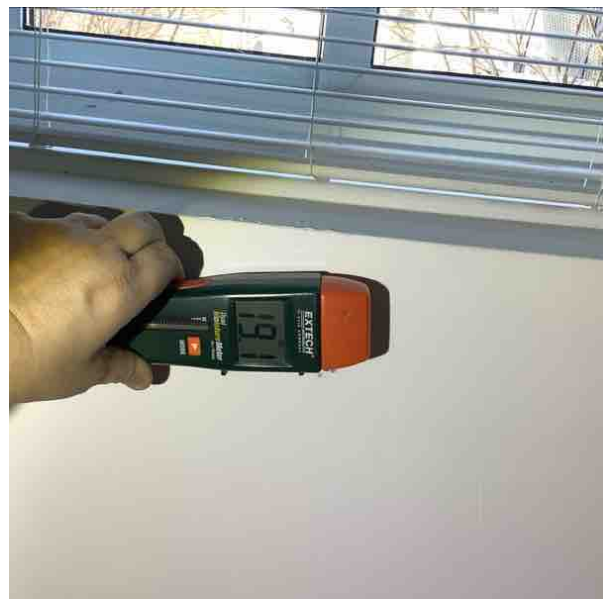
7.2.3 **Block foundation had mainly normal moisture readings, with elevated & high readings (on the block in 2 areas),no signs of seepage, nor efflorescence stains, and is in satisfactory condition.**

7.2.4 The two areas which had elevated/high moisture readings were underneath the electrical panel and in the utility room. All other areas tested, had normal moisture readings.

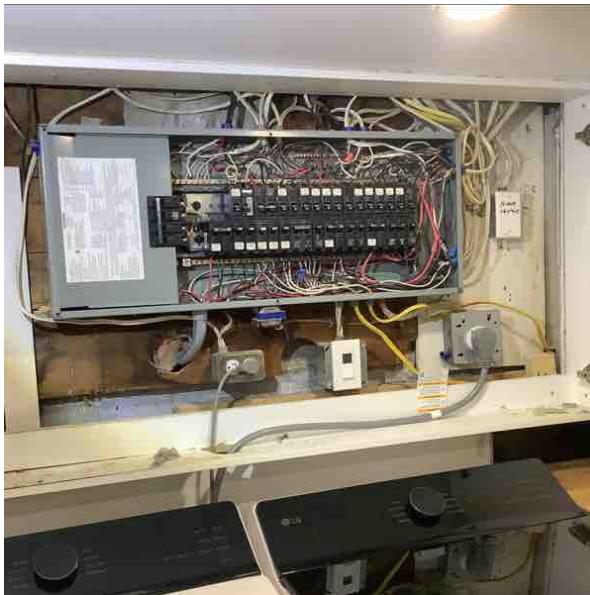
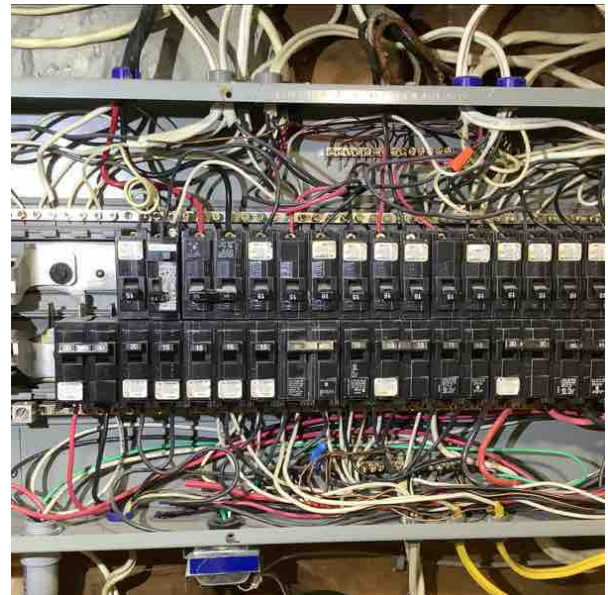
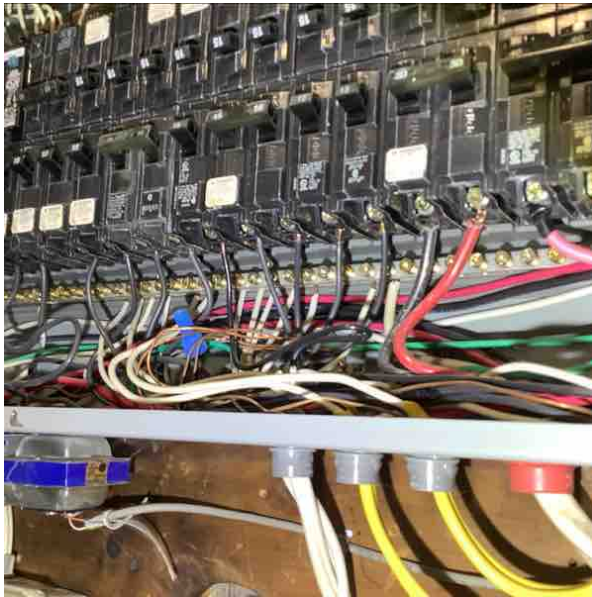
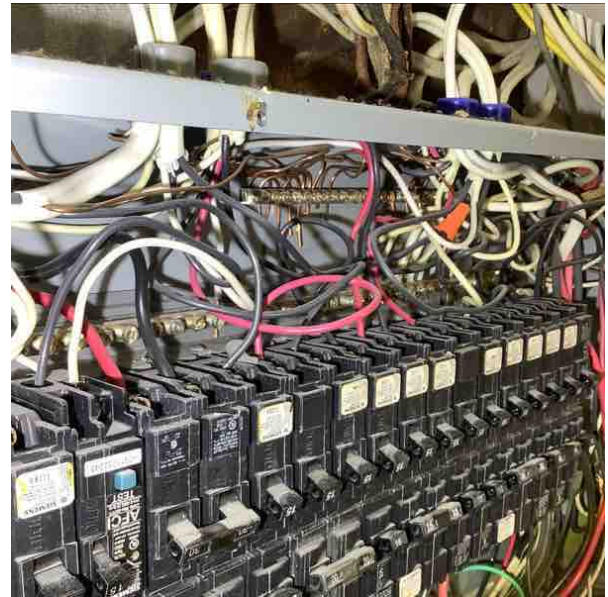
8.6.2 **200 amp Distribution panel has room for expansion, has breakers, grounded copper wiring, showing no scorching or burn marks, professionally installed and is in satisfactory condition.**

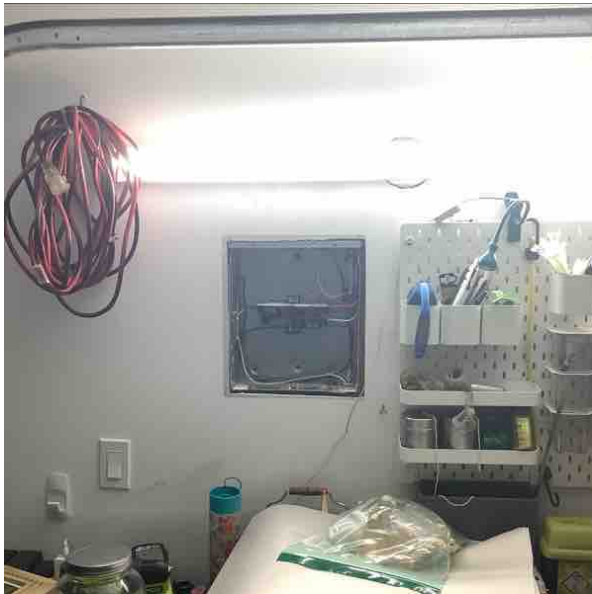
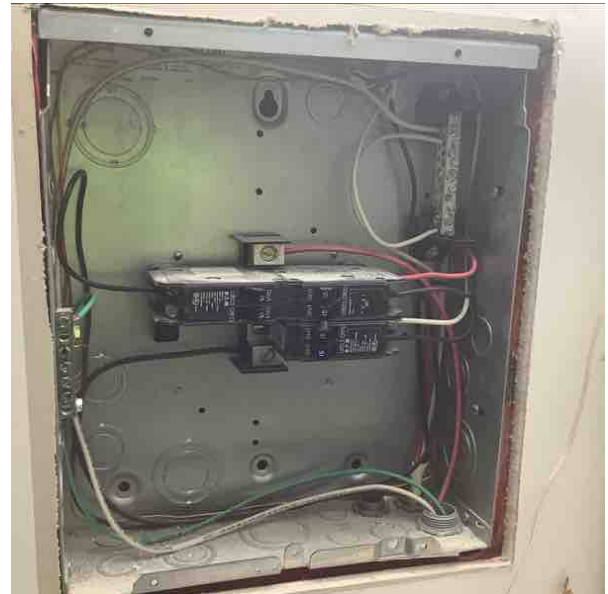
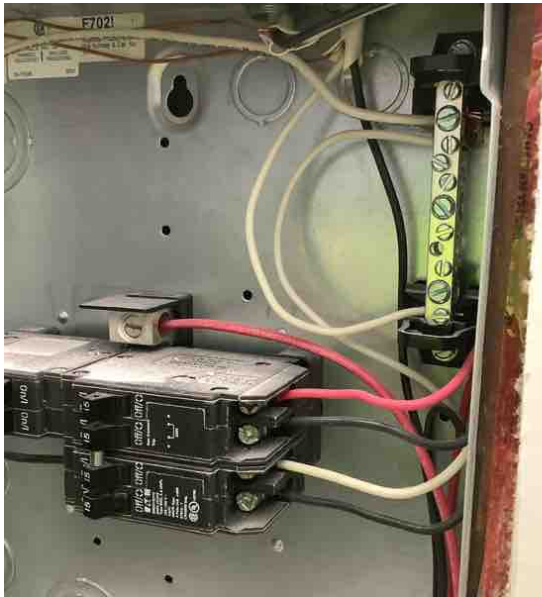
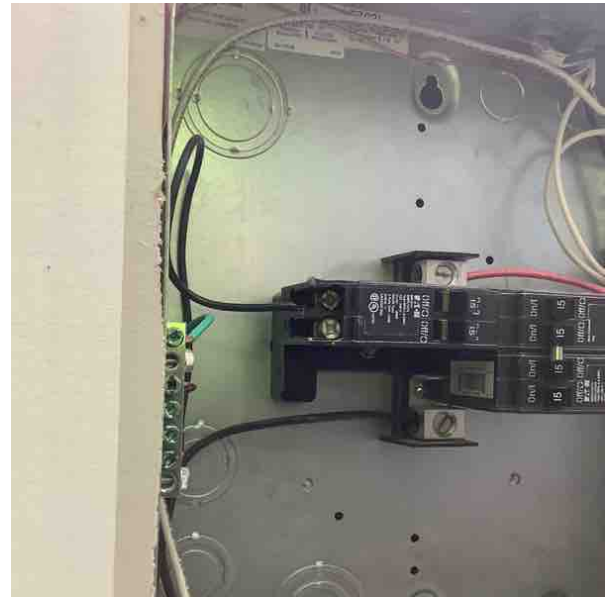
8.7.2 **40 amp Sub panel (Garage), has breakers, copper wiring and is in satisfactory condition.**

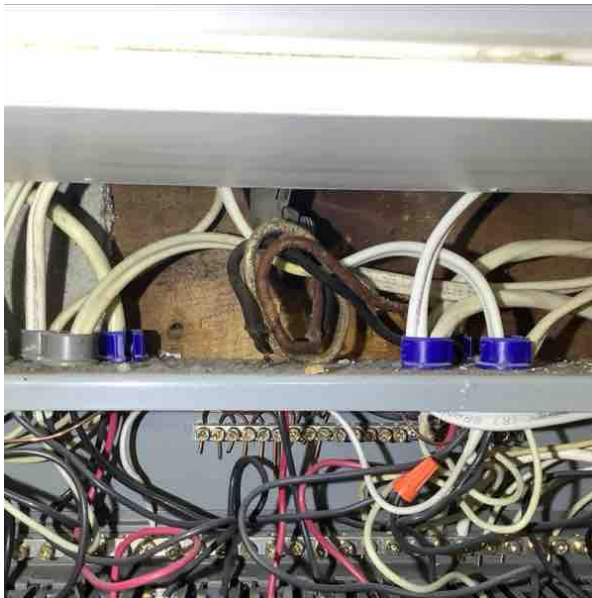
8.8.3 Older cloth sheathed wiring was present (above the panel), but didn't appear to be active. If not in use, recommend removal or to secure inside a junction box (for safety).

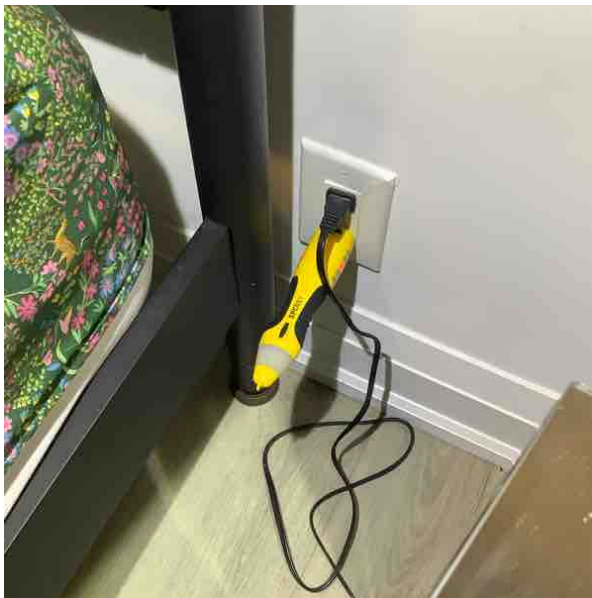
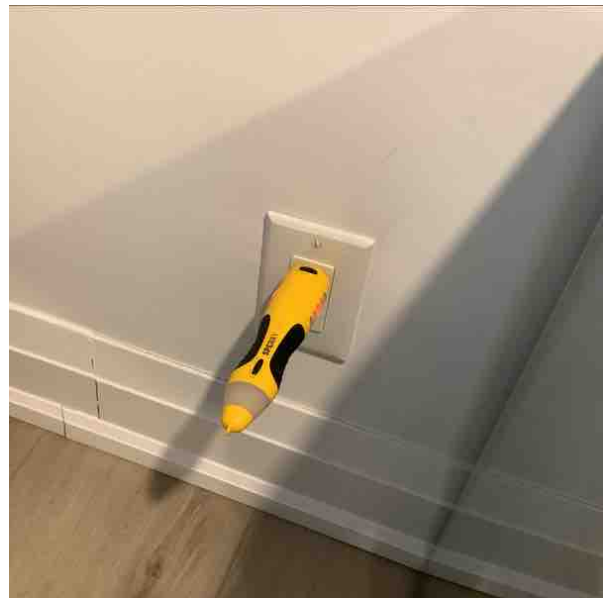
8.9.2 Where is polarity found in the basement bedroom receptacles. Recommend a handyman or qualified contractor repair.

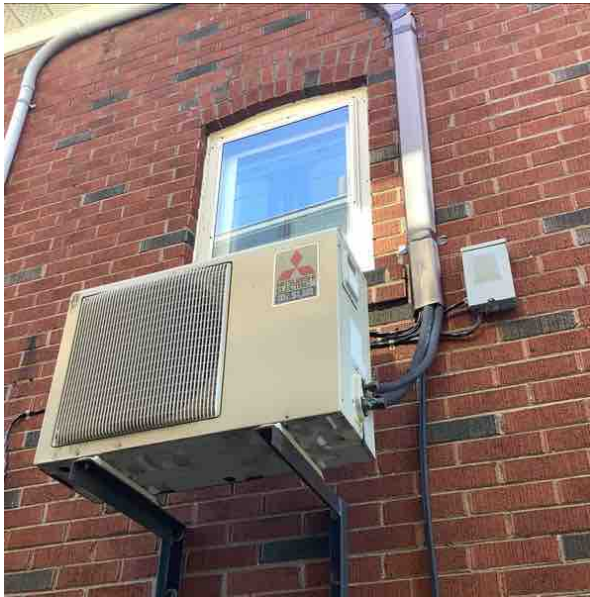
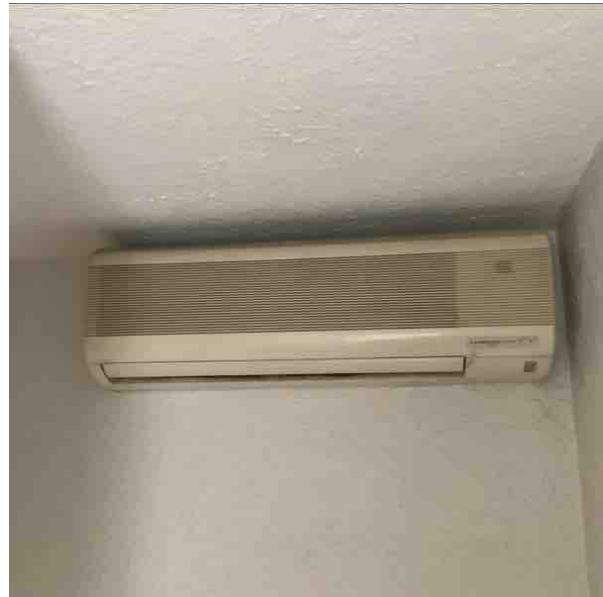
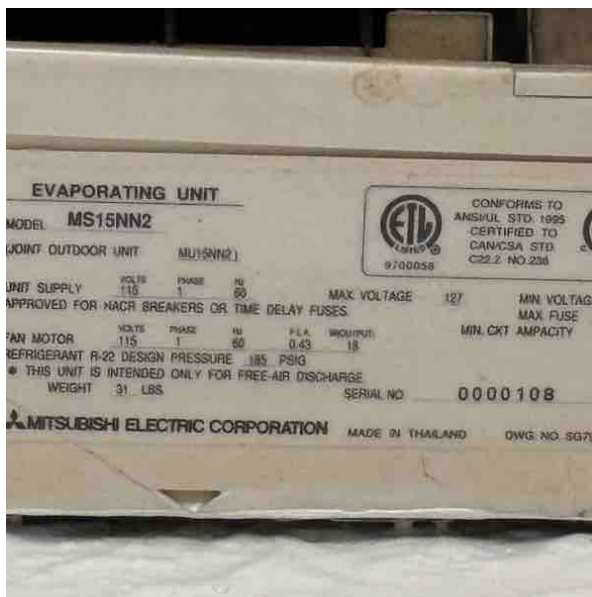
9.3.3 **Mitsubishi Heat Pump / AC unit has an estimated 1.5 ton cooling, over 20 years old, has exceeded typical life cycle and is in satisfactory condition.**

**Typical life expectancy is around 15 years.**

**While additional years may remain, recommend to service annually and to budget for replacement.**

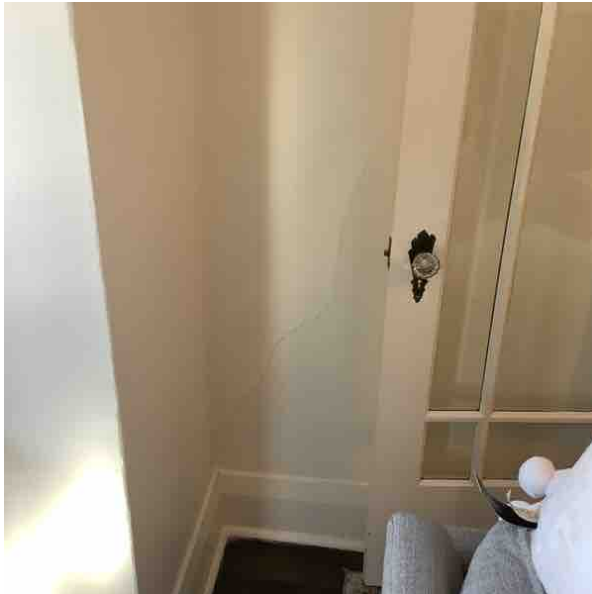
11.2.3 Imperfections and blemishes noted. Considered to be cosmetic in nature as normal moisture readings were found.

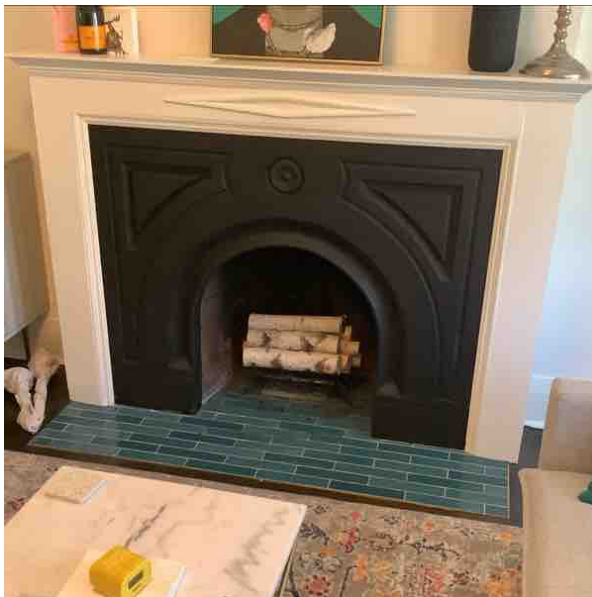
12.1.2 The wood-burning fireplace is present, however was not operated / tested and the functionality / safety was not determined. A qualified wood heating technician should assess the fireplace to determine functionality and compliance with modern safety standards. This may also be a requirement of your insurance company for coverage.

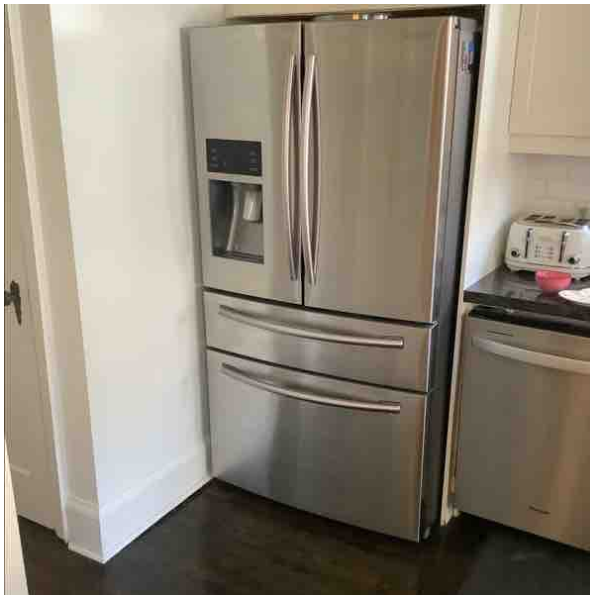
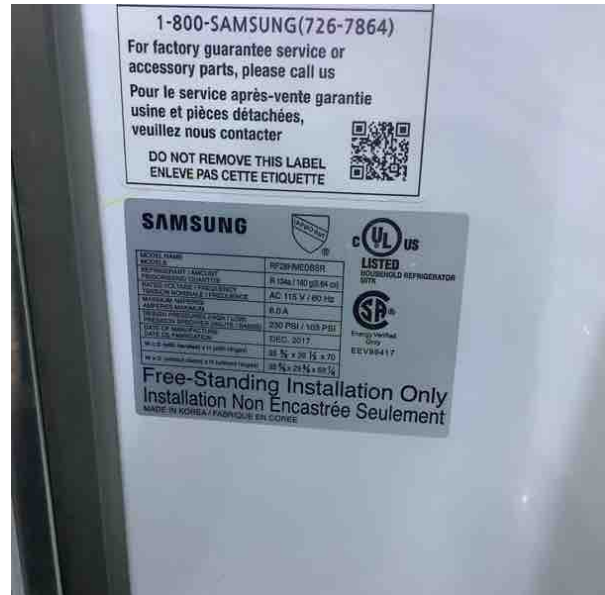
13.1.2 Whirlpool refrigerator & freezer were tested and found to be functional.  
 While the water feature was functional, the ice was not. Recommend to have repaired or to live with as is.
