## HOME INSPECTION REPORT

25 Queensborough Cres

July 16th 2026

Pradeep Samaroo, RHI

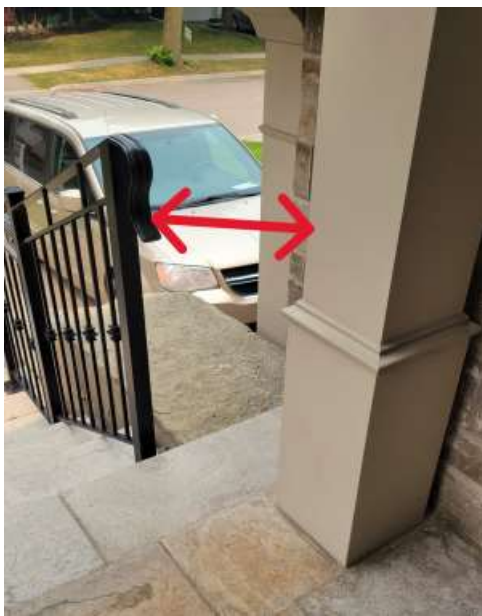
## Exterior Image

☐ [Front entrance-there is a gap between railing and column- Infant fall hazard - install a guard rail](#)

Gap between handrail and column presents an infant fall hazard
