## HOME INSPECTION REPORT

48 Chatsworth Ave

August 27th 2026

Pradeep Samaroo, RHI

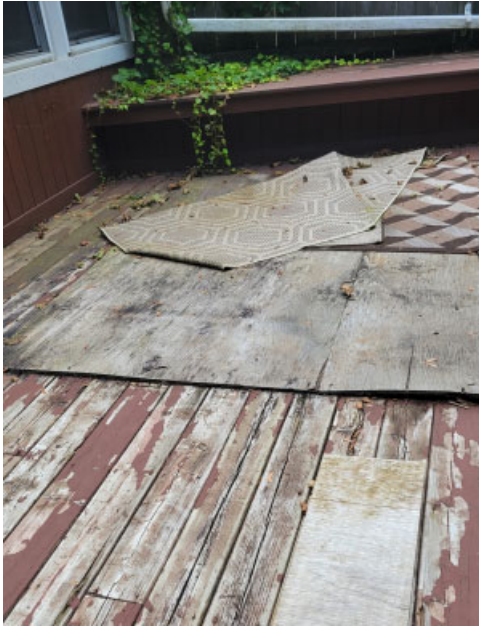
Existing decking is split and rotted. Plywood is used to cover rotted decking

Replace rear deck Time frame 0-1 years Budget \$ 10,000

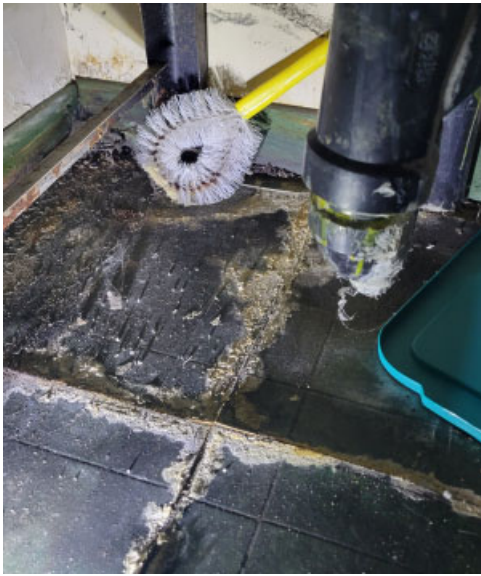
One active leak and several other locations with water stains indicating Time frame years Budget \$

Active water leak through foundation wall in laundry room-

previous moisture infiltration were observed. Recommend further evaluation Time frame 0-1 years Budget \$ 10,000

by a foundation specialist to determine corrective actions required. Time frame years Budget \$

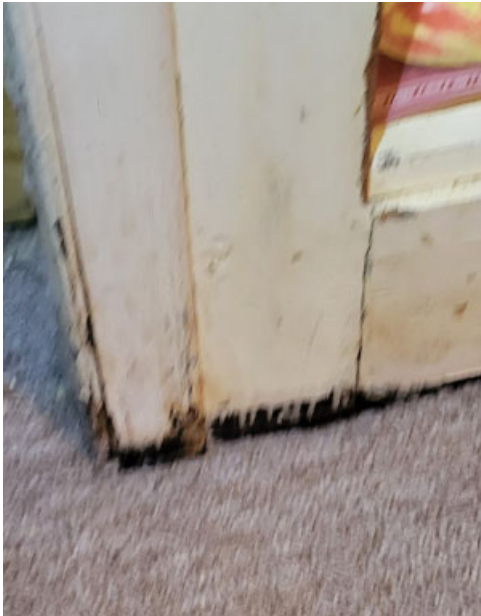
Water stains on wood trim in the basement

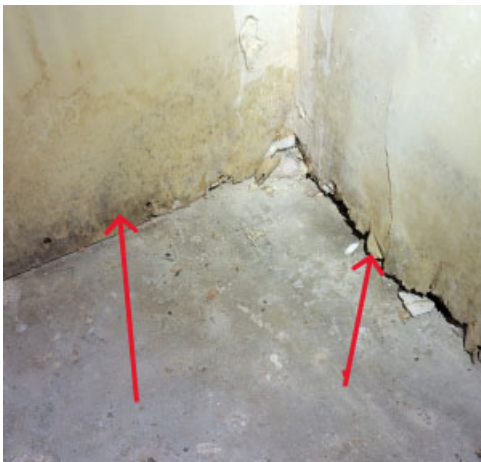
Water damage to bottom of drywall in storage rooms at rear of basement

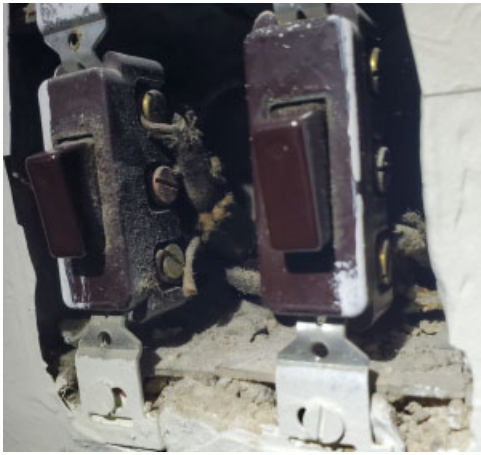
Older cloth- insulated undrounded wiring was observed at the second floor sitches and recepatches. Given the age

and characteristics of the wiring, concealed knob and tube wiring may be present. Recommend further evaluation by

Older 2 wire wiring- Further evaluation by licensed electrician recommended

a licensed electrician to identify the wiring type and extent

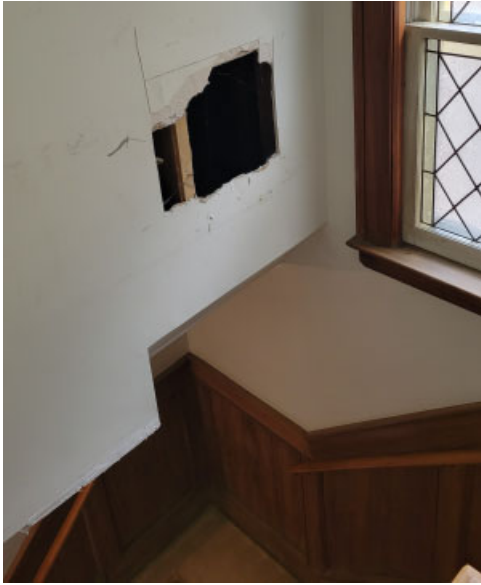
Hole in drywall to access bathtub water supply need to be repaired
