### HOME INSPECTION REPORT

173 High Park Ave

Sept 3rd 2026

Pradeep Samaroo, RHI

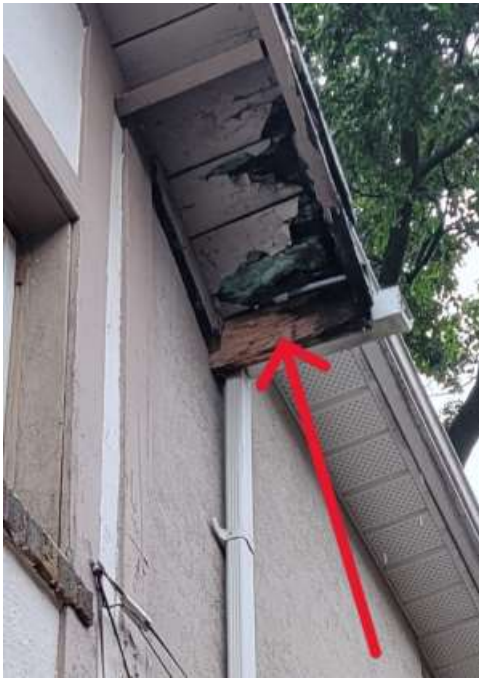
Open eaves on both sides of the house show signs of rot

| Repair atucco, wood trim and open wood eaves | Time frame | ? years | Budget \$ | \$15,000 |

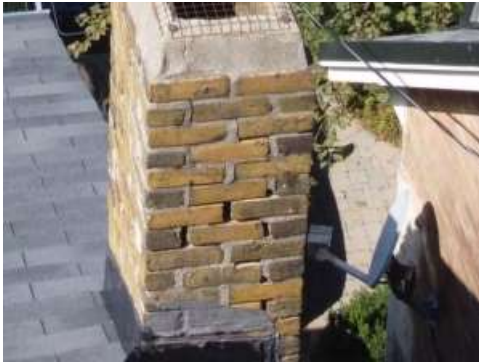
Chimney on north side of the house requires tuck pointing

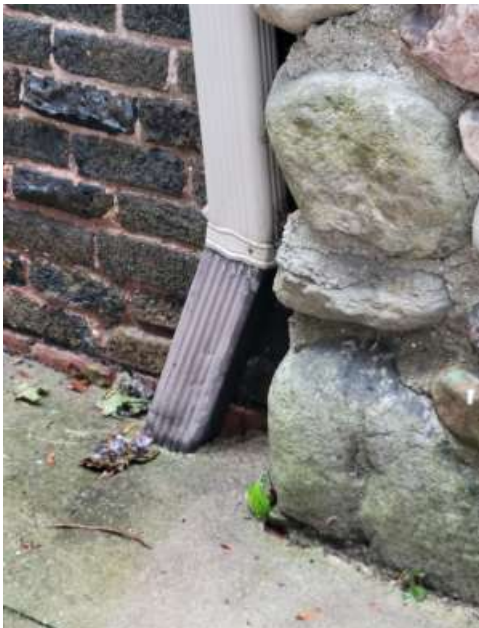
Downspout discharges into drain. Efflorescence is present on the interior on foundation wall

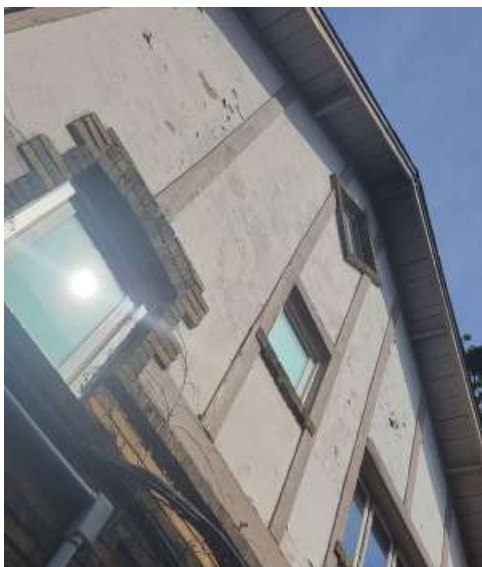
Stucco and associated wood trim show signs of deterioration

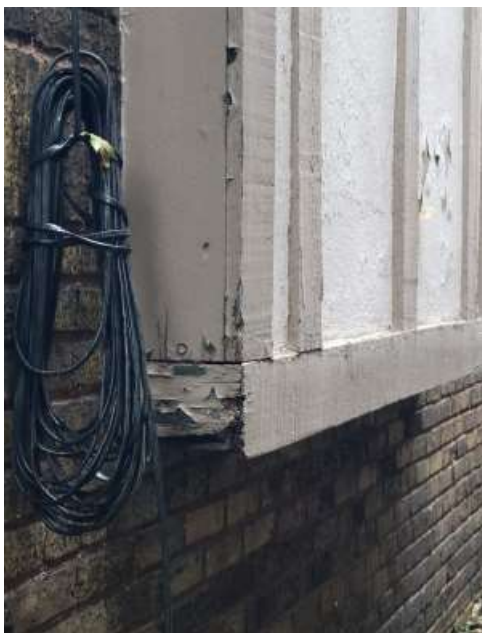
Rotted wood trim

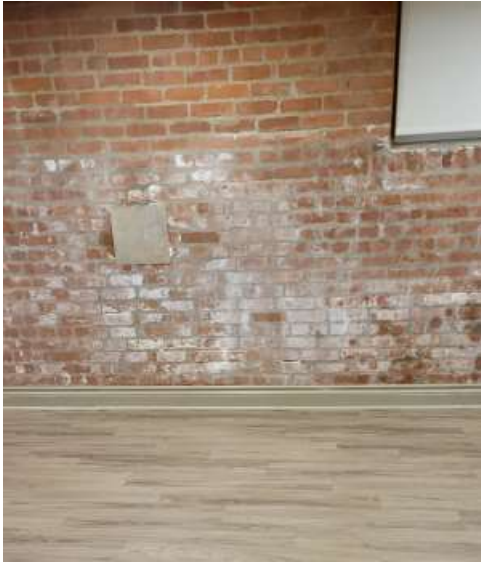
Efflorescence and foundation adjacent to where downspout discharges into the drain/weepers

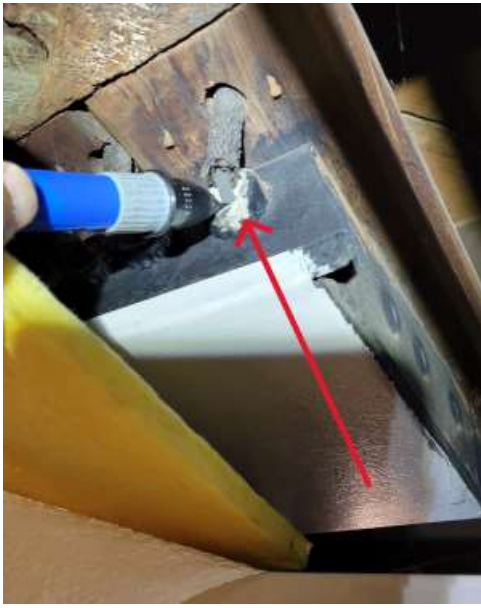
Knob and tube wiring is present throughout the original structure

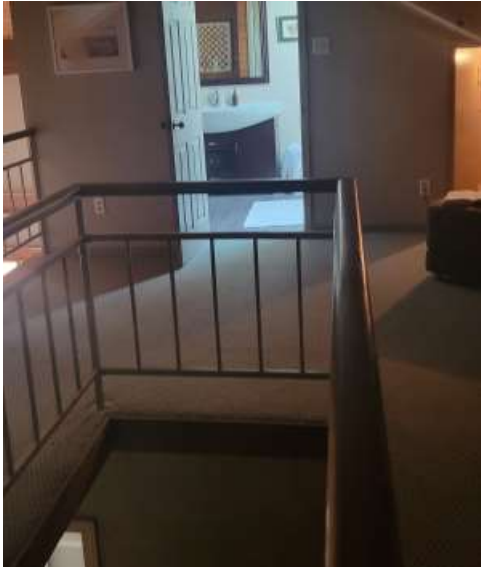
#rd floor - railing is too low and spacing on spindles is too wide
