### HOME INSPECTION REPORT

141 Humbercrest Blvd

August 31th 2026

Pradeep Samaroo, RHI

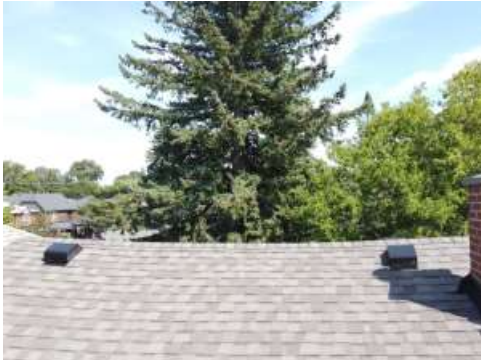
[Dip in ridge of roof- recommend further evaluation by qualified contractor](#)
