20/20 HOME INSPECTIONS

40 Stockell Crescent
Ajax, Ontario L1T 0M4
Telephone: 416-518-9680

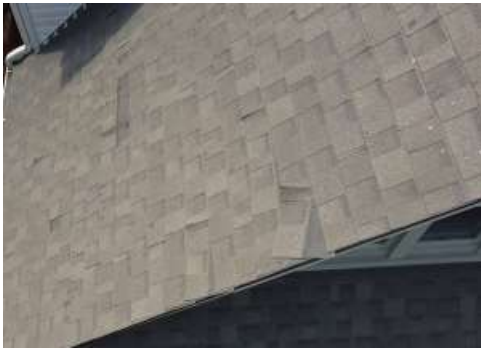
left front upper slope- Some localized repair required- displaces and missing tabs

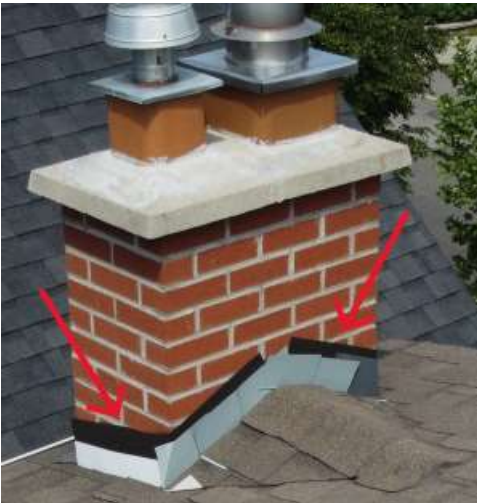
Missing caulking/sealant between flashing and bricks- potential point of water entry

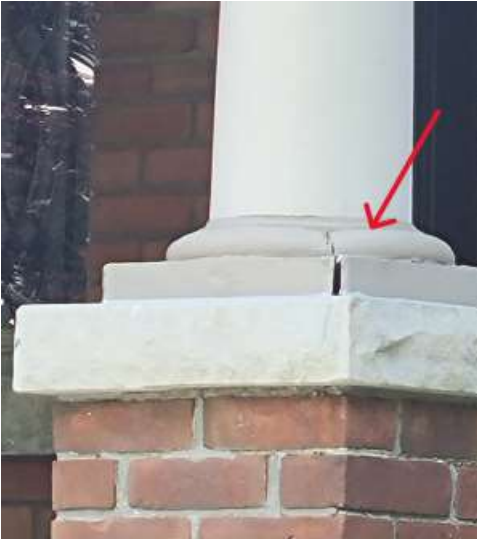
Trim at base of column show signs of deterioration.

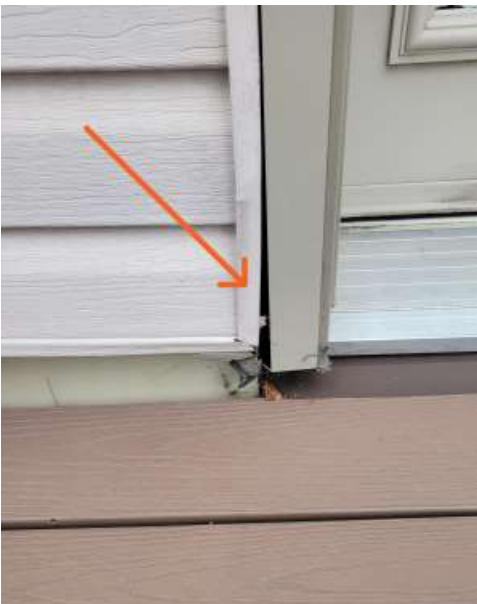
3rd floor door to deck- gap between j mould and trim- potential point of water entry into wall assembly

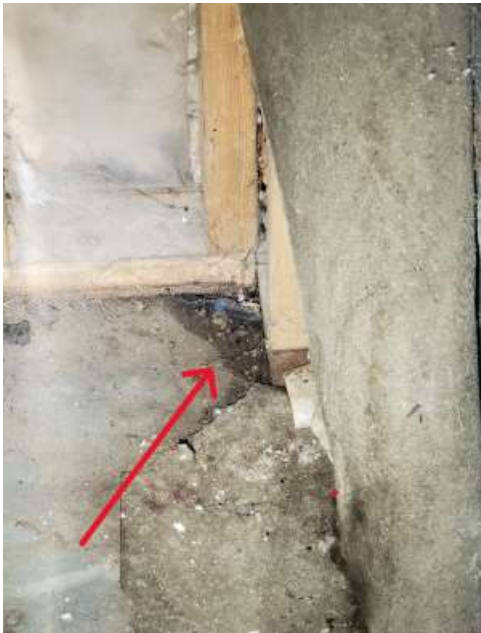
Damp spot along the foundation wall behind the furnace- unable to access - confined space
