# A Buyer's Choice Home Inspections

## PROPERTY INSPECTION REPORT

208 Northcliffe Blvd, Toronto, ON, M6E 3K7

Date of Inspection: 3/6/2021 Time: 12:00 PM Size: 0  
Order ID: 840

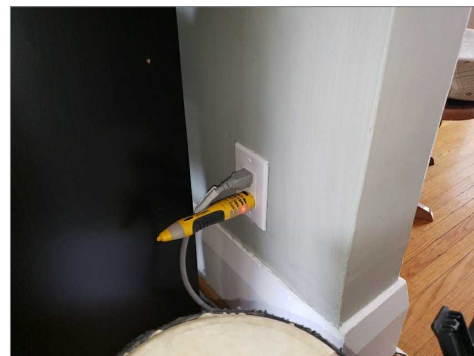
• Repair - Two outlets noted on the main floor with open or missing ground. Recommend evaluation by a qualified professional.

**CORRECTIVE MEASURE TAKEN:**

GFCI outlet installed and cover plate labelled.

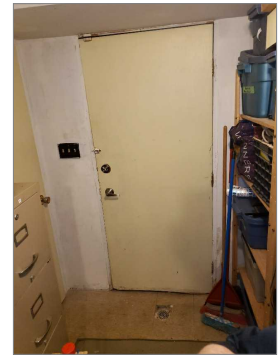
- Wood door with glass
- Maintenance - Painting needed on door and around door jamb area to ensure weathertight seal. Recommend painting as necessary.
- Improve - The basement walk out door is noted with moisture damage and upgrading to a newer entry door is recommended. Recommend evaluation by a qualified professional.

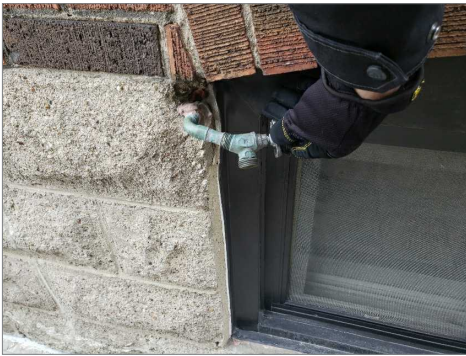
Side hose bib

- Maintenance tip - Exterior shut off valves need to be shut off before freezing temperatures begin.
- Inspection limitation - The valve is shut off for the season and as such it was not operated.

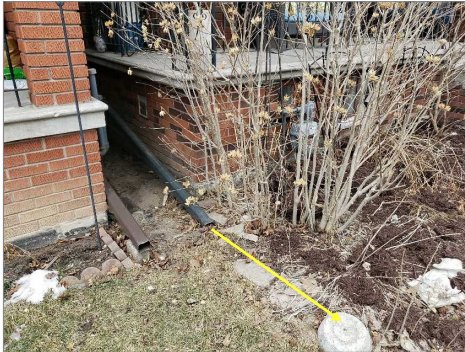
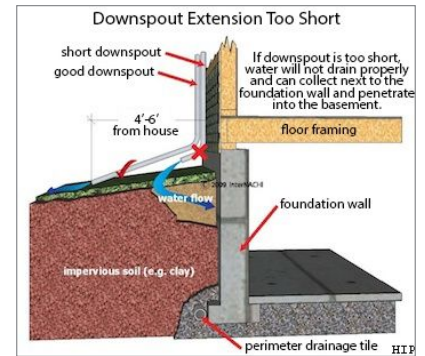
- Improve - Downspout leaders should be extended at least 6 feet beyond the foundation perimeter to move water away from foundation. This will dramatically reduce the amount of water that is present to be absorbed into the foundation walls.

**CORRECTIVE/ PREVENTATIVE MEASURE TAKEN:  
Downspouts extended**

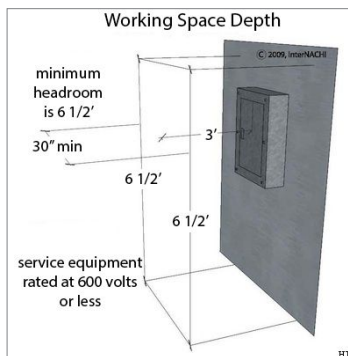
• Repair/Safety - Insufficient clearance noted around panel area. Minimum unobstructed area must be maintained as a minimum of 1 meter in front of the panelboard, 2 meters in height and at least the width of the panelboard or 1 meter, whichever is greater. Recommend removal or rearrangement of the obstructions for safe access to the panel area.

Panel clearance recommendations

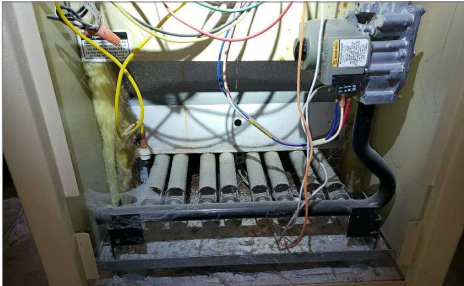
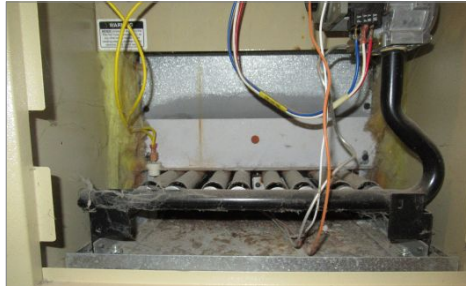
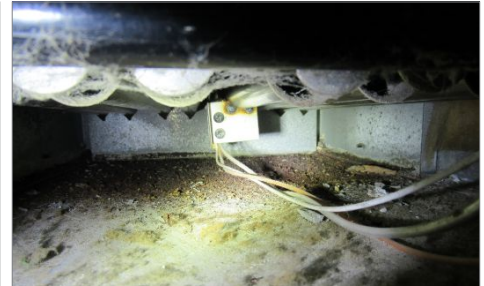
- Maintenance tip - Regular maintenance of the HVAC equipment will prolong their life. Recommend yearly inspection and maintenance by a qualified professional.
- Maintenance - The boiler enclosure is noted as needing maintenance and cleaning. Recommend a qualified professional perform a system Clean-and-Check. HVAC systems require yearly maintenance.

**CORRECTIVE/ PREVENTATIVE MEASURE TAKEN: Maintenance/clean and check has been conducted.**

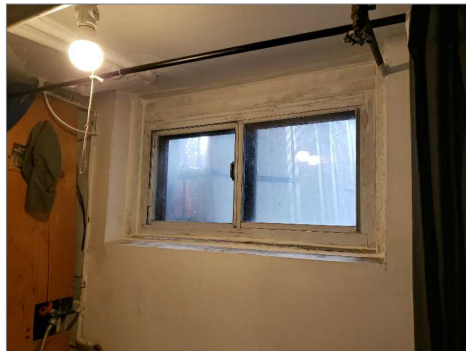
- Improve - Single glazed windows noted. Recommend upgrading to thermal insulated windows for additional security and energy efficiency.

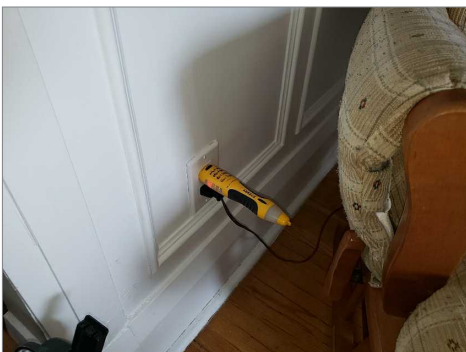
- **Repair** - Two outlets noted on the main floor with open or missing ground. Recommend evaluation by a qualified professional.

**CORRECTIVE MEASURE TAKEN:**

GFCI outlet installed and cover plate labelled.

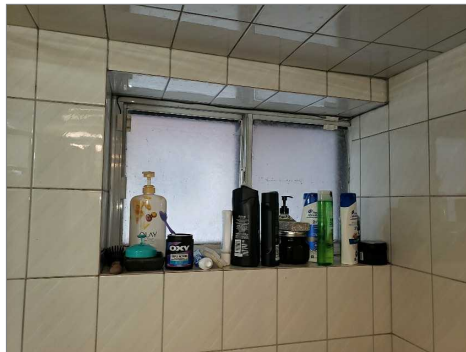
- **Improve - Single glazed windows noted. Recommend upgrading to thermal insulated windows for additional security and energy efficiency.**

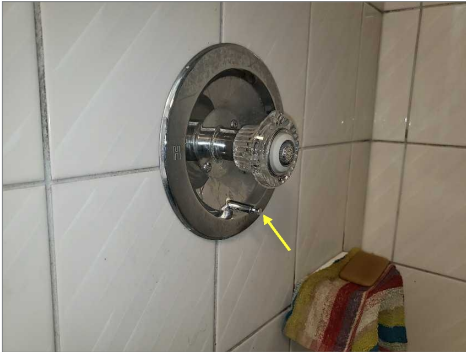
- Repair - The hot & cold water supplies are reversed. This is not a functional problem but to someone who is not familiar with this condition unexpected hot water could scald them. Recommend evaluation by a qualified professional.
- Repair - The faucet diverter is stuck or hard to operate. This is due to built up of calcium over time. Recommend evaluation by a qualified professional.

Diverter stuck

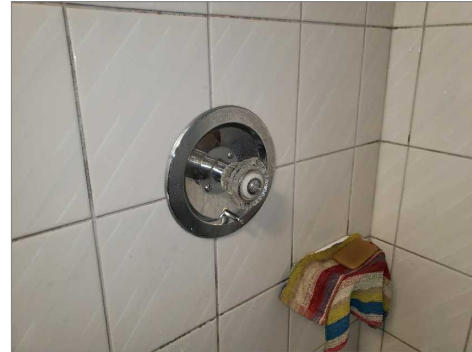
Hot and cold reversed

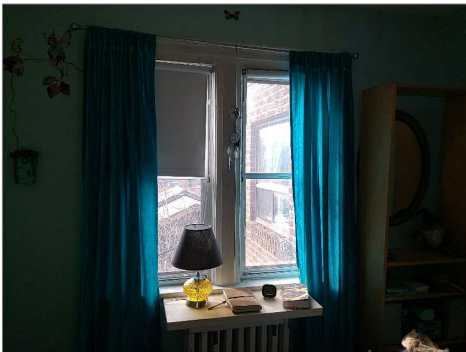
- Improve - Single glazed windows noted. Recommend upgrading to thermal insulated windows for additional security and energy efficiency.
