## Home Inspection Report

PROPERTY INSPECTED:  
**81 Armadale Avenue**  
**Toronto, ON M6S 3W9**

**Date of Inspection: 02/24/2026**

Inspection No. 141168-1803

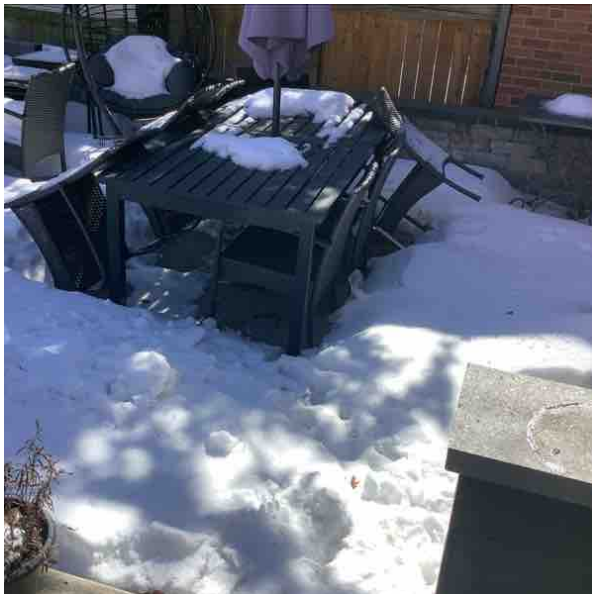
3.9.3 The pavers area was snow covered.

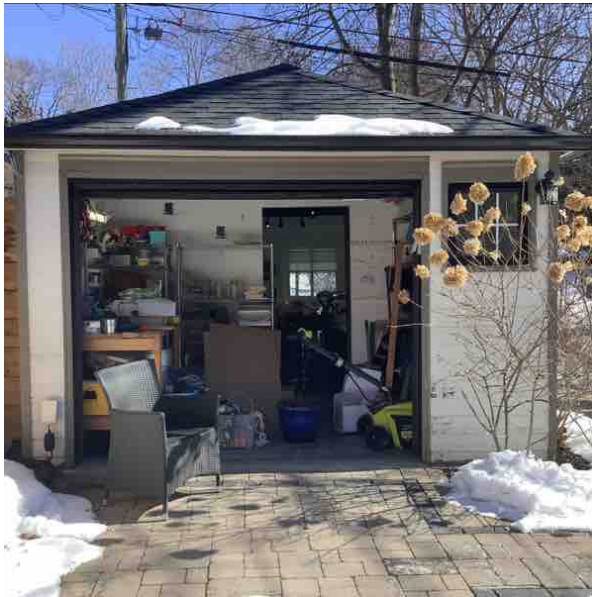
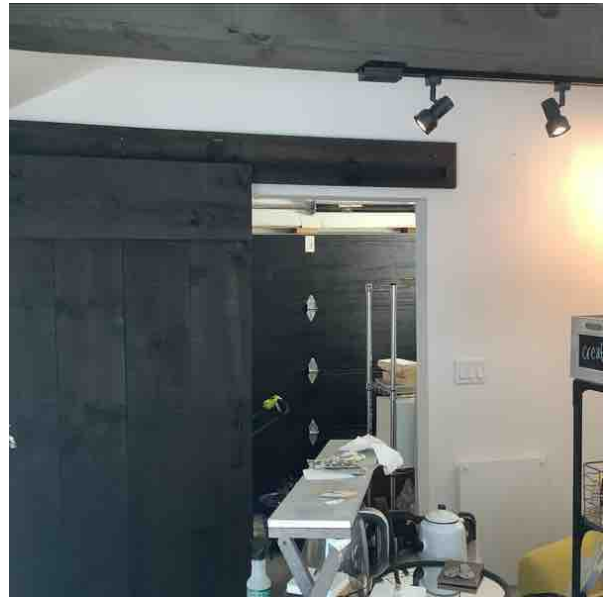
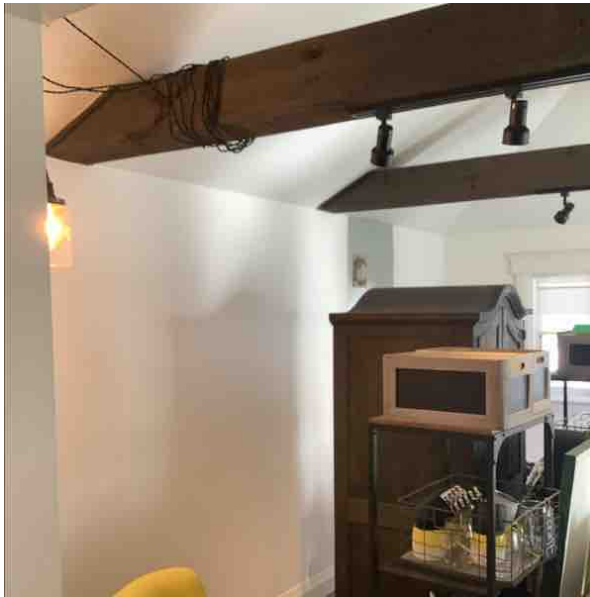
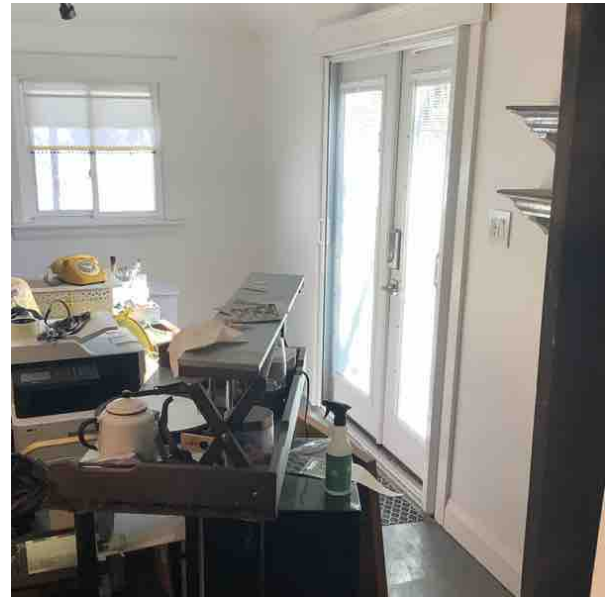
6.2.2 Garage General Photos.

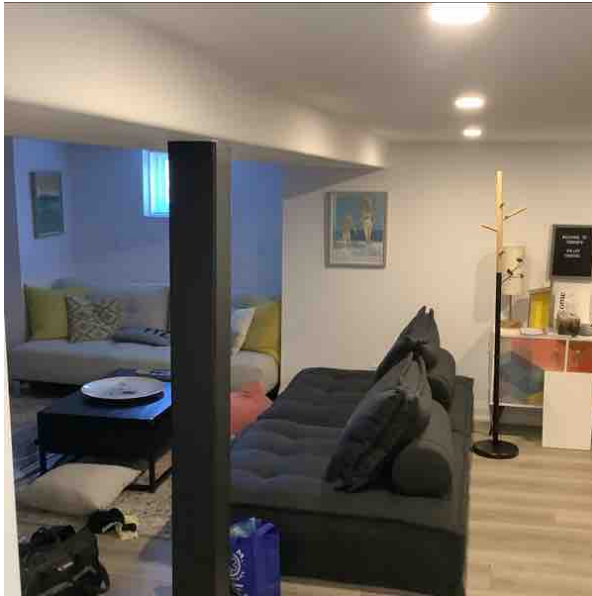
7.3.2 Beams and posts were concealed behind finished materials.

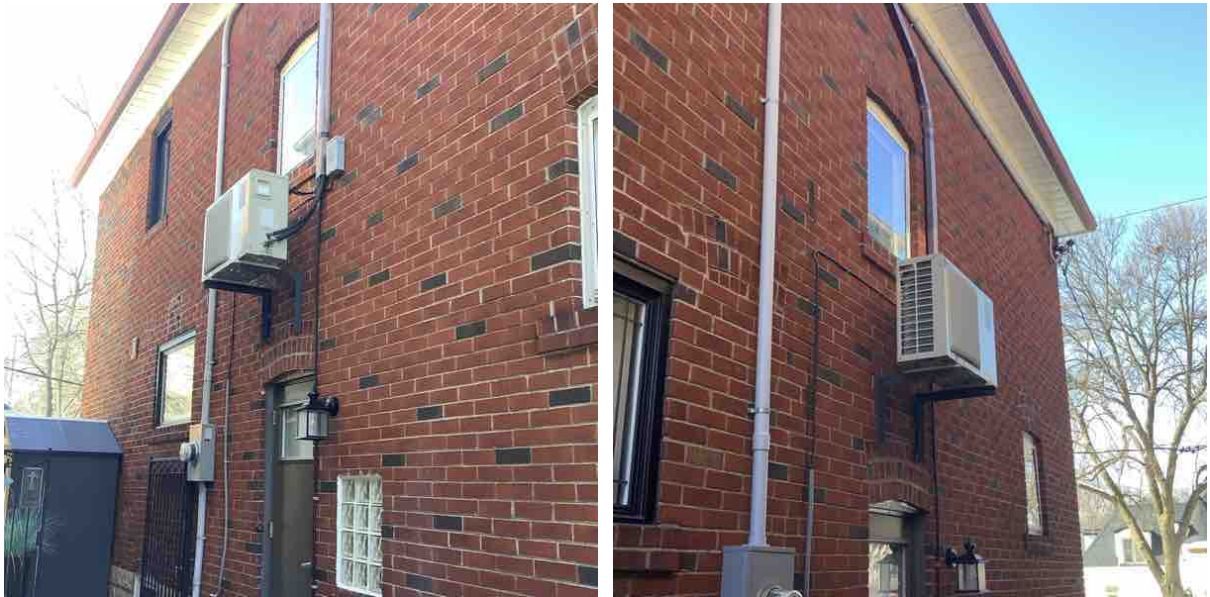
8.3.2 Overhead service entrance cables to a meter located outside at NW corner.

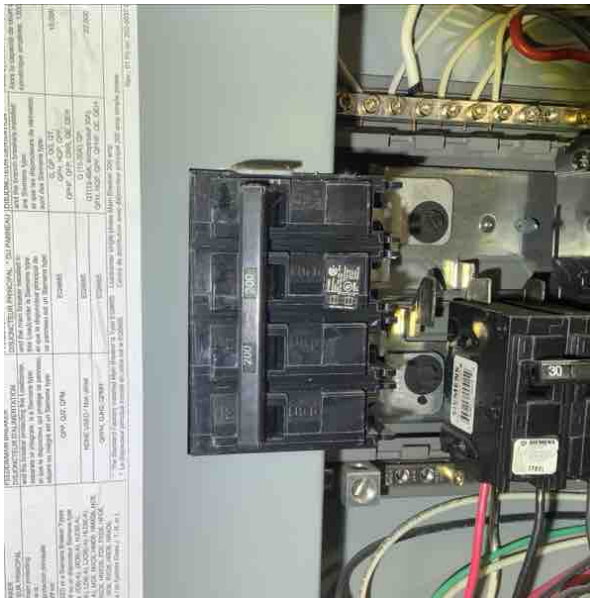
8.5.2 The main disconnect for the electricity going into the distribution panel, is the 200 amp breaker, located at the side of the panel.

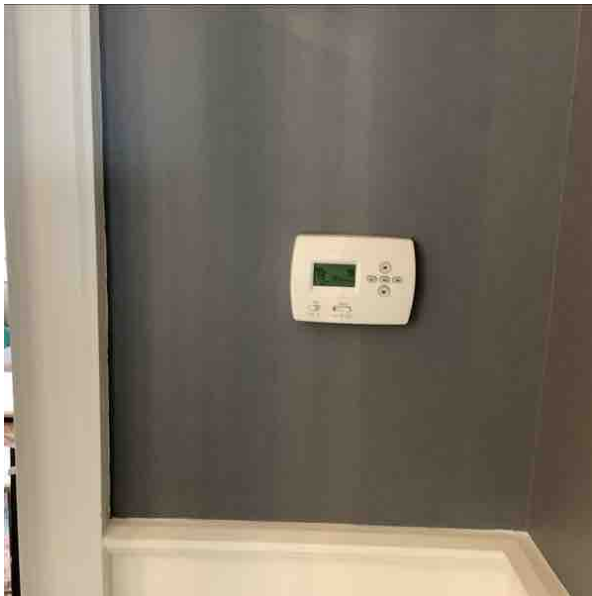
9.1.2 Programable thermostat is located on the dining room wall.

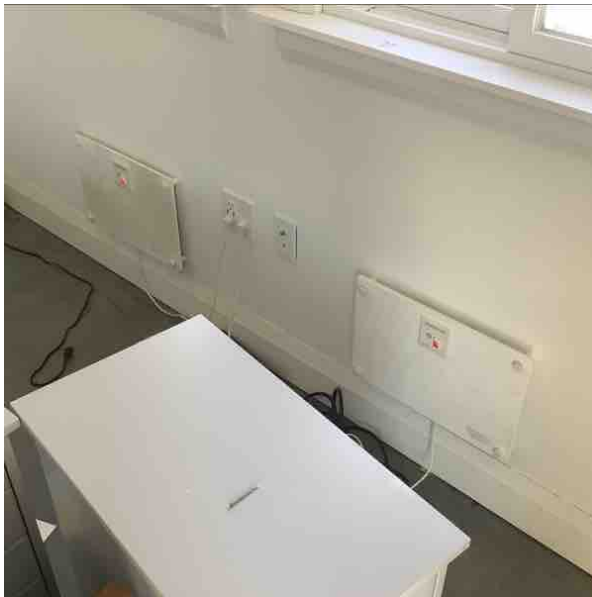
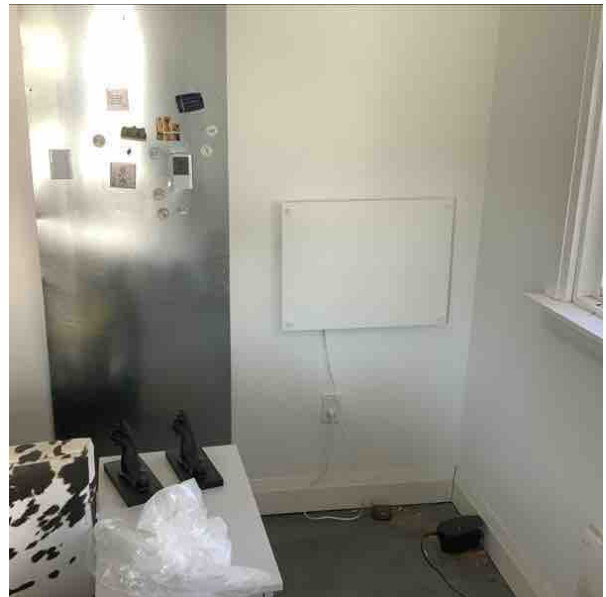
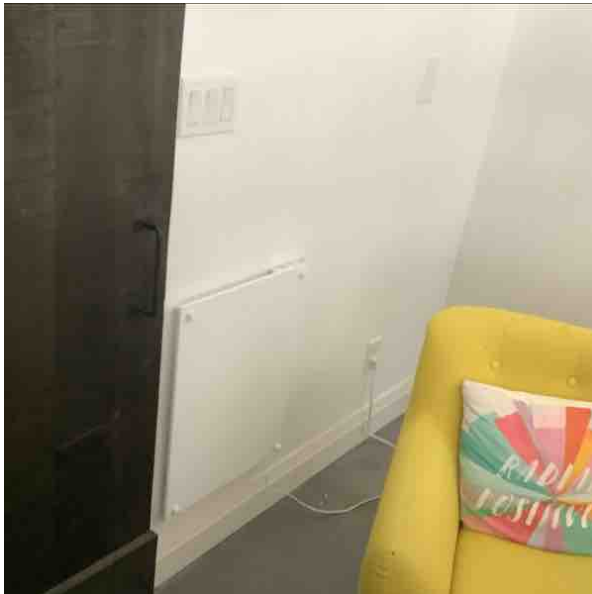
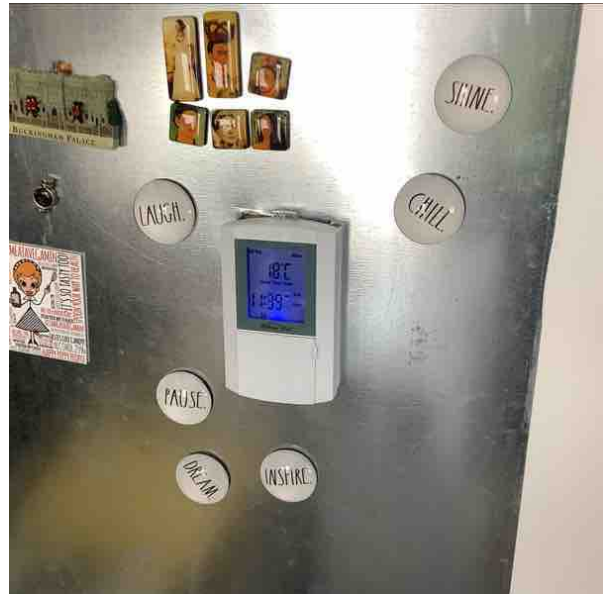
9.4.2 **Electric plug-in heaters were present in the rear as tested, the units were functional.**

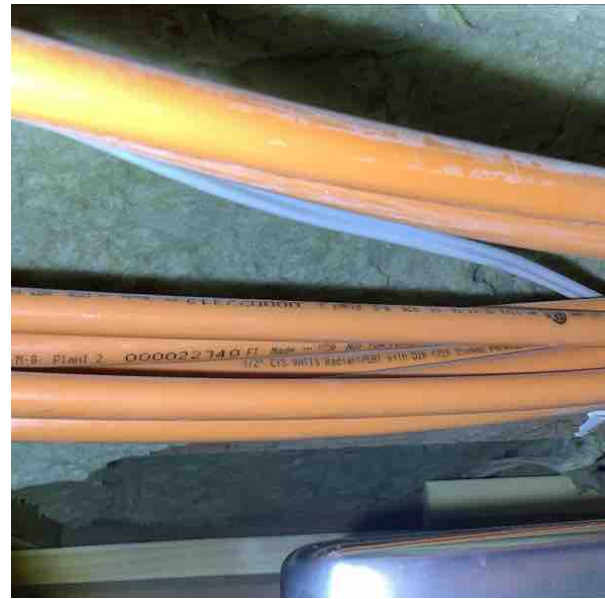
9.6.2 1/2" RadiantPert brand Pex piping distributes the hot water to the radiators.

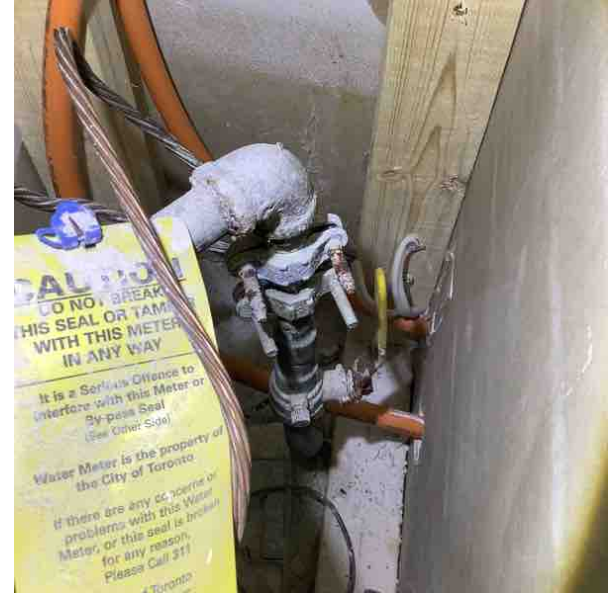
- 10.3.2 Estimated 3/4" Copper supply line to the meter, is located in basement corner (floor cabinet)  
 \*Main shutoff for all water throughout the home is the flat yellow handle. Be sure to keep clear access in case of internal water emergencies.

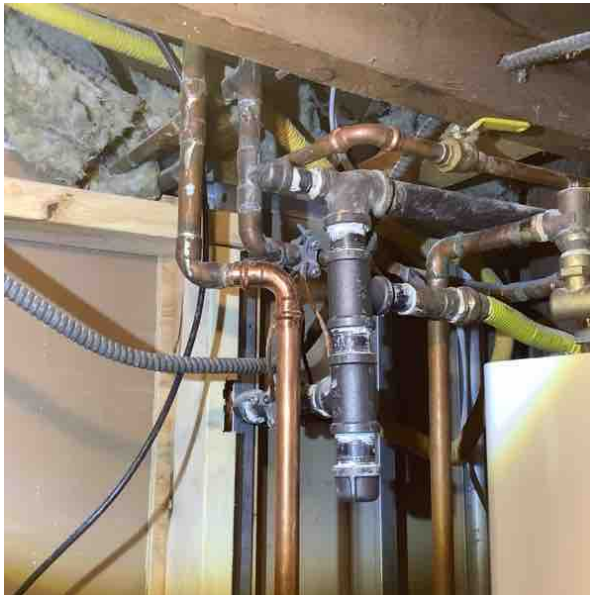
10.4.3 Copper piping was visible in utility room.

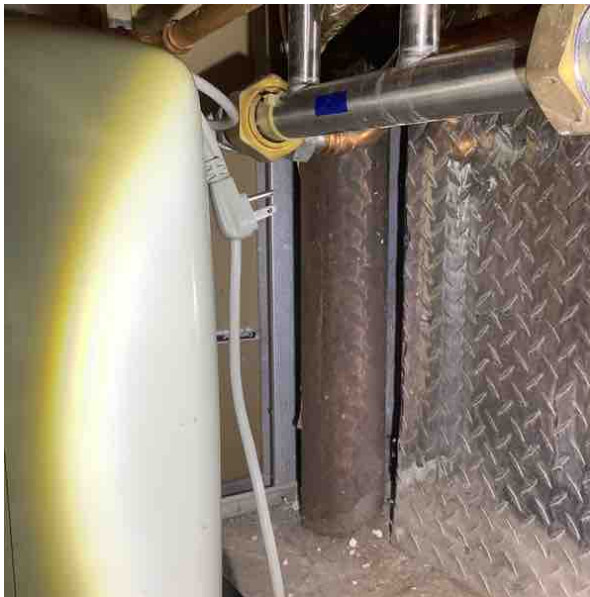
10.5.2 Cast iron piping was visible in the basement utility room.

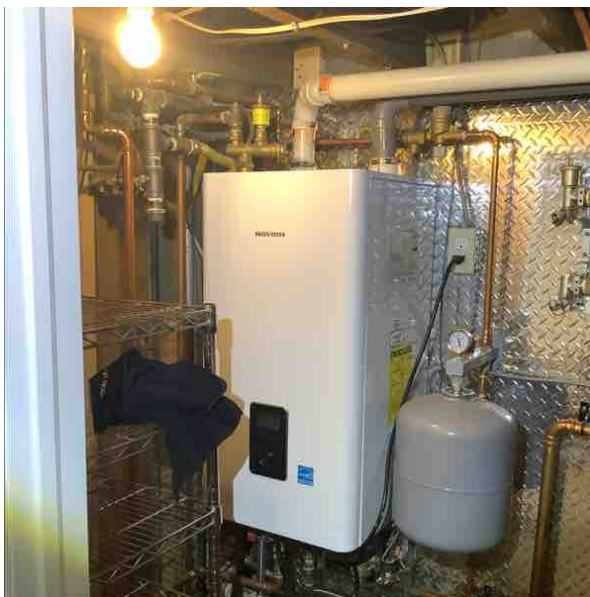
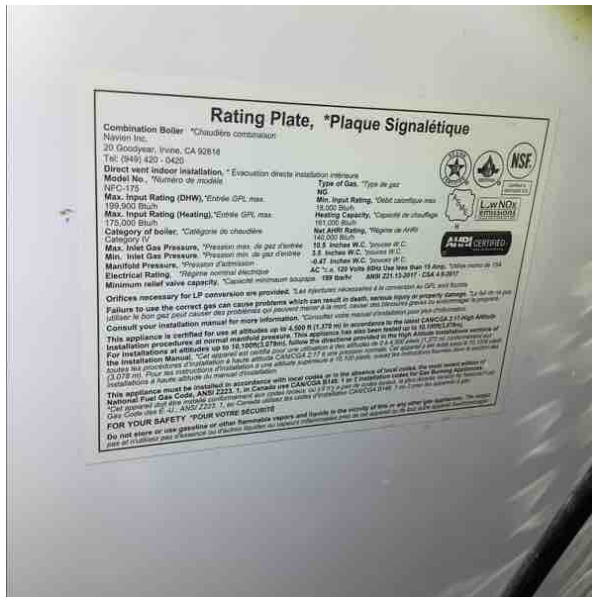
10.6.3 **Navien combo tankless hot water on demand system has 199,000 BTU / Hr Input, is 5 years old, beginning of life cycle and was functional. Typical life expectancy is around 20 years.**

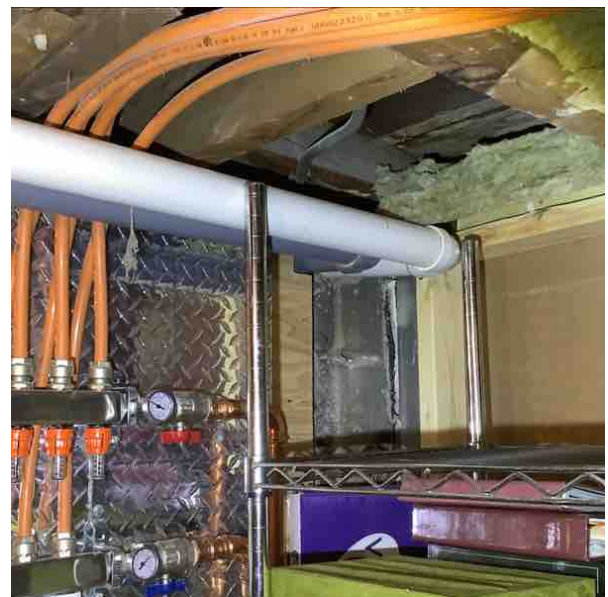
10.7.2 Power vented to the exterior.

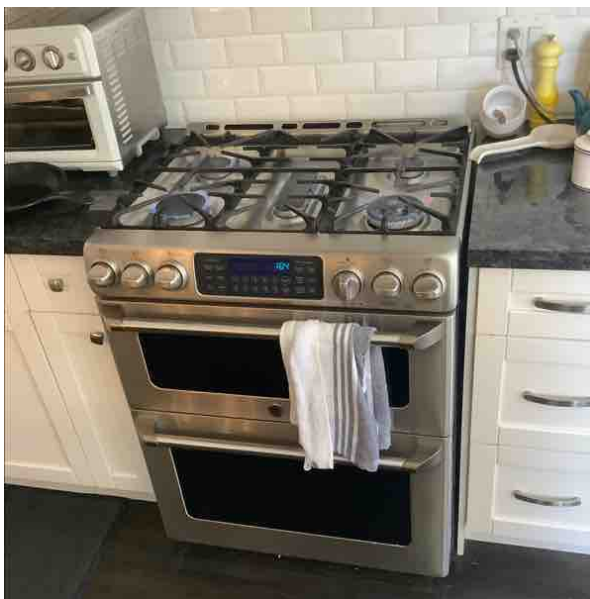
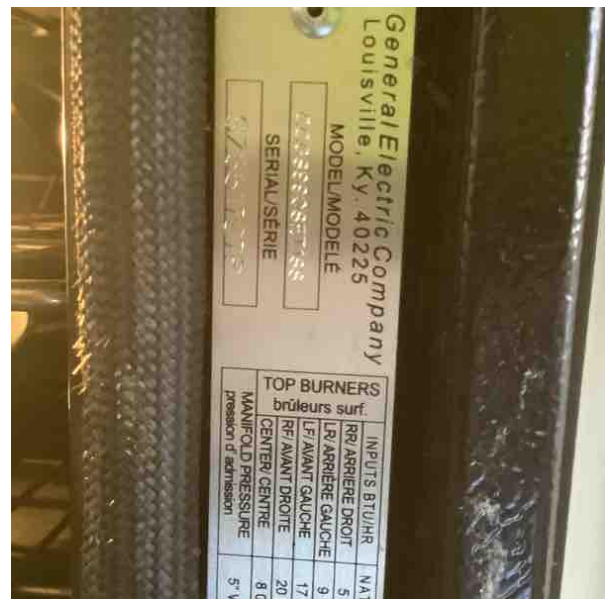
13.2.3 GE natural gas cooktop was tested and all 5 elements were functional.  
 Oven not tested.

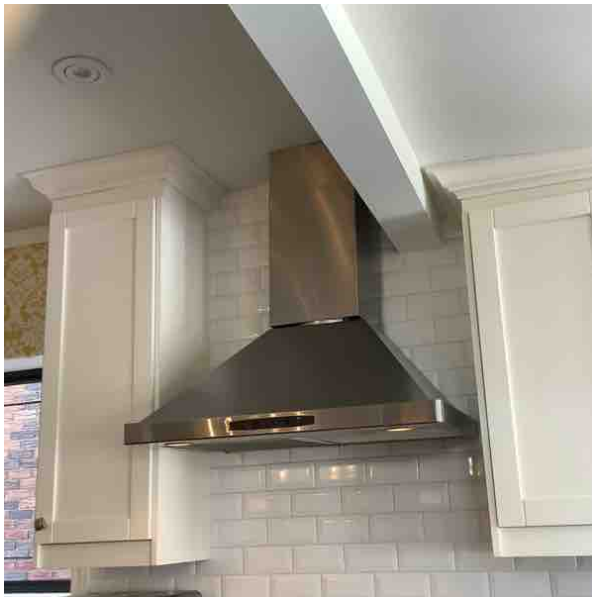
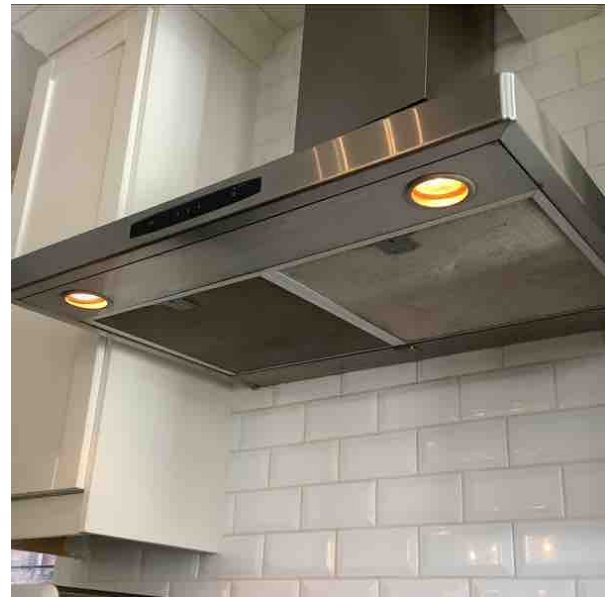
13.3.2 Range hood was tested and both fan and light features were functional.

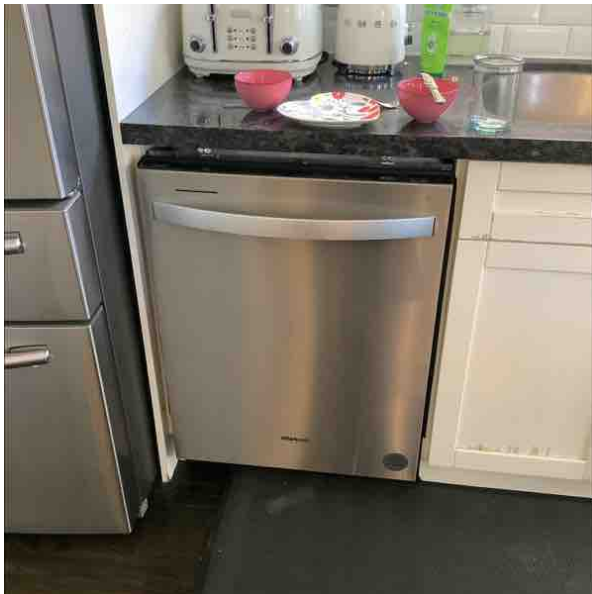
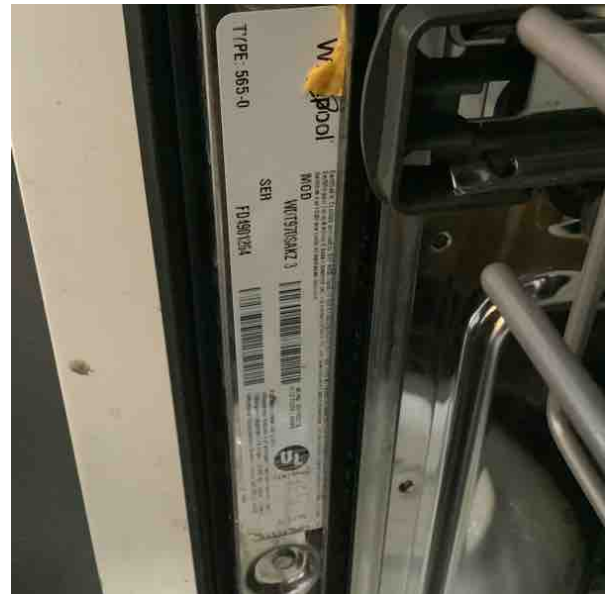
13.4.2 Whirlpool dishwasher was present, responded to operating controls but not tested on a cycle.

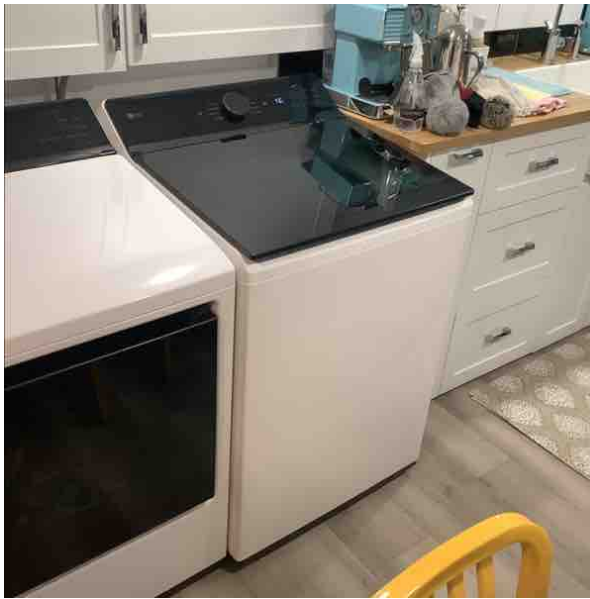
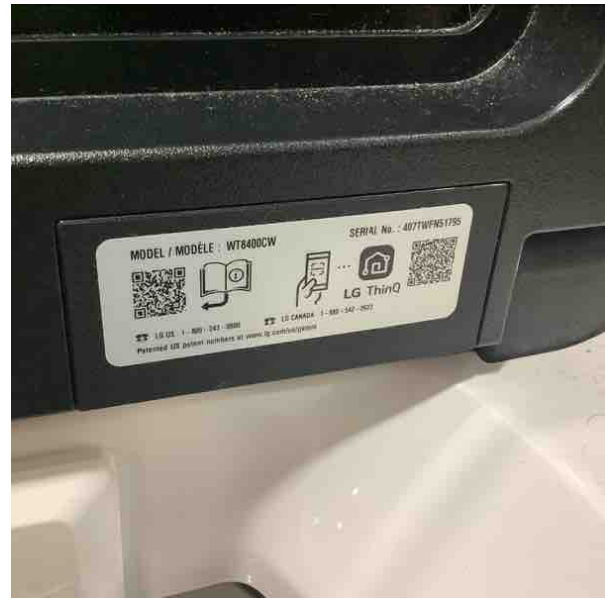
13.5.2 LG washer responded to operating controls but not tested on a cycle.

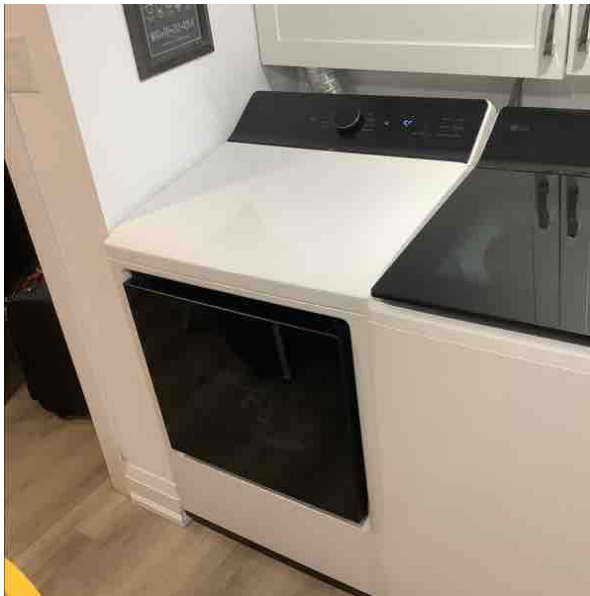
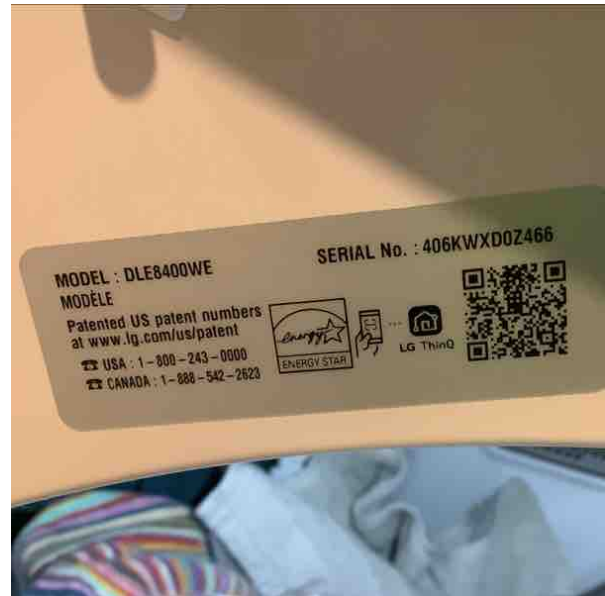
13.6.3 LG dryer responded to operating controls, was tested, and the heating coil was functional.
